**DEPARTMENT OF TRANSPORTATION**

Contract #: 04-0120F4Cty: SF/ALA Rte: 80 PM: 13.2/13.9File #: 1.28**WELDING INSPECTION REPORT****Resident Engineer:** Casey, William**Address:** 333 Burma Road**City:** Oakland, CA 94607**Report No:** WIR-028705**Date Inspected:** 03-Nov-2012**Project Name:** SAS Superstructure**OSM Arrival Time:** 700**Prime Contractor:** American Bridge/Fluor Enterprises, a JV**OSM Departure Time:** 1530**Contractor:** American Bridge/Fluor Enterprises, a JV**Location:** Job site**CWI Name:** Steve Jensen**CWI Present:** Yes No**Inspected CWI report:** Yes No N/A**Rod Oven in Use:** Yes No N/A**Electrode to specification:** Yes No N/A**Weld Procedures Followed:** Yes No N/A**Qualified Welders:** Yes No N/A**Verified Joint Fit-up:** Yes No N/A**Approved Drawings:** Yes No N/A**Approved WPS:** Yes No N/A**Delayed / Cancelled:** Yes No N/A**Bridge No:** 34-0006**Component:** OBG**Summary of Items Observed:**

13W Deck Access Hole Splice (Weld No. DAH-13W-PP124.5-W5)

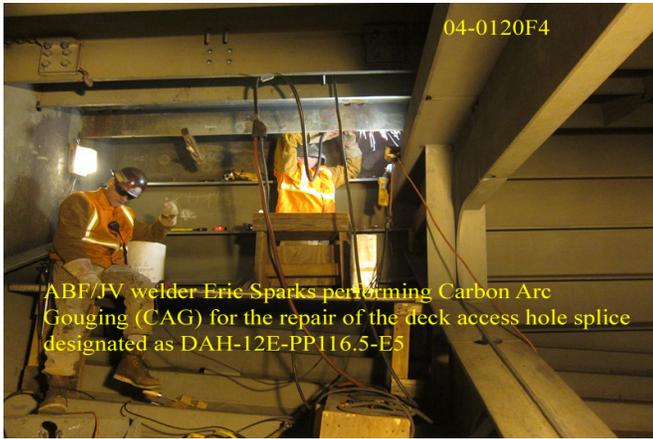
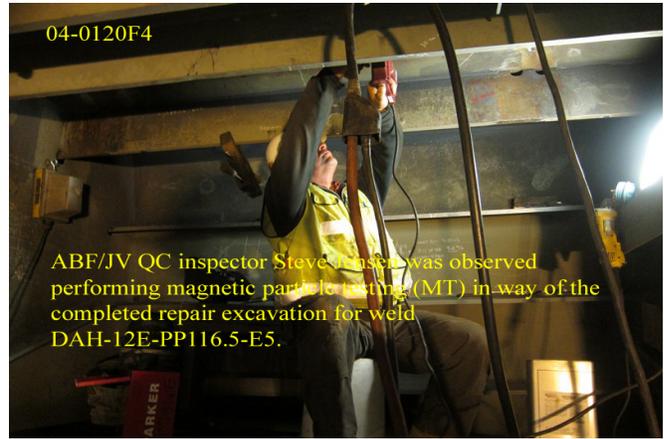
The QAI observed at random intervals ABF/JV welder Eric Sparks performing Carbon Arc Gouging (CAG) for the repair of the deck access hole splice designated as DAH-12E-PP116.5-E5. The ABF/JV QC inspector Steve Jensen was observed performing magnetic particle testing (MT) in way of the completed repair excavation at the following locations,

Y=850, Depth 5, Width 15mm, Length 140mm  
Y=1285, Depth 6, Width 25mm, Length 55mm  
Y=1520, Depth 7, Width 18mm, Length 85mm  
Y=1825, Depth 7, Width 20mm, Length 95mm  
Y=2430, Depth 8, Width 20mm, Length 125mm

The ABF welder Erick Sparks was observed later in the shift performing Shielded Metal Arc Welding (SMAW) in the 4G position utilizing the Caltrans approved Welding Procedure Specifications ABF-WPS-D1.5-1004-Repair at the above mentioned locations. The weld and surrounding area was brought to a temperature of 325°F by the use of induction heaters and maintained throughout the welding process. The QAI observed a post weld heat treatment of 450°F for one hour as required by the applicable repair document. The repairs were performed in accordance

- Y=850-RWR201210-029
- Y=1285-RWR201210-026
- Y=1520-RWR201210-027
- Y=1825-RWR201210-028
- Y=2430-RWR201210-033
