DEPARTMENT OF TRANSPORTATION

Contract #: 04-0120F4Cty: SF/ALA Rte: 80 PM: 13.2/13.9File #: 72.28**WELDING INSPECTION REPORT****Resident Engineer:** Casey, William**Address:** 333 Burma Road**City:** Oakland, CA 94607**Report No:** WIR-028728**Date Inspected:** 09-Nov-2012**Project Name:** SAS Superstructure**OSM Arrival Time:** 1000**Prime Contractor:** American Bridge/Fluor Enterprises, a JV**OSM Departure Time:** 1330**Contractor:** Lubrite**Location:** Meadville PA**CWI Name:** Reno Davis**CWI Present:** Yes No**Inspected CWI report:** Yes No N/A**Rod Oven in Use:** Yes No N/A**Electrode to specification:** Yes No N/A**Weld Procedures Followed:** Yes No N/A**Qualified Welders:** Yes No N/A**Verified Joint Fit-up:** Yes No N/A**Approved Drawings:** Yes No N/A**Approved WPS:** Yes No N/A**Delayed / Cancelled:** Yes No N/A**Bridge No:** 34-0006**Component:** Spherical Bushing Ring Bearing (Hinge K)**Summary of Items Observed:**

WELDING INSPECTION REPORT

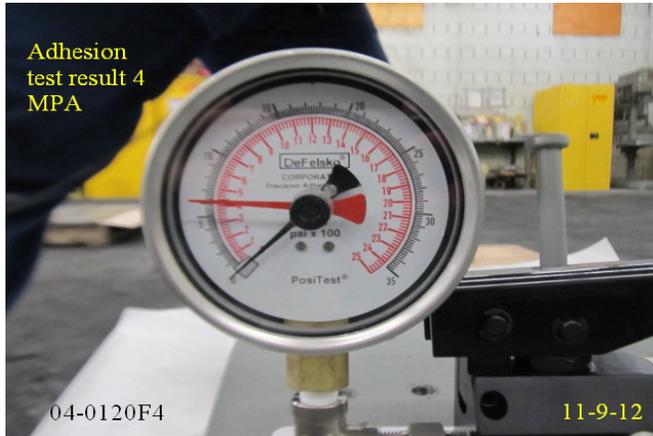
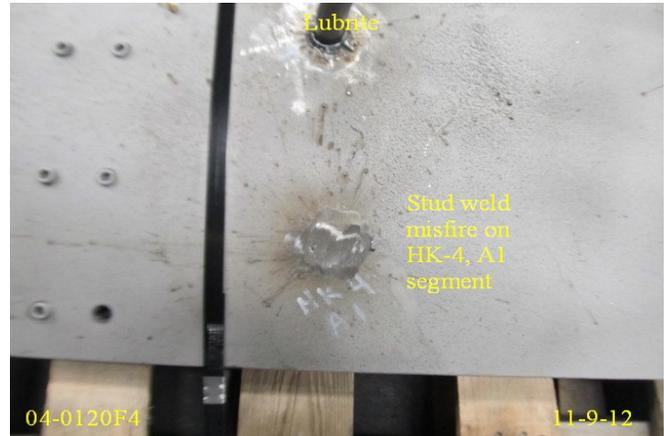
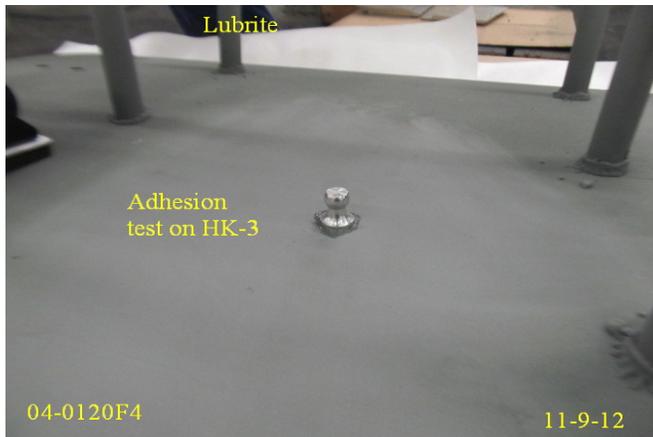
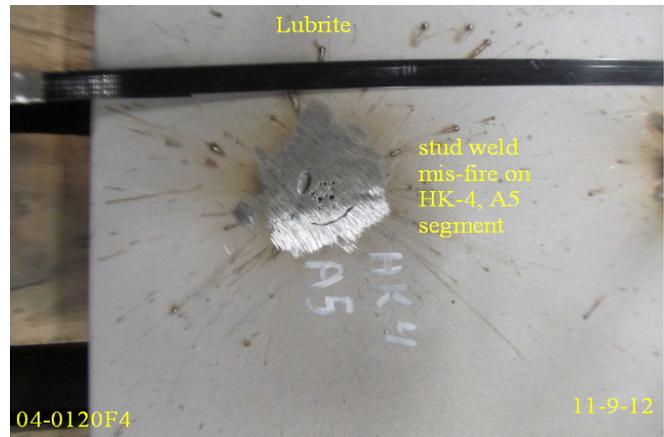
This QA Inspector met with Lubrite QC Barry Vickers for 2 of the 4 segment plates were stud welding had been performed. It was relayed to this QAI that Reno Davis from ABF was onsite for the welding inspection of the studs. This QAI observed 2 stud locations that had been applied and then removed due to non-fusion of the stud to the base material. The non-conformance of the studs to the base material would require base material repair due to the removal of the studs. These studs were rejected by the QC Reno Davis as relayed to this QAI. Due to Lubrite not having the ability to repair the base material the 2 segments, (HK-4 A1 and HK-4 A5) are to be sent to American Bridge in Coraopolis PA for repair. This QAI verified the base material in need of repair (as shown below in photos) and attached a green tag for tracking purpose to the material to be sent to American Bridge for repair. Lot number applied to the material was B350-016-12.
