DEPARTMENT OF TRANSPORTATION

Contract #: 04-0120F4Cty: SF/ALA Rte: 80 PM: 13.2/13.9File #: 1.28**WELDING INSPECTION REPORT****Resident Engineer:** Casey, William**Address:** 333 Burma Road**City:** Oakland, CA 94607**Report No:** WIR-028732**Date Inspected:** 06-Nov-2012**Project Name:** SAS Superstructure**OSM Arrival Time:** 700**Prime Contractor:** American Bridge/Fluor Enterprises, a JV**OSM Departure Time:** 1730**Contractor:** American Bridge/Fluor Enterprises, a JV**Location:** Job Site

WELDING INSPECTION REPORT

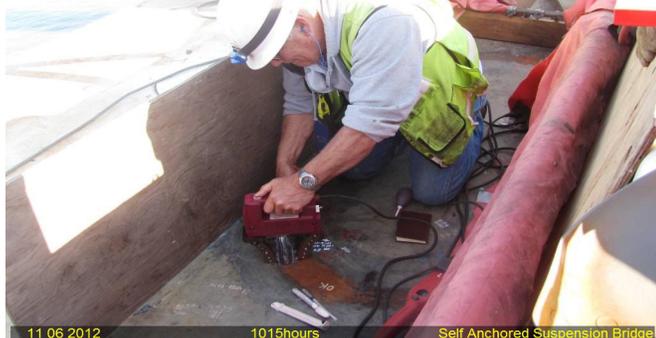
At OBG 2W-PP13.5-W2 deck access hole outside, QA randomly observed ABF/JV qualified welder Lou Xiao Hua continuing to perform CJP groove welding repair on a Non-Seismic Performance Critical Member (SPCM) due to Ultrasonic Testing (UT) detected defect on welded splice butt joint. Since these repairs are still first time repairs, Request for Weld Repair (RWR) is not yet required. The welder preheated the repair area and its vicinity to >150°F using propylene gas torch prior excavation and then ground smooth the groove of the excavation. After its completion, ABF QC Fred Michels performed Magnetic Particle Testing (MT) on the removal of the defects with no relevant defect noted during the test. This QA also performed same test verification and noted same result.

At OBG 2W-PP13.5-W2 deck access hole outside, ABF QC Fred Michels was observed performing Magnetic Particle Testing (MT) on the repair excavation prior SMAW repair welding.

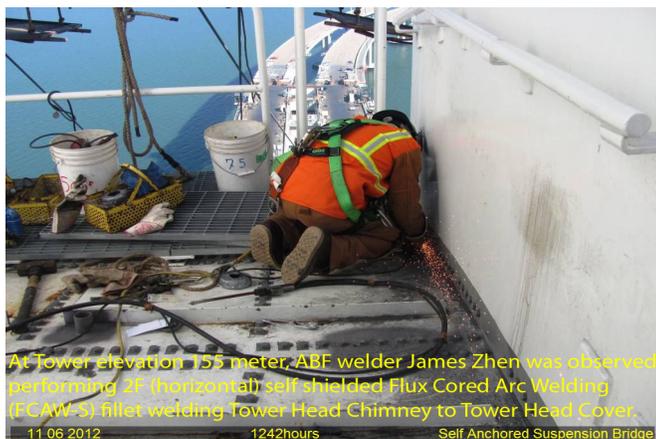
At Tower elevation 155 meters, QA randomly observed ABF welder James Zhen perform 8mm fillet welding between the Tower head cover and Tower head Chimney. The welder was noted welding in 2F (horizontal) position utilizing self-shielded Flux Cored Arc Welding (FCAW-S) with 0.072" diameter E71T-8 wire electrode implementing Caltrans Welding Procedure Specification (WPS) ABF-WPS-D15-F2200-2. Prior fillet welding, the paint coating on both sides of the joint was ground off and the plates were preheated to more than 150 degrees Fahrenheit. During the shift, QA noted ABF QC Andrew Keech was on site monitoring the in process preheats and welding parameters with measured working current of 343 amperes and voltage of 23 volts. At the end of the shift, fillet welding of the Tower head cover to Tower Chimney at East shaft North side was completed and North shaft South side was still continuing.

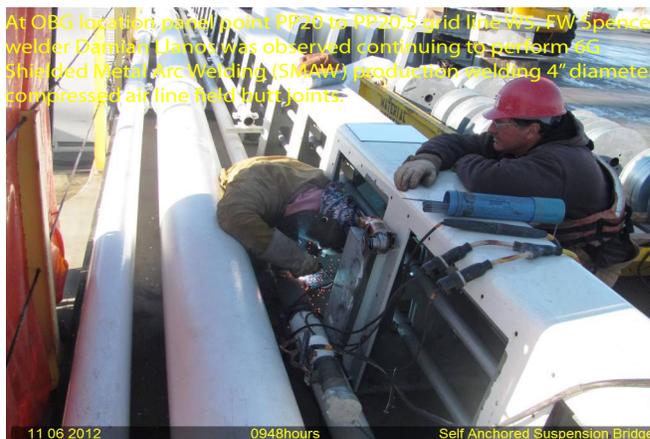
At OBG location panel point PP20 to PP20.5, this QA randomly observed FW Spencer qualified welder Damian Llanos continuing to perform Complete Joint Penetration (CJP) 6G (all position) Shielded Metal Arc Welding (SMAW) welding root pass to cover pass on 4" diameter compressed air line field branch tie-in butt joints. The welder was noted welding the branch joints on 2" diameter weldolet to 4" diameter compressed air line. The welder was noted welding the root pass with 3/32" diameter E6010 electrode and followed by fill pass to cover pass using 3/32" diameter E7018H4R electrode implementing Caltrans procedure FW Spencer WPS 1-12-1. The welder was noted preheating and removing the moisture of the joint using a portable propylene gas torch prior welding. During welding, ABF QC Steve Jensen was noted monitoring the parameters of the welder. At the end of

the FW Spencer shift, CJP welding on two (2) 4" diameter compressed air line pipe tie-in butt joints were completed.
