DEPARTMENT OF TRANSPORTATION

Office of Structural Materials

Contract #: 04-0120F4Cty: SF/ALA Rte: 80 PM: 13.2/13.9File #: 1.28**WELDING INSPECTION REPORT****Resident Engineer:** Casey, William**Address:** 333 Burma Road**City:** Oakland, CA 94607**Report No:** WIR-028734**Date Inspected:** 10-Nov-2012**Project Name:** SAS Superstructure**OSM Arrival Time:** 700**Prime Contractor:** American Bridge/Fluor Enterprises, a JV**OSM Departure Time:** 1530**Contractor:** American Bridge/Fluor Enterprises, a JV**Location:** Job Site

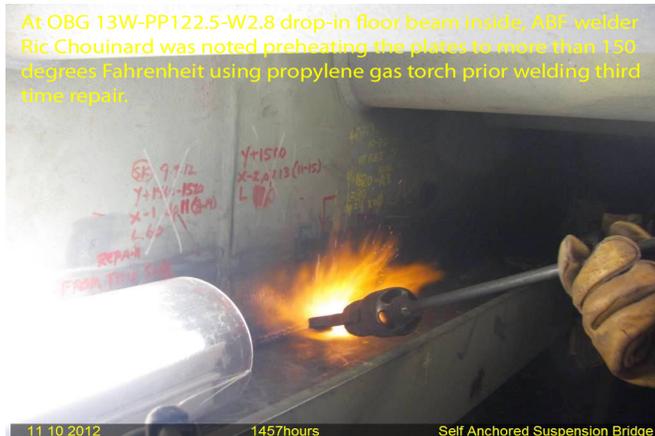
At OBG 13W-PP122.5-W2.8 drop-in floor beam inside, QA randomly observed ABF/JV qualified welder Ric Chouinard perform CJP groove welding repair (R3) on a non-Seismic Performance Critical Member (SPCM) due to Ultrasonic Testing (UT) detected defect on welded T- joint. The third time repair is being welded per Caltrans approved Request for Weld Repair (RWR) #201211-002. The welder preheated the repair area and its vicinity to >150°F using propylene gas torch prior excavation and then ground smooth the groove of the excavation. After its completion, ABF QC Salvador Merino performed Magnetic Particle Testing (MT) on the removal of the defects with no relevant defect noted during the test. This QA also performed same test verification and noted same result. The repair excavation was measured 90mm long x 15mm wide x 5mm deep.

The welder was noted using propylene gas torch to preheat the repair area and its vicinity to 150°F and as soon as the required temperature was attained the welder started performing the welding repair. Welder Ric Chouinard was observed manually welding in 2G (horizontal) position utilizing Shielded Metal Arc Welding (SMAW) with 3.2mm and 4.0mm diameter E7018H4R electrode implementing Caltrans welding procedure ABF-WPS-D15-1000 Repair. During welding, ABF QC Salvador Merino was noted monitoring the welder's welding parameter with measured working current of 126 amperes on the 3.2mm diameter E7018H4R electrodes. At the end of the shift, repair welding at the location mentioned above was completed.

At OBG 13W-PP122.5-W2.8 drop-in floor beam inside, ABF welder Ric Chouinard was noted preheating the plates to more than 150 degrees Fahrenheit using propylene gas torch prior welding third time repair.

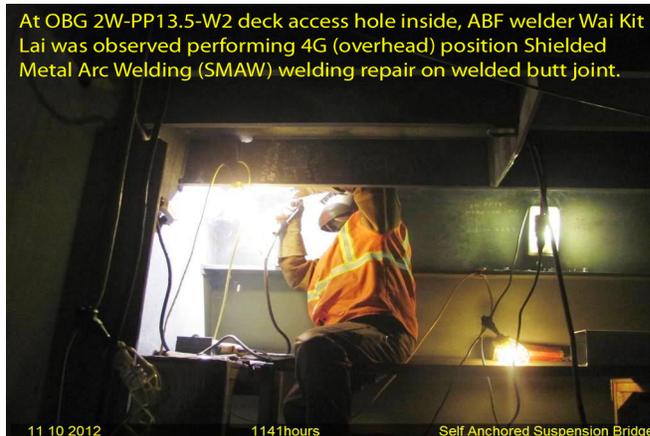
At OBG 2W-PP13.5-W2 deck access hole outside, QA randomly observed ABF/JV qualified welder Wai Kit Lai continuing to perform CJP groove welding repair on a non-Seismic Performance Critical Member (SPCM) due to Ultrasonic Testing (UT) detected defect on welded butt joint. Since these repairs are still second time repairs, Request for Weld Repair (RWR) is not yet required. The welder preheated the repair area and its vicinity to >150°F using propylene gas torch prior excavation and then ground smooth the groove of the excavation. After its completion, ABF QC Brien Connolly performed Magnetic Particle Testing (MT) on the removal of the defects with no relevant defect noted during the test. This QA also performed same test verification and noted same result.

The welder was noted using propylene gas torch to preheat the repair area and its vicinity to 150°F and as soon as the required temperature was attained the welder started performing the welding repair. Welder Wai Kit Lai was observed manually welding in 4G (overhead) position utilizing Shielded Metal Arc Welding (SMAW) with 3.2mm and 4.0mm diameter E7018H4R electrode implementing Caltrans approved welding procedure ABF-WPS-D15-1000 Repair. Welder Wai Kit Lai was noted welding at various Y locations. During welding, ABF QC Barry Drake was noted monitoring the welder's welding parameter with measured working current of 128 amperes on the 3.2mm diameter E7018H4R electrodes. At the end of the shift, repair welding at the various locations was still continuing and should remain Monday.

1. 3940mm 70mm 20mm 10mm N/A R2- completed.
2. 3920mm 70mm 20mm 10mm N/A R2- completed.
3. 3620/3580mm 120mm 40mm 13mm N/A R2- combined excavation.
Completed.

At OBG 2W-PP13.5-W2 deck access hole inside, ABF welder Wai Kit Lai was observed performing 4G (overhead) position Shielded Metal Arc Welding (SMAW) welding repair on welded butt joint.

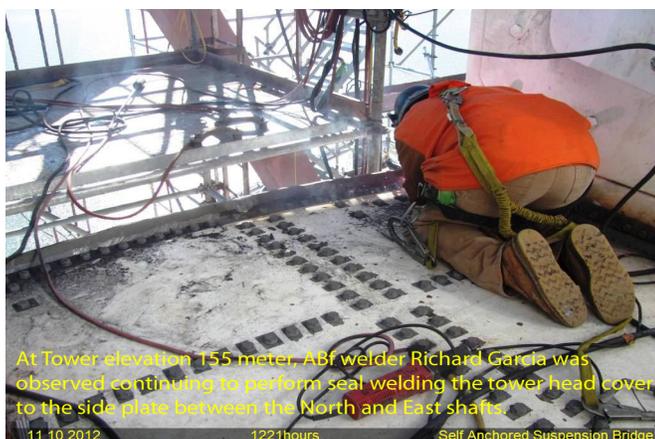
At Tower elevation 155 meters, QA randomly observed ABF welder Richard Garcia continuing to perform fillet welding between the Tower head cover and Tower head Chimney. The welder was noted welding in 2F (horizontal) position utilizing self-shielded Flux Cored Arc Welding (FCAW-S) with 0.072" diameter E71T-8 wire electrode implementing Caltrans Welding Procedure Specification (WPS) ABF-WPS-D15-F2200-2. Prior fillet welding, the paint coating on both sides of the joint was ground off and the plates were preheated to more than 150 degrees Fahrenheit. During the shift, QA noted ABF QC Fred Michels was on site monitoring the in process preheats and welding parameters with measured working current of 340 amperes and voltage of 23 volts. At the end of the shift, fillet welding of the Tower head cover to Tower Chimney at the south side between the Tower shafts South and East was completed.

At Tower elevation 155 meter, ABF welder Richard Garcia was observed continuing to perform seal welding the tower head cover to the side plate between the North and East shafts.

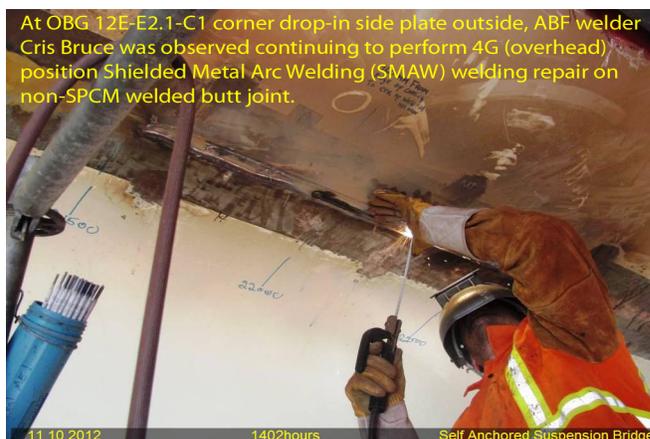
At OBG 12E-E2.1-C1 corner drop-in side plate outside, ABF welder Cris Bruce was observed continuing to perform 4G (overhead) position Shielded Metal Arc Welding (SMAW) welding repair on non-SPCM welded butt joint.
