Contract #: 04-0120F4Cty: SF/ALA Rte: 80 PM: 13.2/13.9File #: 74.28**WELDING INSPECTION REPORT**

**Report No:** WIR-028754  
**Date Inspected:** 12-Nov-2012

**Project Name:** SAS Superstructure  
**Prime Contractor:** American Bridge/Fluor Enterprises, a JV  
**Contractor:** Goodwin Steel, UK

**Bridge No:** 34-0006**Component:** Type B16 Supplemental Cable Bands after pro**Summary of Items Observed:**

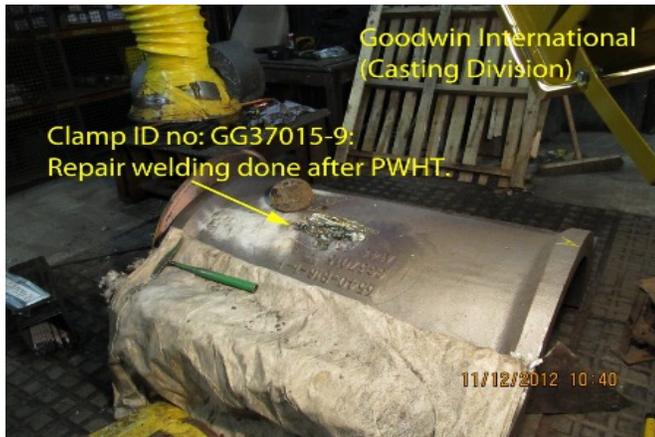
Repair welding is in progress for Clamp ID No: GG37015-9. Welder was identified as Mr. Witold Kaminski and the welding process was identified as Shielded Metal Arc Welding (SMAW). Welding was observed to be done in 1G position. Welding was done as per welding procedure specification (WPS): WPS04-0120F4A Issue-5.

After completion of post weld heat treatment (PWHT), magnetic particle inspection (MPI) was done on the casting surfaces during which, these two locations were identified for repair. It is the first time repair on these locations (when verified with the areas identified for repair – before PWHT).

After completion of weld repair, this QA Inspector along with the Certified Welding Inspector (CWI), Mr. Fred, performed visual inspection of this repaired area. MPI was also performed on the repaired location (as per

procedure: MT06-09-02 Rev - 5). No relevant indications were observed.
