DEPARTMENT OF TRANSPORTATION

Contract #: 04-0120F4Cty: SF/ALA Rte: 80 PM: 13.2/13.9File #: 1.28**WELDING INSPECTION REPORT****Resident Engineer:** Casey, William**Address:** 333 Burma Road**City:** Oakland, CA 94607**Report No:** WIR-028774**Date Inspected:** 20-Nov-2012**Project Name:** SAS Superstructure**OSM Arrival Time:** 700**Prime Contractor:** American Bridge/Fluor Enterprises, a JV**OSM Departure Time:** 1730**Contractor:** American Bridge/Fluor Enterprises, a JV**Location:** Job site**CWI Name:** Jesse Cayabyab**CWI Present:** Yes No**Inspected CWI report:** Yes No N/A**Rod Oven in Use:** Yes No N/A**Electrode to specification:** Yes No N/A**Weld Procedures Followed:** Yes No N/A**Qualified Welders:** Yes No N/A**Verified Joint Fit-up:** Yes No N/A**Approved Drawings:** Yes No N/A**Approved WPS:** Yes No N/A**Delayed / Cancelled:** Yes No N/A**Bridge No:** 34-0006**Component:** Tower ESW**Summary of Items Observed:**

Tower ESW "V"

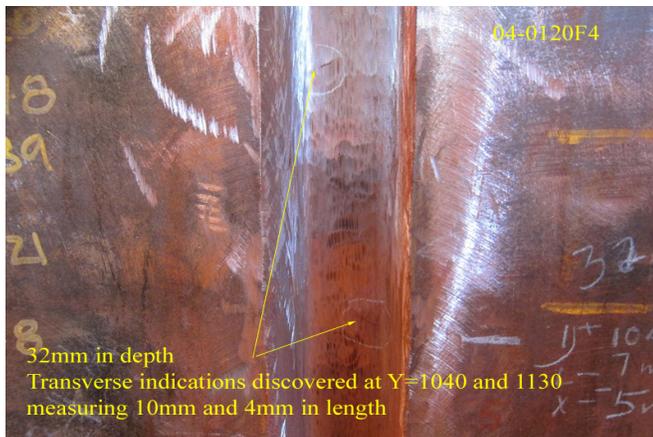
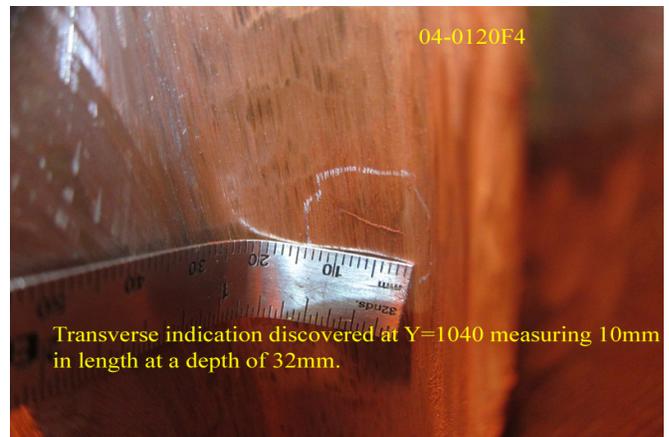
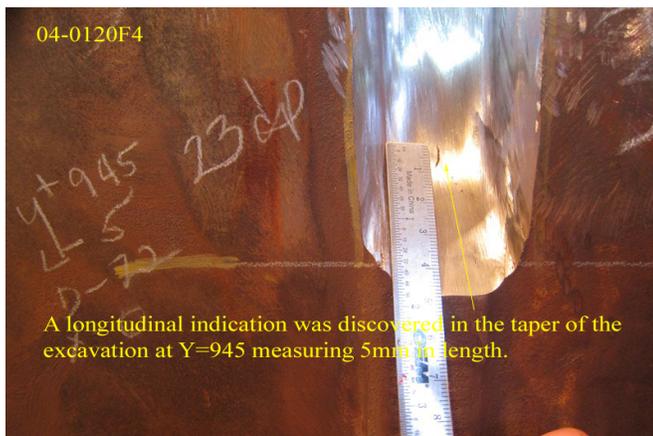
This QA observed ABF/JV welding personnel performing an exploratory excavation of an Electroslag Weld ESW "V" from face B. The exploratory excavation was performed to determine validity a 6db drop technique for the determination of height, on the linear recordable indications present in the electro slag welds. A total of six indications from the ultrasonic test report were excavated in one single excavation at 1~2mm intervals by the use of a grinder from Y=970~1220 for indications that showed the following ultrasonic response on the ABF QC test report;

Magnetic Particle Testing was performed by both QC and QA once the grinding was achieved to the sought depth. The starting depth of excavation on this date was a continuation from the previous shift. The results of the exploratory excavations are as follows;

A longitudinal indication was discovered in the taper of the excavation at Y=945 measuring 5mm in length. The indication was ground from a depth of 22mm~26mm until ABF QC was unable to detect with magnetic particle testing.
