DEPARTMENT OF TRANSPORTATION

Contract #: 04-0120F4Cty: SF/ALA Rte: 80 PM: 13.2/13.9File #: 1.28**WELDING INSPECTION REPORT****Resident Engineer:** Casey, William**Address:** 333 Burma Road**City:** Oakland, CA 94607**Report No:** WIR-028775**Date Inspected:** 19-Nov-2012**Project Name:** SAS Superstructure**OSM Arrival Time:** 700**Prime Contractor:** American Bridge/Fluor Enterprises, a JV**OSM Departure Time:** 1730**Contractor:** American Bridge/Fluor Enterprises, a JV**Location:** Job site**CWI Name:** Jesse Cayabyab**CWI Present:** Yes No**Inspected CWI report:** Yes No N/A**Rod Oven in Use:** Yes No N/A**Electrode to specification:** Yes No N/A**Weld Procedures Followed:** Yes No N/A**Qualified Welders:** Yes No N/A**Verified Joint Fit-up:** Yes No N/A**Approved Drawings:** Yes No N/A**Approved WPS:** Yes No N/A**Delayed / Cancelled:** Yes No N/A**Bridge No:** 34-0006**Component:** Tower ESW**Summary of Items Observed:**

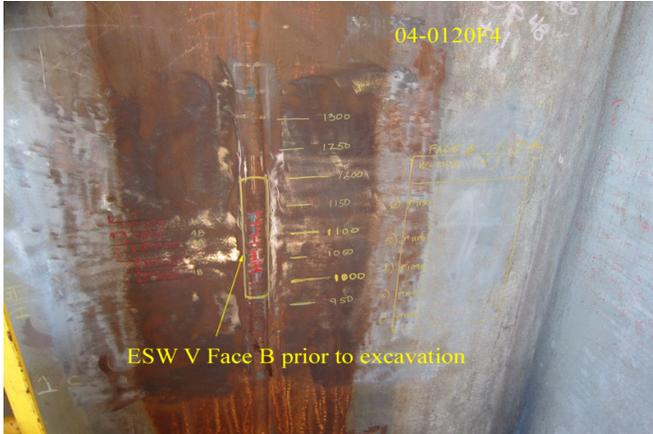
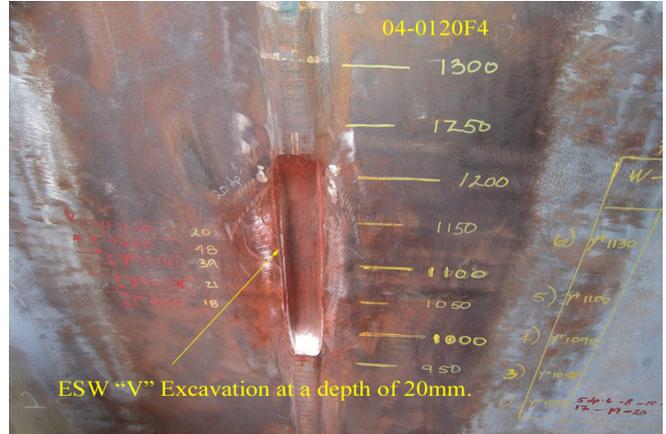
This QA observed ABF/JV welding personnel performing an exploratory excavation of an Electroslag Weld ESW "V" from face B. The exploratory excavation was performed to determine the validity of a 6db drop technique for the determination of height, on the linear recordable indications present in the electro slag welds. A total of six indications from the ultrasonic test report were excavated in one single excavation at 1~2mm intervals by the use of a grinder from Y=970~1220, for indications that showed the following ultrasonic response on the ABF QC test report;

Magnetic Particle Testing was performed by both QC and QA once the grinding was achieved to the sought depth. The results of the exploratory excavations are as follows;

5mm~27mm in depth ground in 1mm~2mm intervals – No indications found
