DEPARTMENT OF TRANSPORTATION

Contract #: 04-0120F4Cty: SF/ALA Rte: 80 PM: 13.2/13.9File #: 1.28**WELDING INSPECTION REPORT****Resident Engineer:** Casey, William**Address:** 333 Burma Road**City:** Oakland, CA 94607**Report No:** WIR-028791**Date Inspected:** 29-Nov-2012**Project Name:** SAS Superstructure**OSM Arrival Time:** 700**Prime Contractor:** American Bridge/Fluor Enterprises, a JV**OSM Departure Time:** 1730**Contractor:** American Bridge/Fluor Enterprises, a JV**Location:** Job Site**CWI Name:** As noted below**CWI Present:** Yes No**Inspected CWI report:** Yes No N/A**Rod Oven in Use:** Yes No N/A**Electrode to specification:** Yes No N/A**Weld Procedures Followed:** Yes No N/A**Qualified Welders:** Yes No N/A**Verified Joint Fit-up:** Yes No N/A**Approved Drawings:** Yes No N/A**Approved WPS:** Yes No N/A**Delayed / Cancelled:** Yes No N/A**Bridge No:** 34-0006**Component:** SAS OBG**Summary of Items Observed:**

WELDING INSPECTION REPORT

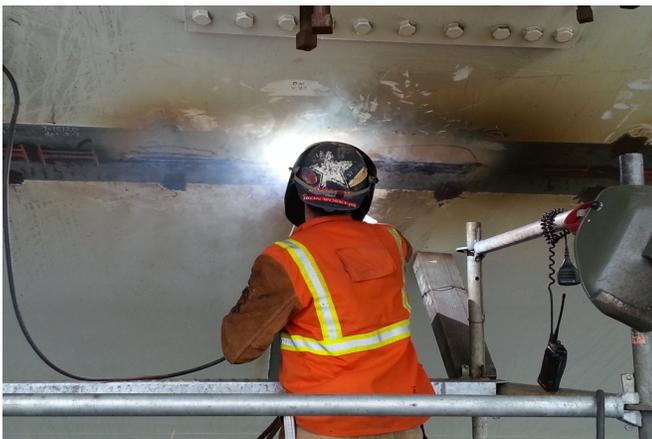
ABF welder Mike Jimenez #4671 was observed performing ongoing weld repairs on weld 12E-E2.1-C1.1 at y=12, 900mm. The dimensions of the excavation were noted as 60L/20W/8D. The welder was observed utilizing WPS ABF-WPS-D15-1004-Repair-Revision 0 for SMAW. The welder was observed preheating the welds prior to Carbon Arc Gouging and welding. Other welding parameters as inspected by the QC Inspector appeared to be in compliance with the WPS noted above. RWR-201210-016 was referenced during this weld repair.

ABF welder Chris Bruce #8901 was observed performing ongoing weld repairs on weld 12W-W2.1-C1.1 at y=24, 370mm to 24,050mm. The dimensions of the excavation were noted as 320L/45W/10D. At 23,770mm to 23,000mm; the dimensions of the excavation were noted as 770L/45W/12D. The welder was observed utilizing WPS ABF-WPS-D15-1000-Repair-Revision 2 for SMAW. The welder was observed preheating the welds prior to Carbon Arc Gouging and welding. Other welding parameters as inspected by QC Inspector appeared to be in compliance with the WPS noted above. RWR-201211-005 was referenced during this weld repair.

ABF welder Richard Chouard #8959 was observed performing ongoing weld repairs on weld 12W-W2.1-C1.1 at y=15,000mm to 14,000mm. The dimensions of the excavation were noted as 1000L/42W/10D. The welder was observed utilizing WPS ABF-WPS-D15-1004-Repair-Revision 0 for SMAW. The welder was observed preheating the welds prior to Carbon Arc Gouging and welding. Other welding parameters as inspected by the QC Inspector appeared to be in compliance with the WPS noted above. RWR-201211-005 was referenced during this weld repair.
