DEPARTMENT OF TRANSPORTATION

Contract #: 04-0120F4Cty: SF/ALA Rte: 80 PM: 13.2/13.9File #: 1.28**WELDING INSPECTION REPORT****Resident Engineer:** Casey, William**Address:** 333 Burma Road**City:** Oakland, CA 94607**Report No:** WIR-028792**Date Inspected:** 28-Nov-2012**Project Name:** SAS Superstructure**OSM Arrival Time:** 700**Prime Contractor:** American Bridge/Fluor Enterprises, a JV**OSM Departure Time:** 1730**Contractor:** American Bridge/Fluor Enterprises, a JV**Location:** Job Site**CWI Name:** See below.**CWI Present:** Yes No**Inspected CWI report:** Yes No N/A**Rod Oven in Use:** Yes No N/A**Electrode to specification:** Yes No N/A**Weld Procedures Followed:** Yes No N/A**Qualified Welders:** Yes No N/A**Verified Joint Fit-up:** Yes No N/A**Approved Drawings:** Yes No N/A**Approved WPS:** Yes No N/A**Delayed / Cancelled:** Yes No N/A**Bridge No:** 34-0006**Component:** OBG**Summary of Items Observed:**

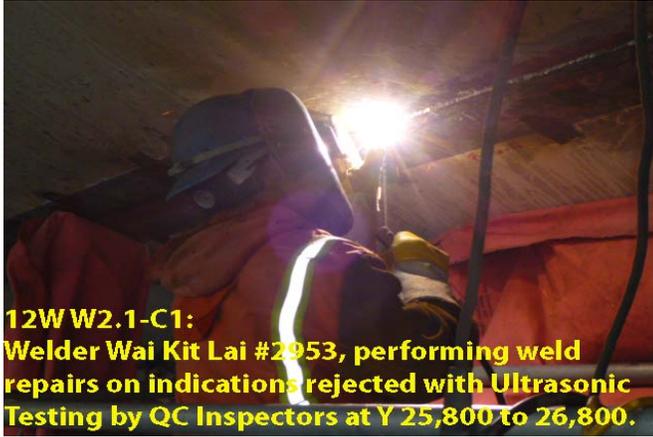
Welder was observed performing R1 exterior weld repairs on weld 12W W2.1-C1 indications rejected with Ultrasonic Testing (UTSW) by QC Inspectors between Y 25,800 and 26,800. Welder was observed utilizing Welding Procedure Specification (WPS) ABF-WPS-D15-1000 Repair for Shielded Metal Arc Welding (SMAW). Welder was observed preheating the weld prior to welding. Welding parameters as verified by QC Inspector William Sherwood appear to be in compliance with the WPS noted above. Weld sections at Y 18,600 to 31,000 is non SPCM, a "Request for Weld Repair" or (RWR) is not required for R1 repairs.

12W W2.1-C1:
Welder Wai Kit Lai #2953, performing weld repairs on indications rejected with Ultrasonic Testing by QC Inspectors at Y 25,800 to 26,800.

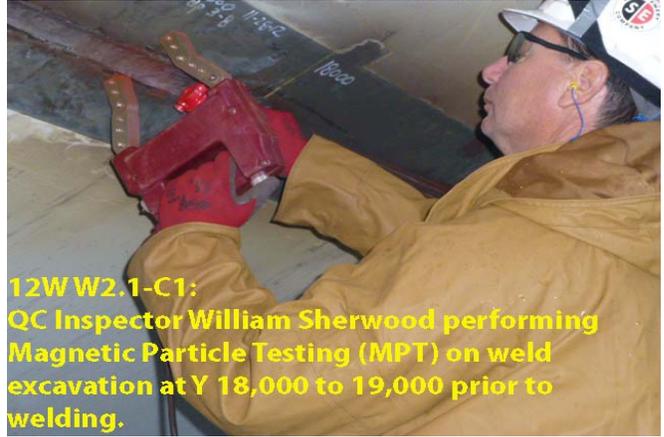
- Exterior Excavation 1000 x 45 x 10 Deep at Y 18,000 to 19,000 (Accept)

12W W2.1-C1:
QC Inspector William Sherwood performing Magnetic Particle Testing (MPT) on weld excavation at Y 18,000 to 19,000 prior to welding.
