**DEPARTMENT OF TRANSPORTATION**

Contract #: 04-0120F4Cty: SF/ALA Rte: 80 PM: 13.2/13.9File #: 1.28**WELDING INSPECTION REPORT****Resident Engineer:** Casey, William**Address:** 333 Burma Road**City:** Oakland, CA 94607**Report No:** WIR-028794**Date Inspected:** 27-Nov-2012**Project Name:** SAS Superstructure**OSM Arrival Time:** 700**Prime Contractor:** American Bridge/Fluor Enterprises, a JV**OSM Departure Time:** 1730**Contractor:** American Bridge/Fluor Enterprises, a JV**Location:** Job Site

# WELDING INSPECTION REPORT

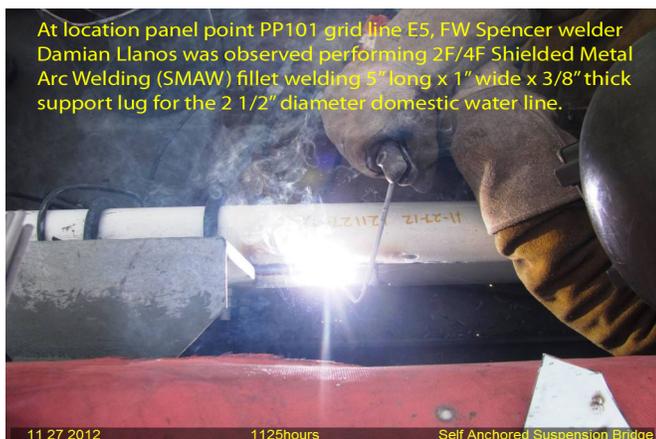
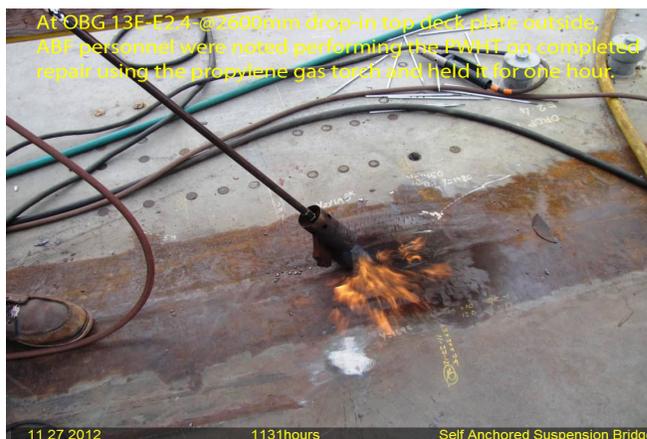
The QAI observe the ongoing installation, field fit-up and tack welding of the utility pipe support lug 5” long x 1” wide x 3/8” thick along the E5 grid line (panel point PP101). The lug pipe support was fillet welded on both sides of the 2 1/2” diameter domestic water line and 4” diameter compressed air line. The QC inspection was performed by Steve Jensen utilizing the Welding Procedure Specification (WPS) identified as Fillet Murex to monitor the tack welding and fillet welding to verify the welding parameters. The welding parameters were observed and recorded as 90 amps utilizing 2.4 mm electrodes with the welding performed in the 2F/4F positions. The tack welding/fillet welding was performed and completed by FW Spencer welder Damian Llanos. At the end of the shift, two (2) support lugs welded on each line were completed.
