DEPARTMENT OF TRANSPORTATION

Office of Structural Materials

Contract #: 04-0120F4Cty: SF/ALA Rte: 80 PM: 13.2/13.9File #: 1.28**WELDING INSPECTION REPORT****Resident Engineer:** Casey, William**Address:** 333 Burma Road**City:** Oakland, CA 94607**Report No:** WIR-028803**Date Inspected:** 26-Nov-2012**Project Name:** SAS Superstructure**OSM Arrival Time:** 700**Prime Contractor:** American Bridge/Fluor Enterprises, a JV**OSM Departure Time:** 1730**Contractor:** American Bridge/Fluor Enterprises, a JV**Location:** Job Site**CWI Name:** As noted below.**CWI Present:** Yes No**Inspected CWI report:** Yes No N/A**Rod Oven in Use:** Yes No N/A**Electrode to specification:** Yes No N/A**Weld Procedures Followed:** Yes No N/A**Qualified Welders:** Yes No N/A**Verified Joint Fit-up:** Yes No N/A**Approved Drawings:** Yes No N/A**Approved WPS:** Yes No N/A**Delayed / Cancelled:** Yes No N/A**Bridge No:** 34-0006**Component:** Tower**Summary of Items Observed:**

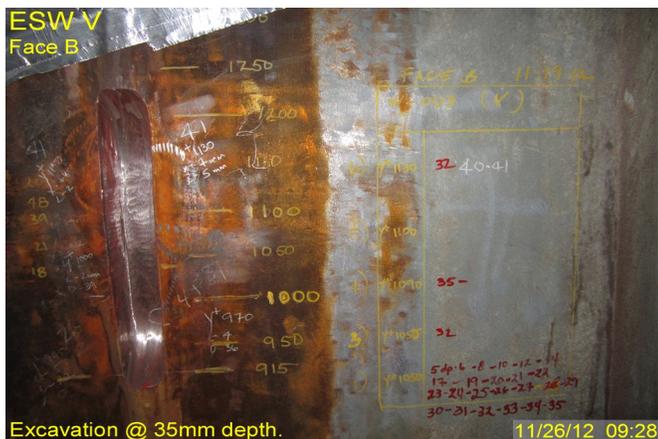
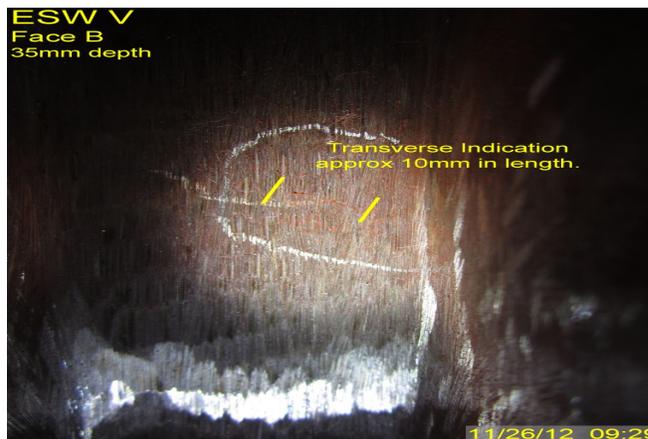
This QA performed observation of excavation of Electroslag Weld (ESW) designated as ESW V. Excavation was performed at location (Y= 912mm~1200mm). This work was initiated on a previous days shift and this QA started observation at the excavated depth of 41mm.

Y= 1210 possible longitudinal, exploration required to ascertain length.

* Longitudinal indication was discovered on the slope of the excavation. Overall length of the excavation will be expanded so that we may better observe the length of the indication.
