DEPARTMENT OF TRANSPORTATION

Contract #: 04-0120F4Cty: SF/ALA Rte: 80 PM: 13.2/13.9File #: 1.28**WELDING INSPECTION REPORT**

Report No: WIR-028804
Date Inspected: 27-Nov-2012

Project Name: SAS Superstructure
Prime Contractor: American Bridge/Fluor Enterprises, a JV
Contractor: American Bridge/Fluor Enterprises, a JV

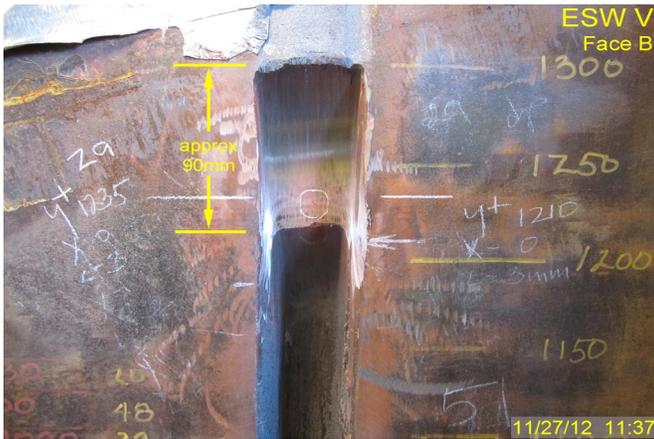
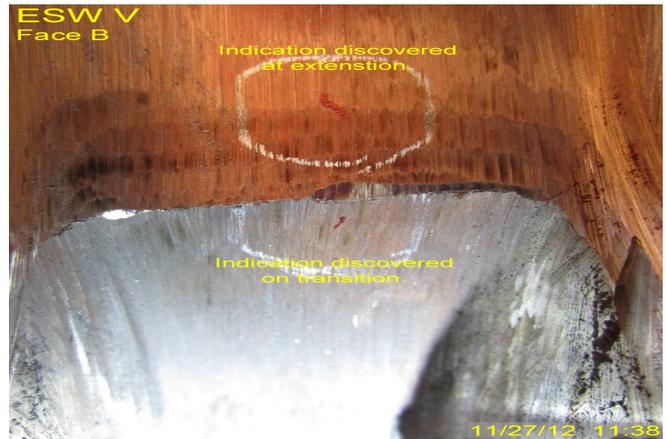
This QA performed observation of excavation of Electroslag Weld (ESW) designated as ESW V. Excavation was performed at location (Y= 912mm~1275mm). Excavation length was increased by approximately 75mm to investigate possible planar indication at (Y= 1210mm). Depth measurements represent excavation of extended region.

Y= 1255 Transverse indication observed on slope at approximately 37mm in depth.

Y= 1255 Transverse indication observed on slope at approximately 38mm in depth.

Excavation has been halted at end of shift.

Excavation was performed by ABF personnel Reginald Humphrey using a mechanical grinder removing approximately 1mm at a time. This QA observed Quality Control Inspector Jesse Cayabyab performing visual inspection and Magnetic Particle Testing (MT) of this excavation between passes. This QA performed visual inspection and intermittent verification MT of this excavation between passes.
