**DEPARTMENT OF TRANSPORTATION**

Contract #: 04-0120F4Cty: SF/ALA Rte: 80 PM: 13.2/13.9File #: 1.28**WELDING INSPECTION REPORT****Resident Engineer:** Casey, William**Address:** 333 Burma Road**City:** Oakland, CA 94607**Report No:** WIR-028809**Date Inspected:** 01-Dec-2012**Project Name:** SAS Superstructure**OSM Arrival Time:** 700**Prime Contractor:** American Bridge/Fluor Enterprises, a JV**OSM Departure Time:** 1530**Contractor:** American Bridge/Fluor Enterprises, a JV**Location:** Job Site

**Bridge No:** 34-0006**Component:** SAS OBG**Summary of Items Observed:**

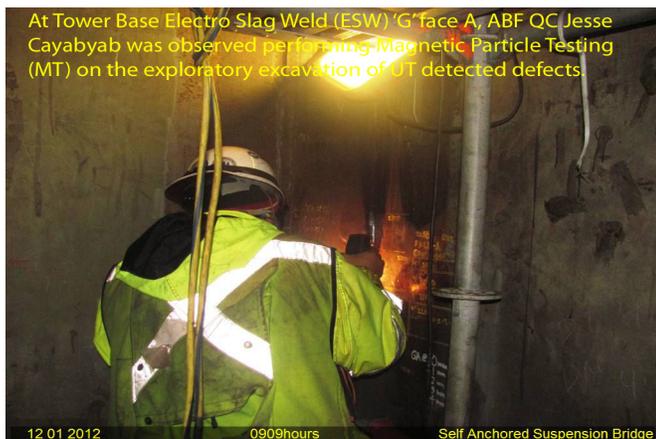
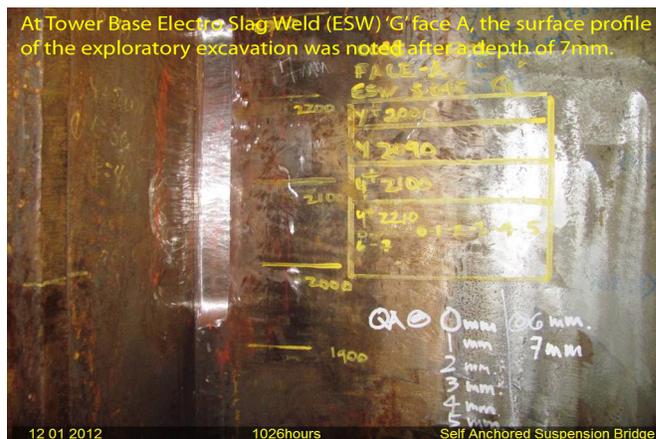
At Tower Base Electro Slag Weld (ESW) 'G' weld joint #S-045, ABF personnel was observed continuing to perform exploratory excavation on welded ESW at locations Y=2000, Y=2090, Y=2100 and Y=2210mm due to UT detected defects. The ABF personnel have resumed the exploratory excavation from 4mm deep where they left off Friday. The personnel were noted using only the disc grinder in every 1mm increments of excavation. ABF QC Jesse Cayabyab was observed performing Magnetic Particle Testing (MT) on the following various depths with no significant indication noted so far. This QA also performed the same test and noted same result. During the shift, the ABF personnel continued the excavation in 1mm increments using the same method of test and verification up to 15mm with same result. The shift was completed up to this depth of excavation.

The starting depth of excavation on this date was a continuation from the previous shift. The results of the exploratory excavations are as follows;

1. 5mm in depth – no significant indication noted.
2. 6mm in depth – no significant indication noted.
3. 7mm in depth – no significant indication noted.
4. 8mm in depth – no significant indication noted.
5. 9mm in depth – no significant indication noted.

- 6. 10mm in depth – no significant indication noted.
- 7. 11mm in depth – no significant indication noted.
- 8. 12mm in depth – no significant indication noted.
- 9. 13mm in depth – no significant indication noted.
- 10. 14mm in depth – no significant indication noted.
- 11. 15mm in depth – no significant indication noted.
