DEPARTMENT OF TRANSPORTATION

Contract #: 04-0120F4Cty: SF/ALA Rte: 80 PM: 13.2/13.9File #: 1.28**WELDING INSPECTION REPORT****Resident Engineer:** Casey, William**Address:** 333 Burma Road**City:** Oakland, CA 94607**Report No:** WIR-028830**Date Inspected:** 15-Nov-2012**Project Name:** SAS Superstructure**OSM Arrival Time:** 700**Prime Contractor:** American Bridge/Fluor Enterprises, a JV**OSM Departure Time:** 1730**Contractor:** American Bridge/Fluor Enterprises, a JV**Location:** Job Site**CWI Name:** Fred Michels and Barry Drake**CWI Present:** Yes No**Inspected CWI report:** Yes No N/A**Rod Oven in Use:** Yes No N/A**Electrode to specification:** Yes No N/A**Weld Procedures Followed:** Yes No N/A**Qualified Welders:** Yes No N/A**Verified Joint Fit-up:** Yes No N/A**Approved Drawings:** Yes No N/A**Approved WPS:** Yes No N/A**Delayed / Cancelled:** Yes No N/A**Bridge No:** 34-0006**Component:** SAS OBG**Summary of Items Observed:**

WELDING INSPECTION REPORT

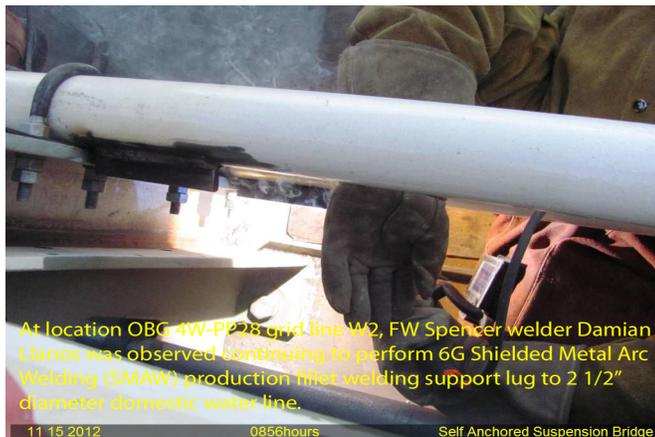
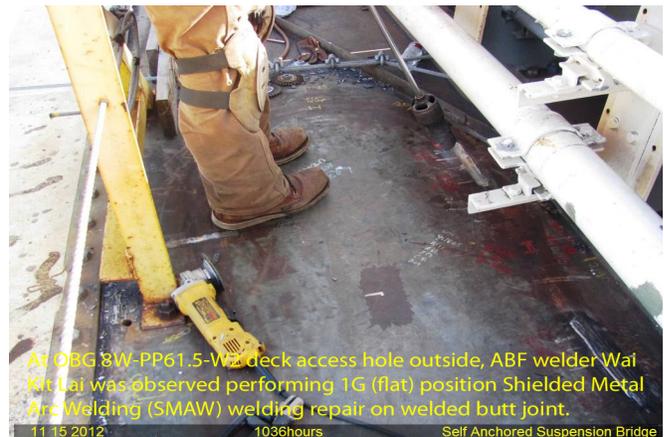
The QAI observe the ongoing installation, field fit-up and tack welding of the utility pipe support lug 5” long x 1” wide x 3/8” thick along the W2 grid line (panel point PP28). The lug pipe support was fillet welded on both sides of the 2 ½” diameter domestic water line and 4” diameter compressed air line. The QC inspection was performed by Barry Drake utilizing the Welding Procedure Specification (WPS) identified as Fillet Murex to monitor the tack welding and fillet welding to verify the welding parameters. The welding parameters were observed and recorded as 90 amps utilizing 2.4 mm electrodes with the welding performed in the 2F/4F positions. The tack welding/fillet welding was performed and completed by FW Spencer welder Damian Llanos. At the end of the shift, two (2) support lugs welded on each line were completed.

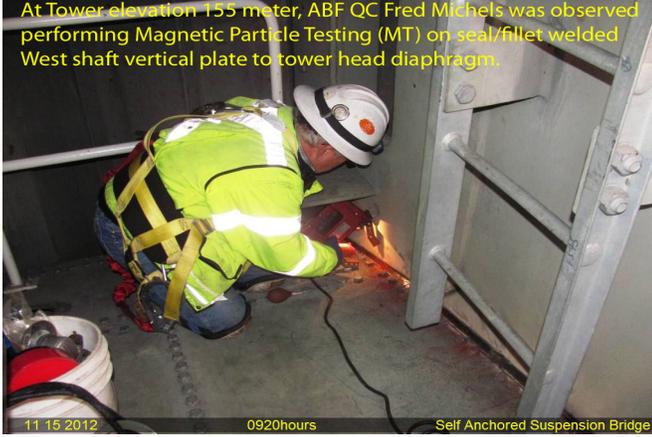
At Tower elevation 155 meter, ABF QC Fred Michels was observed performing Magnetic Particle Testing (MT) on seal/fillet welded West shaft vertical plate to tower head diaphragm.
