**DEPARTMENT OF TRANSPORTATION**

Contract #: 04-0120F4Cty: SF/ALA Rte: 80 PM: 13.2/13.9File #: 1.28**WELDING INSPECTION REPORT****Resident Engineer:** Casey, William**Address:** 333 Burma Road**City:** Oakland, CA 94607**Report No:** WIR-028832**Date Inspected:** 01-Dec-2012**Project Name:** SAS Superstructure**OSM Arrival Time:** 700**Prime Contractor:** American Bridge/Fluor Enterprises, a JV**OSM Departure Time:** 1530**Contractor:** American Bridge/Fluor Enterprises, a JV**Location:** Job Site**CWI Name:** As noted below**CWI Present:** Yes No**Inspected CWI report:** Yes No N/A**Rod Oven in Use:** Yes No N/A**Electrode to specification:** Yes No N/A**Weld Procedures Followed:** Yes No N/A**Qualified Welders:** Yes No N/A**Verified Joint Fit-up:** Yes No N/A**Approved Drawings:** Yes No N/A**Approved WPS:** Yes No N/A**Delayed / Cancelled:** Yes No N/A**Bridge No:** 34-0006**Component:** SAS OBG**Summary of Items Observed:**

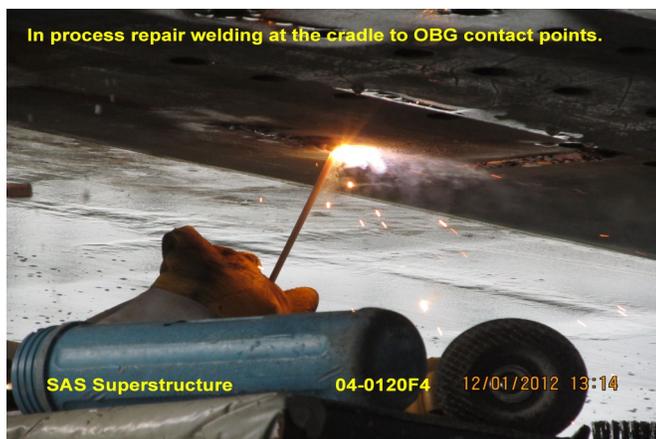
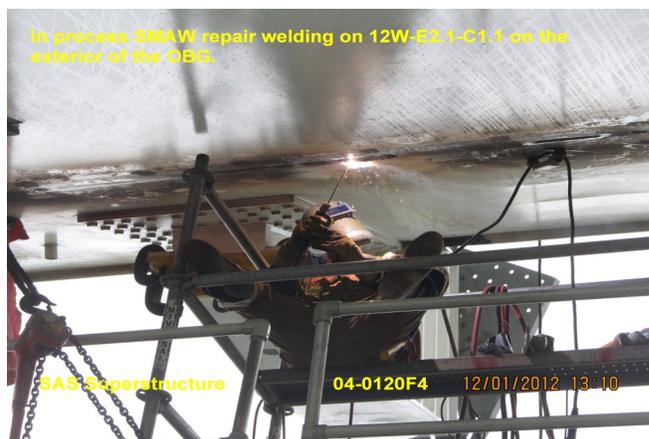
ABF welder Mike Jimenez #4671 was observed performing ongoing weld repairs on weld 12W-W2.1-C1.1 at y=7, 200mm. The welder was observed utilizing WPS ABF-WPS-D15-1004-Repair-Revision 0 for SMAW. The welder was observed preheating the welds prior to Carbon Arc Gouging and welding. Other welding parameters as inspected by the QC Inspector appeared to be in compliance with the WPS noted above. RWR-201211-005 was referenced during this weld repair.

ABF welder Chris Bruce #8901 was observed performing ongoing weld repairs on weld 12W-W2.1-C1.1 at y=24, 350mm. The welder was observed utilizing WPS ABF-WPS-D15-1004-Repair-Revision 0 for SMAW. The welder was observed preheating the welds prior to Carbon Arc Gouging and welding. Other welding parameters as inspected by QC Inspector appeared to be in compliance with the WPS noted above. RWR-201211-005 was referenced during this weld repair.

ABF welder Rick Clayborn #2773 was observed performing ongoing weld repairs on weld 12W-W2.1-C1.1 at y=15,090mm. The dimensions of the excavation were noted as 360L/55W/10D. The welder was observed utilizing WPS ABF-WPS-D15-1004-Repair-Revision 0 for SMAW. The welder was observed preheating the welds prior to

Carbon Arc Gouging and welding. Other welding parameters as inspected by the QC Inspector appeared to be in compliance with the WPS noted above. RWR-201211-005 was referenced during this weld repair.
