DEPARTMENT OF TRANSPORTATION

Contract #: 04-0120F4Cty: SF/ALA Rte: 80 PM: 13.2/13.9File #: 1.28**WELDING INSPECTION REPORT****Resident Engineer:** Casey, William**Address:** 333 Burma Road**City:** Oakland, CA 94607**Report No:** WIR-028834**Date Inspected:** 07-Dec-2012**Project Name:** SAS Superstructure**OSM Arrival Time:** 700**Prime Contractor:** American Bridge/Fluor Enterprises, a JV**OSM Departure Time:** 1730**Contractor:** American Bridge/Fluor Enterprises, a JV**Location:** Job Site**CWI Name:** Jesse Cayabyab**CWI Present:** Yes No**Inspected CWI report:** Yes No N/A**Rod Oven in Use:** Yes No N/A**Electrode to specification:** Yes No N/A**Weld Procedures Followed:** Yes No N/A**Qualified Welders:** Yes No N/A**Verified Joint Fit-up:** Yes No N/A**Approved Drawings:** Yes No N/A**Approved WPS:** Yes No N/A**Delayed / Cancelled:** Yes No N/A**Bridge No:** 34-0006**Component:** SAS Tower**Summary of Items Observed:**

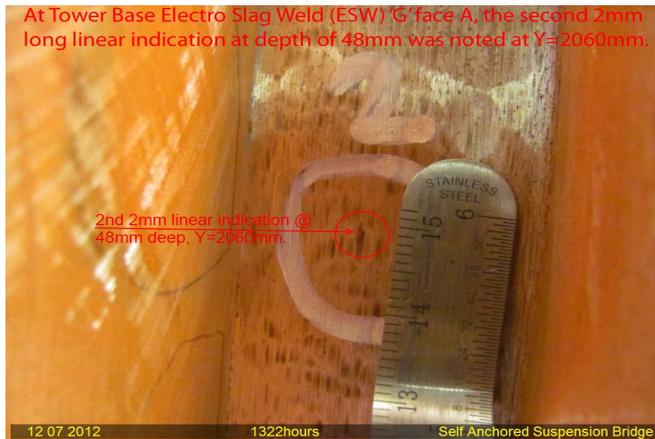
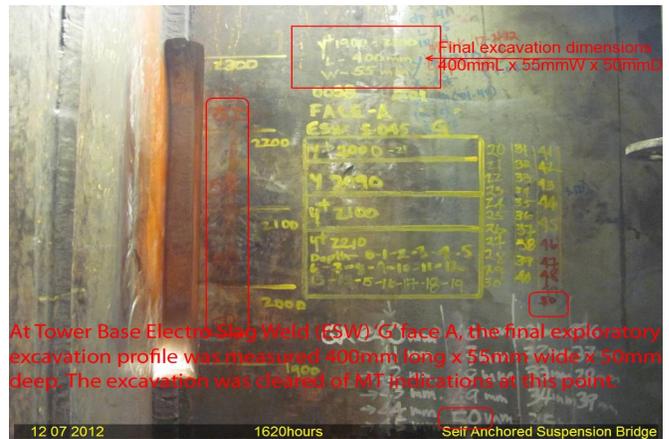
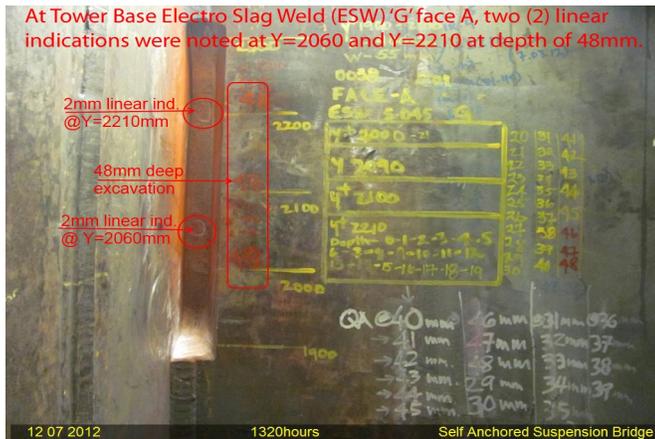
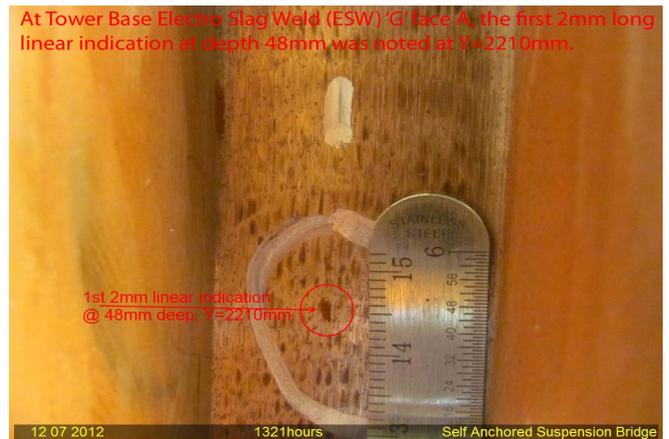
At Tower Base Electro Slag Weld (ESW) 'G' weld joint #S-045 face A, ABF personnel was observed continuing to perform exploratory excavation on welded ESW at locations Y=2000, Y=2090, Y=2100 and Y=2210mm due to UT detected defects. The ABF personnel have resumed the exploratory excavation from 46mm deep where they left off Monday. The personnel were noted using only the disc grinder in every 1mm increments of excavation. ABF QC Jesse Cayabyab was observed performing Magnetic Particle Testing (MT) on the following various depths with three (3) linear indications noted so far. This QA also performed the same test and noted same result. During the shift, the ABF personnel continued the excavation in 1mm increments using the same method of test and verification up to 50mm with five (5) linear indications noted. The shift was completed up to this depth of excavation and ABF is waiting for further instruction if they will excavate deeper into this exploratory excavation.

1. 46mm in depth – 6mm linear indication noted @y=2210mm, X=-10.
2. 47mm in depth – 6mm linear indication noted @y=2210mm, X=-10.
3. 48mm in depth – 2mm linear indication noted @y=2210mm, X=-10.
4. 48mm in depth – 2mm linear indication noted @y=2060mm, X=-10.

5. 49mm in depth –2mm linear indication noted @y=2210mm, X=-10.

6. 50mm in depth - no significant indication noted. All linear indications that were previously noted have all been removed.

The exploratory excavations at this location has stopped with final excavation profile of 400mm long x 55mm wide x 50mm deep. ABF QC and other personnel were told that the next exploratory excavation will be the continuation of excavation at ESW 'V' face B with Y location from Y=915mm to Y=1300mm..
