Contract #: 04-0120F4Cty: SF/ALA Rte: 80 PM: 13.2/13.9File #: 1.28**WELDING INSPECTION REPORT****Resident Engineer:** Casey, William**Address:** 333 Burma Road**City:** Oakland, CA 94607**Report No:** WIR-028842**Date Inspected:** 07-Dec-2012**Project Name:** SAS Superstructure**OSM Arrival Time:** 700**Prime Contractor:** American Bridge/Fluor Enterprises, a JV**OSM Departure Time:** 1730**Contractor:** American Bridge/Fluor Enterprises, a JV**Location:** Job Site**CWI Name:** As noted below.**CWI Present:** Yes No**Inspected CWI report:** Yes No N/A**Rod Oven in Use:** Yes No N/A**Electrode to specification:** Yes No N/A**Weld Procedures Followed:** Yes No N/A**Qualified Welders:** Yes No N/A**Verified Joint Fit-up:** Yes No N/A**Approved Drawings:** Yes No N/A**Approved WPS:** Yes No N/A**Delayed / Cancelled:** Yes No N/A**Bridge No:** 34-0006**Component:** Tower**Summary of Items Observed:**

WELDING INSPECTION REPORT

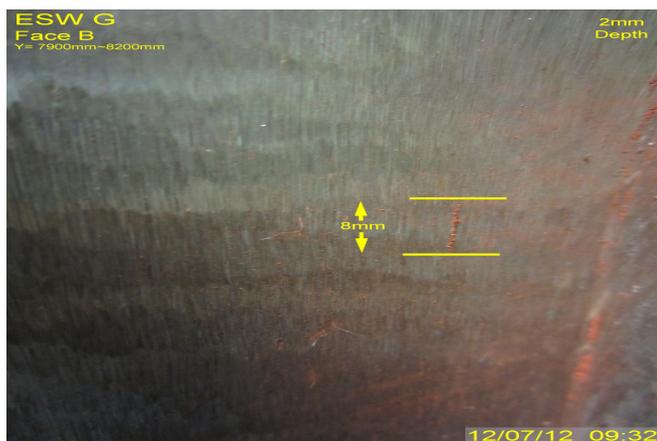
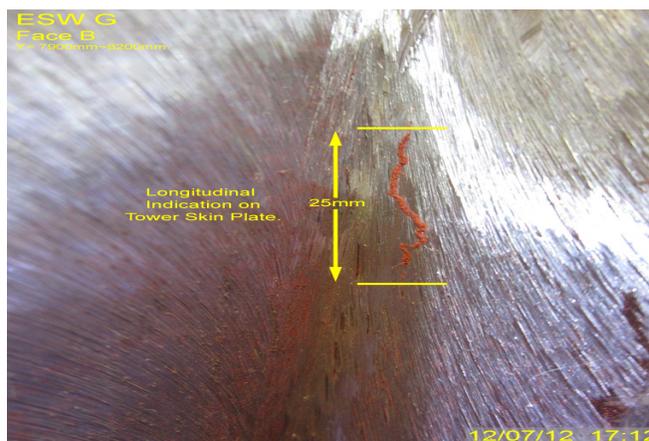
This QA performed observation of excavation of Electroslag Weld (ESW) designated as ESW G. Excavation was performed at location (Y= 7900mm~8200mm).

One (1) longitudinal indication observed.

Observed one (1) longitudinal indication on the side wall (tower skin plate) of this excavation.

-1m on skin plate. Indication is still present.

-2mm on skin plate. Indication is still present.

Excavation of skin plate indication has been halted until further instruction.
