Contract #: 04-0120F4Cty: SF/ALA Rte: 80 PM: 13.2/13.9File #: 1.28**WELDING INSPECTION REPORT**

Report No: WIR-028845
Date Inspected: 10-Dec-2012

Project Name: SAS Superstructure
Prime Contractor: American Bridge/Fluor Enterprises, a JV
Contractor: American Bridge/Fluor Enterprises, a JV

CWI Present: Yes No
Rod Oven in Use: Yes No N/A
Weld Procedures Followed: Yes No N/A
Verified Joint Fit-up: Yes No N/A
Approved WPS: Yes No N/A
Delayed / Cancelled: Yes No N/A
Component: Tower

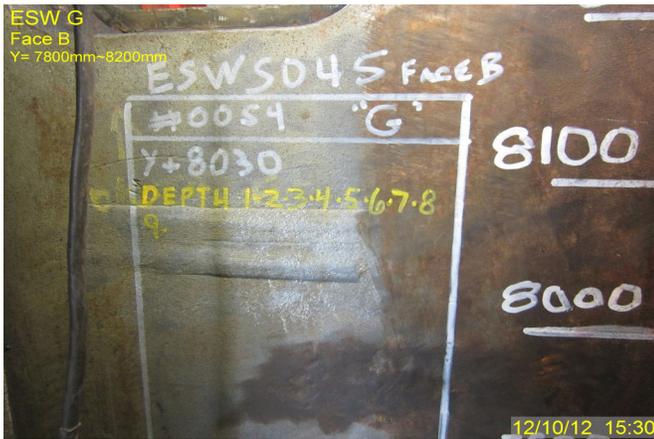
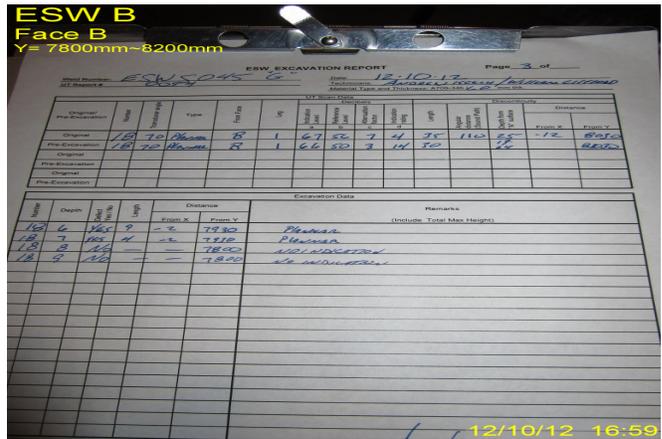
This QA performed observation of excavation of Electroslag Weld (ESW) designated as ESW G. Excavation was performed at location (Y= 7800mm~8200mm).

One (1) longitudinal indication observed.

Excavation was extended by 100mm to (Y= 7800mm~8200mm).

Excavation was performed by ABF welding personnel using a mechanical grinder removing approximately 1mm at a time. This QA observed Quality Control Inspector Andrew Keech performing visual inspection and Magnetic Particle Testing (MT) of this excavation between passes. This QA performed visual inspection and intermittent verification MT of this excavation between passes.
