Contract #: 04-0120F4Cty: SF/ALA Rte: 80 PM: 13.2/13.9File #: 1.28**WELDING INSPECTION REPORT****Resident Engineer:** Casey, William**Address:** 333 Burma Road**City:** Oakland, CA 94607**Report No:** WIR-028856**Date Inspected:** 12-Dec-2012**Project Name:** SAS Superstructure**OSM Arrival Time:** 700**Prime Contractor:** American Bridge/Fluor Enterprises, a JV**OSM Departure Time:** 1730**Contractor:** American Bridge/Fluor Enterprises, a JV**Location:** Job Site

Bridge No: 34-0006**Component:** SAS Tower**Summary of Items Observed:**

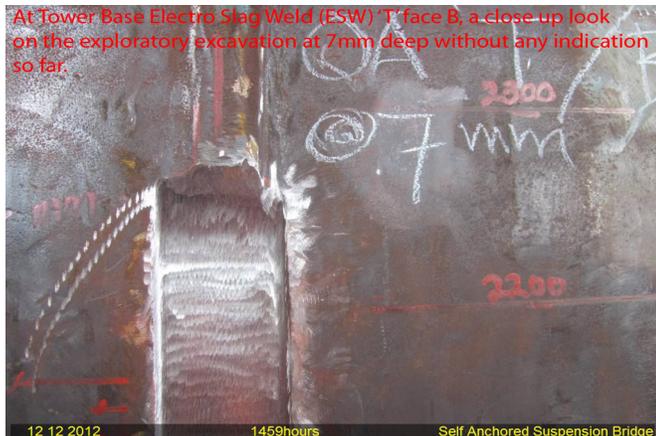
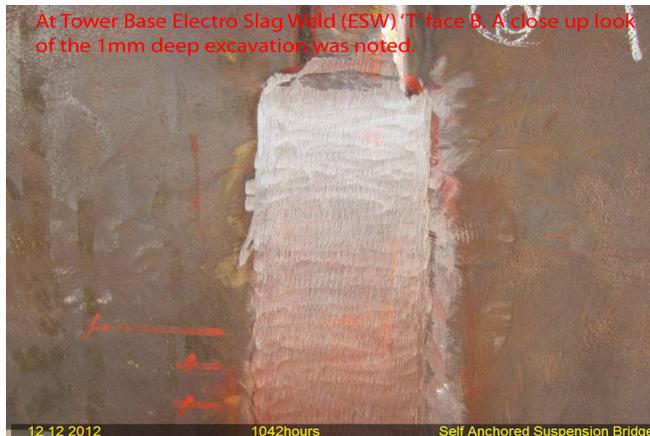
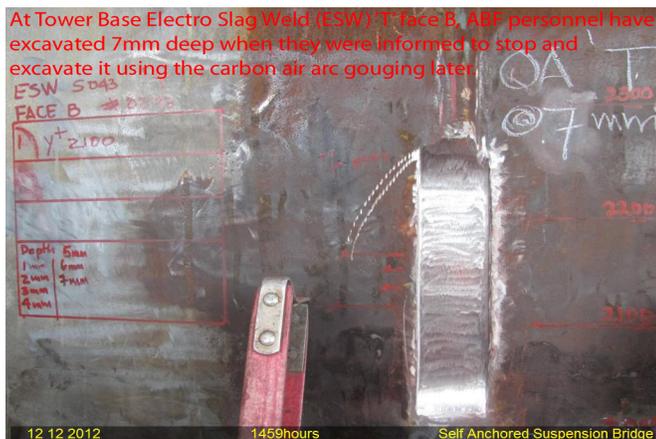
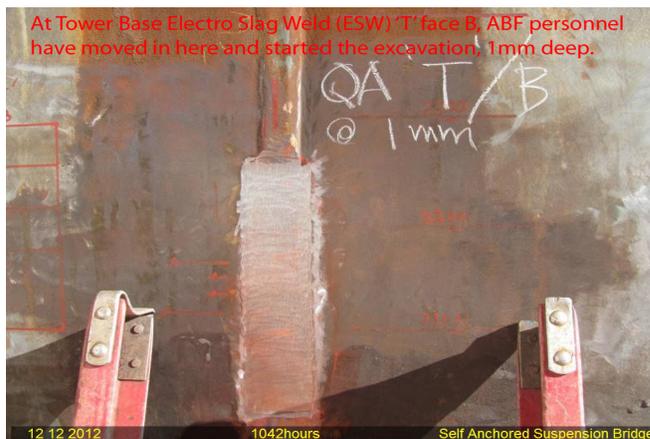
At Tower Base Electro Slag Weld (ESW) 'T' weld joint #S-043 face A, ABF personnel was observed continuing to perform exploratory excavation on welded ESW at locations Y=2100, Y=2110 and Y=2130mm due to UT detected defects. ABF personnel have started the exploratory excavation from 0mm deep. Prior to the excavation, ABF QC Jesse Cayabyab performed UT and confirmed the existence of the defects. Fellow QA William Clifford also performed the UT on the same defects and verified the existence of such defects. ABF personnel were noted using only the disc grinder in every 1mm increments of excavation. ABF QC Jesse Cayabyab was observed performing Magnetic Particle Testing (MT) on the following various depths with no significant indication noted so far. This QA also performed the same test and noted same result. During the shift, the ABF personnel continued the excavation in 1mm increments using the same method of test and verification up to 7mm with no indication noted. The shift was completed up to this depth of excavation.

The starting depth of excavation on this date was from zero. The results of the exploratory excavations are as follows;

1. 1mm in depth – no significant indication noted.
2. 2mm in depth – no significant indication noted.
3. 3mm in depth – no significant indication noted.

4. 4mm in depth – no significant indication noted.
5. 5mm in depth – no significant indication noted.
6. 6mm in depth – no significant indication noted.
7. 7mm in depth – no significant indication noted.

According to ABF QC Jesse Cayabyab, ABF will stop excavating the UT detected defects mentioned above into 1mm increments but instead excavate using the carbon air arc gouging and repair the defects accordingly. This was the instruction forwarded to him by ABF QC Bill Norris.
