DEPARTMENT OF TRANSPORTATION

Contract #: 04-0120F4Cty: SF/ALA Rte: 80 PM: 13.2/13.9File #: 1.28**WELDING INSPECTION REPORT****Resident Engineer:** Casey, William**Address:** 333 Burma Road**City:** Oakland, CA 94607**Report No:** WIR-028859**Date Inspected:** 06-Dec-2012**Project Name:** SAS Superstructure**OSM Arrival Time:** 700**Prime Contractor:** American Bridge/Fluor Enterprises, a JV**OSM Departure Time:** 1730**Contractor:** American Bridge/Fluor Enterprises, a JV**Location:** S.A.S. Job site**CWI Name:** N / A**CWI Present:** Yes No**Inspected CWI report:** Yes No N/A**Rod Oven in Use:** Yes No N/A**Electrode to specification:** Yes No N/A**Weld Procedures Followed:** Yes No N/A**Qualified Welders:** Yes No N/A**Verified Joint Fit-up:** Yes No N/A**Approved Drawings:** Yes No N/A**Approved WPS:** Yes No N/A**Delayed / Cancelled:** Yes No N/A**Bridge No:** 34-0006**Component:** S.A.S. Structure**Summary of Items Observed:**

WELDING INSPECTION REPORT

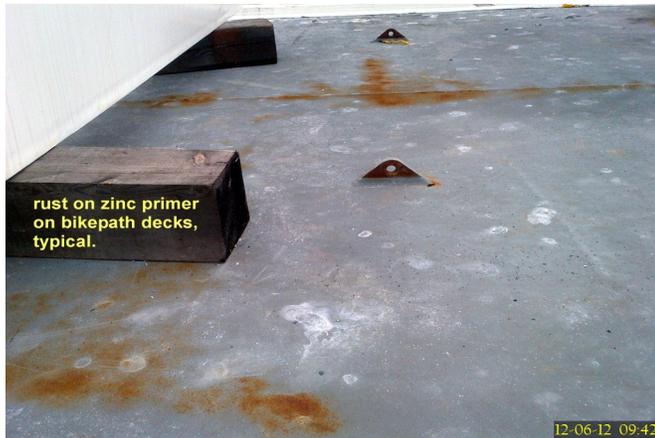
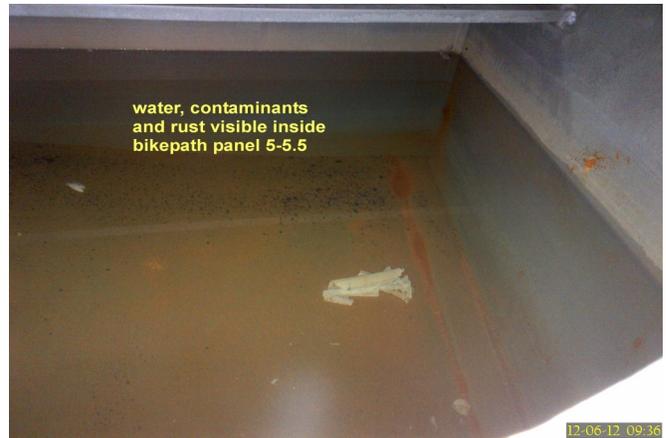
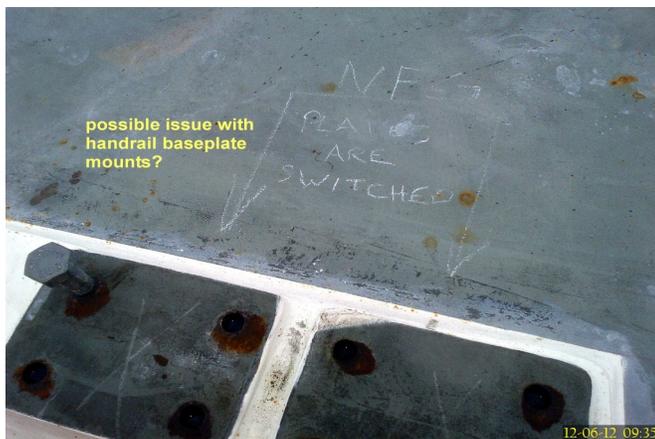
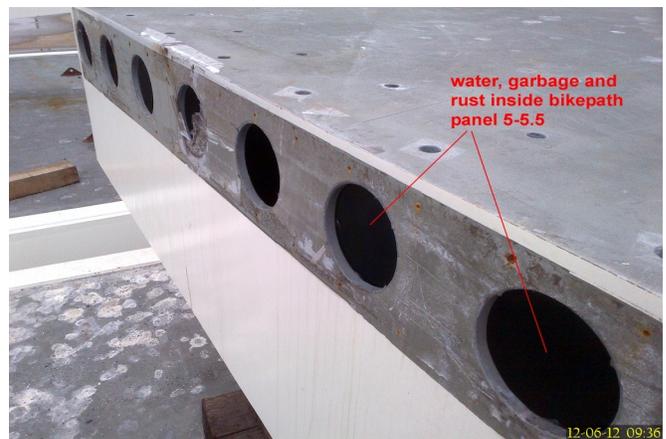
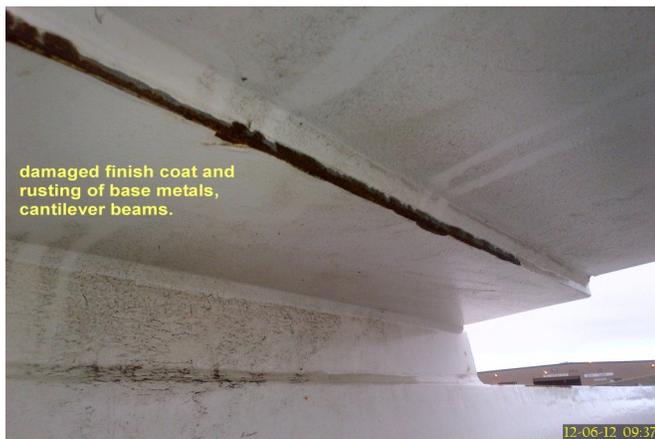
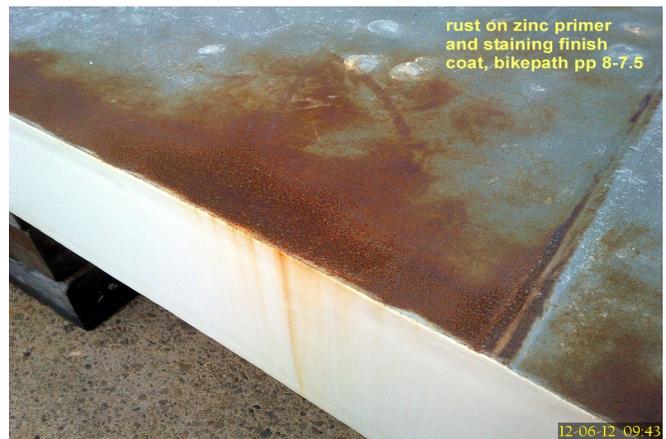
The QAI examined 3 bikepath panel segments and their supporting cantilever beams / cross beams, to note the conditions of the parts. The QAI noted that all components (bikepath panel 8-7.5, 7.5-5.5, 5.5-5, 2 main support beams, 2 cross beams and 1 additional support beam) have damage to the finish coating and zinc primer coating (where finish coat is not required). The QAI noted that some of the damage appears to be caused by handling, i.e. the corners and other portions are scraped. The QAI noted that panel 5.5-5 has exposed / unfilled holes on the exterior and the visible interior of the panel has water, contaminants and visible rusting. The QAI also noted that this panel has been written on indicating a possible issue with handrail mounting plates. This issue is being researched at this time. See the attached photos of the conditions observed.
