**DEPARTMENT OF TRANSPORTATION**

Contract #: 04-0120F4Cty: SF/ALA Rte: 80 PM: 13.2/13.9File #: 74.28**WELDING INSPECTION REPORT****Resident Engineer:** Casey, William**Address:** 333 Burma Road**City:** Oakland, CA 94607**Report No:** WIR-028860**Date Inspected:** 12-Dec-2012**Project Name:** SAS Superstructure**OSM Arrival Time:** 630**Prime Contractor:** American Bridge/Fluor Enterprises, a JV**OSM Departure Time:** 1700**Contractor:** Goodwin Steel, UK**Location:** Trentham, UK**CWI Name:** Alan Bentley - QC Director**CWI Present:** Yes No**Inspected CWI report:** Yes No N/A**Rod Oven in Use:** Yes No N/A**Electrode to specification:** Yes No N/A**Weld Procedures Followed:** Yes No N/A**Qualified Welders:** Yes No N/A**Verified Joint Fit-up:** Yes No N/A**Approved Drawings:** Yes No N/A**Approved WPS:** Yes No N/A**Delayed / Cancelled:** Yes No N/A**Bridge No:** 34-0006**Component:** Type B16 Cable Band**Summary of Items Observed:**

Cable Band Casting GG37014-9 (Male Section) and GG37015-9 (Female Section):

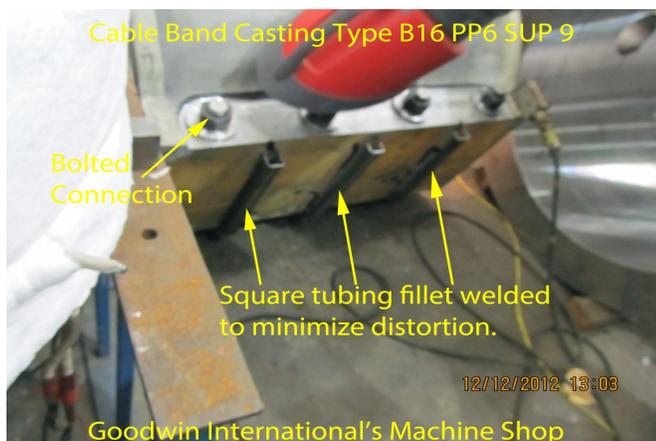
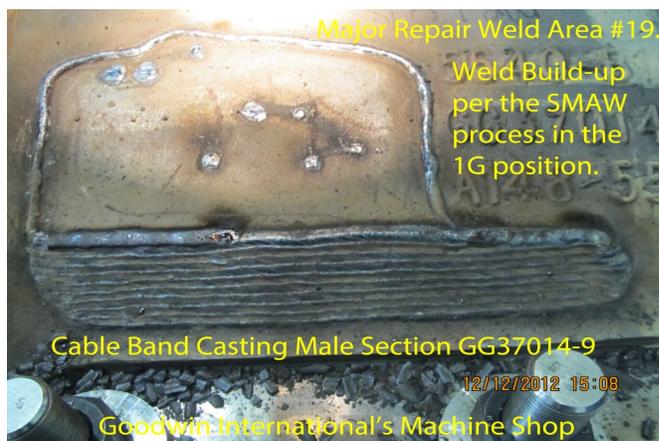
The QA Inspector randomly observed GI welding personnel Mick Edwards performing the Shielded Metal Arc Welding (SMAW) operation in the (1G) flat position on two (2) areas identified as a major repair on the exterior side of the bore of cable band casting Male section GG37014-9. The two (2) major repair areas were identified as (#19) with an area dimension of (460 mm long x 320 mm wide x 10 mm deep of weld build-up); and (#20) with an area dimension of (380 mm long x 340 mm wide x 10 mm deep of weld build-up).

The two (2) areas requiring the weld build-up were verified by this QA Inspector after GI Chief Inspector Tony Godwin outlined the two (2) areas that were under tolerance – nominal dimension for the bore wall thickness is: (35 mm + 5mm – 0.15 mm). The nominal dimensions of the bore wall thickness outlined in the two (2) areas ranged from (29 mm ~ 32 mm).

The repair weld operation being performed on major repair area (#19) appeared to be in general compliance with WPS 04-0120F4B Issue 5. The repair weld operation was in-process at the end of this QA Inspector's shift.

The QA Inspector observed the cable band casting being preheated by GI welding personnel Mick Edwards to the minimum temperature listed in WPS 04-0120F4B Issue 5 of 160 degrees Celsius and Mick Edwards utilized the 160 degree Celsius tempilstik to verify the temperature was maintained in an area of at least 75 mm around the perimeter of the two (2) major repair weld areas identified as (#19 and #20).

Afterwards, GI welding personnel Mick Edwards proceed with the weld build-up on the exterior side of the cable band bore on cable band casting Male Section GG37014-9 per the SMAW process in the (1G) flat position and this QA Inspector verified that the welding parameters – (Amps) were observed to be between the minimum of (100) and maximum of (180) on the welding machine utilizing the (4.0) mm diameter E7018 electrode as listed on the approved WPS 04-0120F4B Issue 5.
