DEPARTMENT OF TRANSPORTATION

Contract #: 04-0120F4Cty: SF/ALA Rte: 80 PM: 13.2/13.9File #: 1.28**WELDING INSPECTION REPORT****Resident Engineer:** Casey, William**Address:** 333 Burma Road**City:** Oakland, CA 94607**Report No:** WIR-028901**Date Inspected:** 19-Dec-2012**Project Name:** SAS Superstructure**OSM Arrival Time:** 700**Prime Contractor:** American Bridge/Fluor Enterprises, a JV**OSM Departure Time:** 1730**Contractor:** American Bridge/Fluor Enterprises, a JV**Location:** Job Site**CWI Name:** Fred Michels and Barry Drake**CWI Present:** Yes No**Inspected CWI report:** Yes No N/A**Rod Oven in Use:** Yes No N/A**Electrode to specification:** Yes No N/A**Weld Procedures Followed:** Yes No N/A**Qualified Welders:** Yes No N/A**Verified Joint Fit-up:** Yes No N/A**Approved Drawings:** Yes No N/A**Approved WPS:** Yes No N/A**Delayed / Cancelled:** Yes No N/A**Bridge No:** 34-0006**Component:** SAS Tower**Summary of Items Observed:**

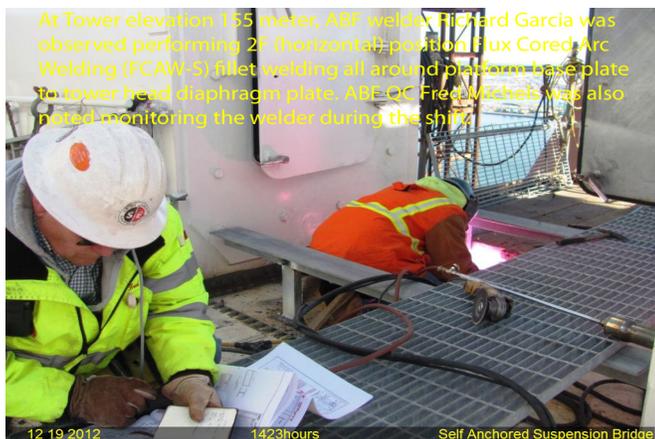
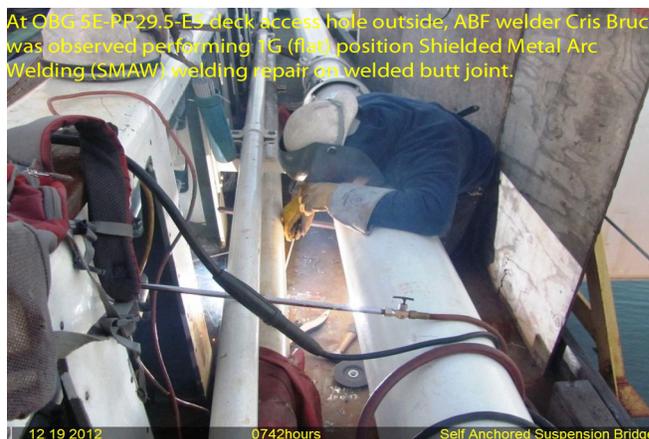
At Tower elevation 155 meters, QA randomly observed ABF welder Richard Garcia continuing to perform 6mm all around fillet welding between the Tower head diaphragm and platform base plate. The welder was observed 2F (horizontal) position fillet welding utilizing self-shielded Flux Cored Arc Welding (FCAW-S) with 0.072” diameter E71T-8 wire electrode implementing Caltrans Welding Procedure Specification (WPS) ABF-WPS-D15-F2200-2. Prior welding, the paint coating on both sides of the joint was ground off and the plates were preheated to more than 150 degrees Fahrenheit. During the shift, QA noted ABF QC Fred Michels was on site monitoring the in process preheats and welding parameters. At the end of the shift, fillet welding of the Tower head diaphragm to platform base plate was completed.

At the request of Quality Control Field Supervisor, Bonifacio Daquinag, QA has randomly verified the QC VT/MT on the interior Tower Head side plate seal weld joint. The QA verification was performed to verify that the welding and the VT/MT inspection performed by the QC inspector meet the requirements of the contract documents. At the conclusion of the QA verification it appeared that the welds and the QC inspection complied with the contract documents.

1. Tower elev. 155M – Weld joint #A3 inside tower head seal weld joint QA verified.
2. Tower elev. 155M – Weld joint #A4 inside tower head seal weld joint QA verified.
3. Tower elev. 155M – Weld joint #A2.1 inside tower head seal weld joint QA verified.
4. Tower elev. 155M – Weld joint #A2.2 inside tower head seal weld joint QA verified.
5. Tower elev. 155M – Weld joint #A2.3 inside tower head seal weld joint QA verified.
6. Tower elev. 155M – Weld joint #A2.4 inside tower head seal weld joint QA verified.
