Contract #: 04-0120F4Cty: SF/ALA Rte: 80 PM: 13.2/13.9File #: 74.28**WELDING INSPECTION REPORT**

**Report No:** WIR-028903  
**Date Inspected:** 18-Dec-2012

**Project Name:** SAS Superstructure  
**Prime Contractor:** American Bridge/Fluor Enterprises, a JV  
**Contractor:** Goodwin Steel, UK

Type B16 Cable Band Casting Supplemental #9 (Male Section) and (Female Section):

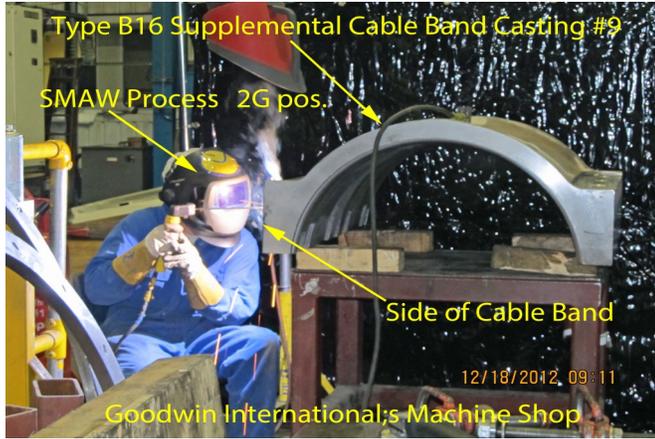
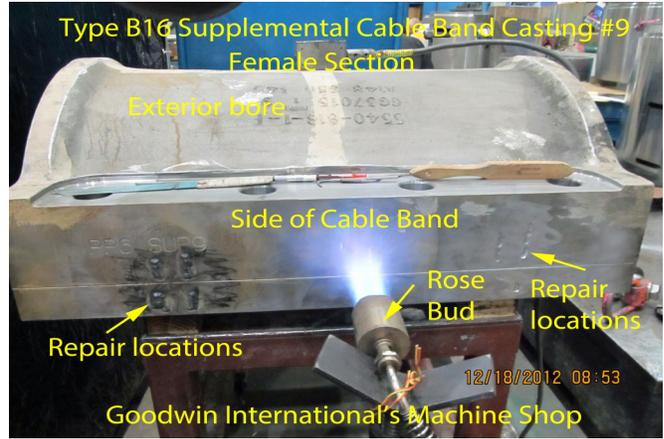
The minor repair welding will be performed to repair weld undercut – (< 2 mm x approximately 75 ~ 100 mm in length) at six (6) locations on both sides of the Male and Female sections of the cable band casting where the temporary attachments – (square tubing) were located as part of GI's distortion control plan to minimize distortion from the major repair welding performed on the Male section of the cable band casting.

The minor repair weld operation performed at the six (6) locations on each side of the Male and Female sections of the Type B16 supplemental cable band casting #9 appeared to be in general compliance with WPS 04-0120F4A Issue 5. The repair weld operation was completed by the end of this QA Inspector's shift.

This QA Inspector also performed a random visual inspection of the minor repair weld areas on both the Male and Female sections of the cable band casting and the random visual inspection appeared to be in general compliance with the visual requirements in MSS SP 55.

Afterwards, GI welding personnel Ryan Bielawa performed the minor weld repair operation at each of the excavated areas per the SMAW process in the (2G) horizontal and (3G) vertical positions and this QA Inspector verified that the welding parameters – (Amps) were observed to be between the minimum of (80) and maximum of (140) on the welding machine's calibrated meter utilizing the (3.2) mm diameter E7018 electrode – (Certification of electrode #2012/0369) as per approved WPS 04-0120F4A Issue 5.
