DEPARTMENT OF TRANSPORTATION

Contract #: 04-0120F4Cty: SF/ALA Rte: 80 PM: 13.2/13.9File #: 1.28**WELDING INSPECTION REPORT****Resident Engineer:** Casey, William**Address:** 333 Burma Road**City:** Oakland, CA 94607**Report No:** WIR-028917**Date Inspected:** 20-Dec-2012**Project Name:** SAS Superstructure**OSM Arrival Time:** 700**Prime Contractor:** American Bridge/Fluor Enterprises, a JV**OSM Departure Time:** 1730**Contractor:** American Bridge/Fluor Enterprises, a JV**Location:** Job Site**CWI Name:** Fred Michels and Barry Drake**CWI Present:** Yes No**Inspected CWI report:** Yes No N/A**Rod Oven in Use:** Yes No N/A**Electrode to specification:** Yes No N/A**Weld Procedures Followed:** Yes No N/A**Qualified Welders:** Yes No N/A**Verified Joint Fit-up:** Yes No N/A**Approved Drawings:** Yes No N/A**Approved WPS:** Yes No N/A**Delayed / Cancelled:** Yes No N/A**Bridge No:** 34-0006**Component:** SAS Tower**Summary of Items Observed:**

WELDING INSPECTION REPORT

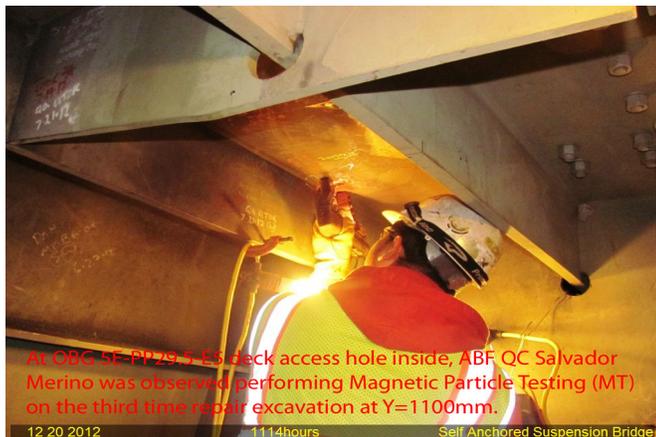
At OBG 5E-PP29.5-E5 deck access hole inside, QA randomly observed ABF/JV welder Chris Bruce continuing to perform CJP groove welding third time repair on a Non-Seismic Performance Critical Member (SPCM) due to Ultrasonic Testing (UT) detected defect on welded splice butt joint. The welder excavated the defect using a die grinder and after its completion, ABF QC Salvador Merino performed Magnetic Particle Testing (MT) on the removal of the defects with no relevant defect noted during the test. The welder was noted using propylene gas torch to preheat the repair area and its vicinity to 150°F and as soon as the required temperature was attained the welder started performing the welding repair. Welder Chris Bruce was observed manually welding in 1G (flat) position utilizing Shielded Metal Arc Welding (SMAW) with 4.0mm diameter E7018H4R electrode implementing the welding procedure ABF-WPS-D15-1000 Repair. Welder Chris Bruce was noted welding at location Y=1100mm with excavation dimensions 110mm long x 40mm wide x 11mm deep. During welding, ABF QC Barry Drake was observed monitoring the welding parameters which were noted as 160 amperes. The RWR #201212-005 was utilized as a reference during the welding of the R3 cycle repair and was completed during this shift.

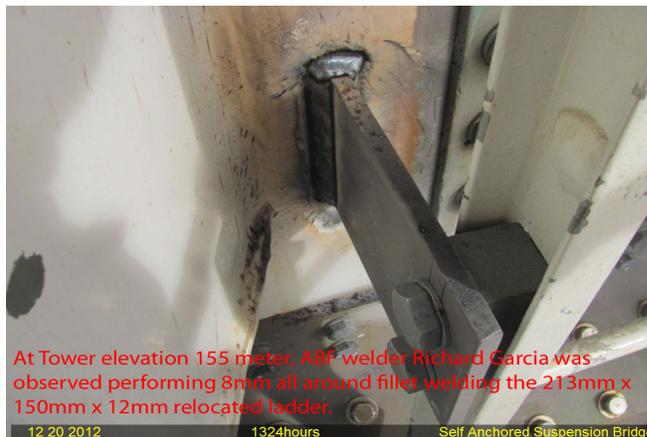
At Tower elevation 155 meters, QA randomly observed ABF welder Richard Garcia performing the 8mm all around fillet welding between the west Tower head vertical plate to 213mm long x 150mm wide x 12mm thick relocated ladder bracket. The welder was observed fillet welding utilizing self-shielded Flux Cored Arc Welding

(FCAW-S) with 0.072” diameter E71T-8 wire electrode implementing Welding Procedure Specification (WPS) ABF-WPS-D15-F2200-2. Prior to welding, the paint coating on both sides of the joint was removed by grinding and the plates were preheated to 150 degrees Fahrenheit. During the shift, QA noted ABF QC Fred Michels monitoring the preheat temperature and welding parameters. The fillet welding of the west Tower head vertical plate to the 213mm long x 150mm wide x 12mm thick ladder bracket was completed during this shift.
