**DEPARTMENT OF TRANSPORTATION**

Contract #: 04-0120F4Cty: SF/ALA Rte: 80 PM: 13.2/13.9File #: 1.28**WELDING INSPECTION REPORT****Resident Engineer:** Casey, William**Address:** 333 Burma Road**City:** Oakland, CA 94607**Report No:** WIR-028918**Date Inspected:** 26-Dec-2012**Project Name:** SAS Superstructure**OSM Arrival Time:** 700**Prime Contractor:** American Bridge/Fluor Enterprises, a JV**OSM Departure Time:** 1730**Contractor:** American Bridge/Fluor Enterprises, a JV**Location:** Job Site

# WELDING INSPECTION REPORT

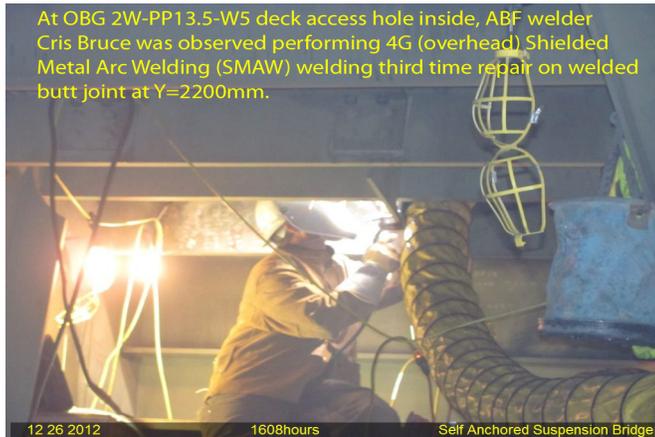
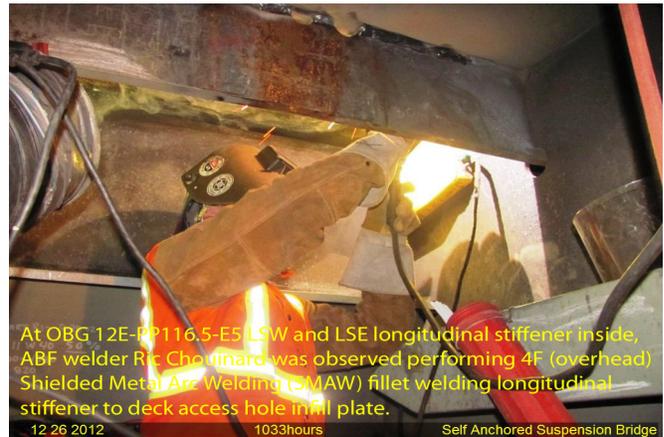
At OBG 2W-PP13.5-W5 deck access hole inside, QA randomly observed ABF/JV welder Chris Bruce continuing to perform CJP groove welding third time repair on a Non-Seismic Performance Critical Member (SPCM) due to Ultrasonic Testing (UT) detected defect on welded splice butt joint. The welder excavated the defect using a die grinder and after its completion, ABF QC Salvador Merino performed Magnetic Particle Testing (MT) on the removal of the defects with no relevant defect noted during the test. The welder was noted using propylene gas torch to preheat the repair area and its vicinity to 150°F and as soon as the required temperature was attained the welder started performing the welding repair. Welder Chris Bruce was observed welding in 4G (overhead) position utilizing the Shielded Metal Arc Welding (SMAW) with 3.2mm diameter E7018H4R electrode implementing welding procedure ABF-WPS-D15-1000 Repair. Welder Chris Bruce was noted welding at the following locations; Y=2200mm, with the excavation dimensions of 120mm long x 40mm wide x 12mm deep and utilizing the RWR #201212-039 as a reference. The second location was noted at Y=3600mm, with excavation dimensions of 100mm long x 50mm wide x 12mm deep and utilizing the RWR #201212-041 as a reference. During welding, ABF QC Barry Drake was noted monitoring the welding parameters which were noted as 126 amperes. The R3 cycle repair welding was completed during this shift at both locations.

At OBG 12E-PP116.5-E5 deck access hole inside, QA randomly observed ABF/JV qualified welder Ric Chouinard perform fillet welding on both sides of 485W plate stiffener to deck access hole infill plate. The welder

was noted fillet welding the area where it was left by the contractor from ZPMC, China. The welder was observed welding in the 4F (overhead) position utilizing Shielded Metal Arc Welding (SMAW) with 3.2mm diameter E7018H4R electrode implementing welding procedure ABF-WPS-D15-F1200A Rev. 1. The fillet weld connection was preheated to more than 250 degree Fahrenheit using propane gas torch prior welding. The welding activity was monitored by ABF QC William Sherwood. During the shift, the welder has completed the 8mm fillet welding on both sides of the plate stiffener (PS1) to the deck access hole infill plate.
