DEPARTMENT OF TRANSPORTATION

Contract #: 04-0120F4Cty: SF/ALA Rte: 80 PM: 13.2/13.9File #: 1.28**WELDING INSPECTION REPORT****Resident Engineer:** Casey, William**Address:** 333 Burma Road**City:** Oakland, CA 94607**Report No:** WIR-028921**Date Inspected:** 27-Dec-2012**Project Name:** SAS Superstructure**OSM Arrival Time:** 700**Prime Contractor:** American Bridge/Fluor Enterprises, a JV**OSM Departure Time:** 1730**Contractor:** American Bridge/Fluor Enterprises, a JV**Location:** Job Site**CWI Name:** William Sherwood**CWI Present:** Yes No**Inspected CWI report:** Yes No N/A**Rod Oven in Use:** Yes No N/A**Electrode to specification:** Yes No N/A**Weld Procedures Followed:** Yes No N/A**Qualified Welders:** Yes No N/A**Verified Joint Fit-up:** Yes No N/A**Approved Drawings:** Yes No N/A**Approved WPS:** Yes No N/A**Delayed / Cancelled:** Yes No N/A**Bridge No:** 34-0006**Component:** SAS Tower and OBG**Summary of Items Observed:**

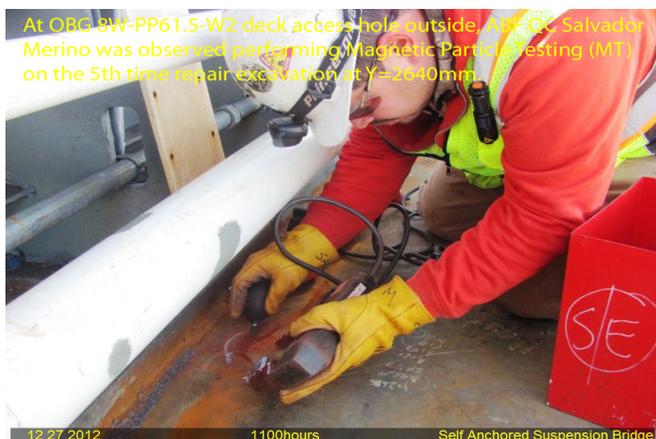
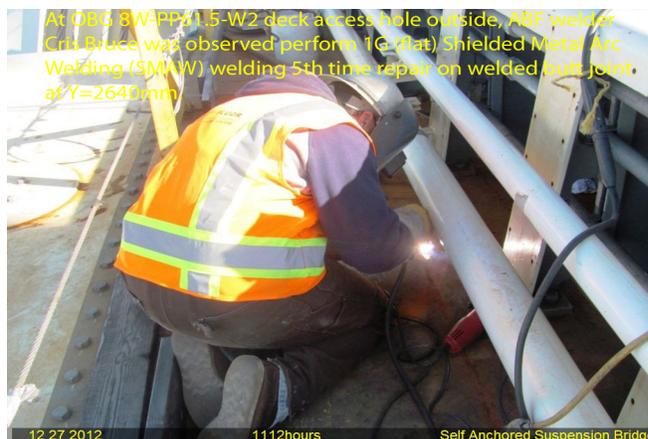
At OBG 8W-PP61.5-W2 deck access hole outside, QA randomly observed ABF/JV welder Cris Bruce continuing to perform CJP groove welding third time repair on a Non-Seismic Performance Critical Member (SPCM) due to Ultrasonic Testing (UT) detected defect on welded splice butt joint. The welder excavated the defect using a die grinder and after its completion, ABF QC Salvador Merino performed Magnetic Particle Testing (MT) on the removal of the defects with no relevant defect noted during the test. The welder was noted using propylene gas torch to preheat the repair area and its vicinity to 150°F and as soon as the required temperature was attained the welder started performing the welding repair. Welder Cris Bruce was observed manually welding in 1G (flat) position utilizing Shielded Metal Arc Welding (SMAW) with 3.2mm diameter E7018H4R electrode implementing the welding procedure ABF-WPS-D15-1000 Repair. Welder Cris Bruce was noted welding at location Y=2640mm with excavation dimensions 70mm long x 20mm wide x 10mm deep and with RWR #201211-035. During welding, ABF QC Barry Drake was noted monitoring the welder's welding parameter with measured working current of 135 amperes on the 3.2mm diameter E7018H4R electrodes. During the shift, this 5th time repair welding mentioned above was completed.

At OBG 12E-PP109.5-E2 and 12E-PP109.5-E5 deck access hole inside, QA randomly observed ABF/JV qualified welder Ric Chouinard continuing to perform fillet welding on both sides of 485W plate stiffener to deck access hole infill plate. The welder was noted fillet welding the area where it was left by the contractor from ZPMC,

China. The welder was observed welding in the 4F (overhead) position utilizing Shielded Metal Arc Welding (SMAW) with 3.2mm diameter E7018H4R electrode implementing the welding procedure ABF-WPS-D15-F1200A Rev. 1. The fillet weld connection between two different grades of material (HPS 485W/A709) was preheated to more than 250 degree Fahrenheit using propane gas torch prior welding. The welding activity was monitored by ABF QC Salvador Merino. During the shift, the welder has completed the 8mm fillet welding on both sides of the plate stiffener (PS1) to the deck access hole infill plate.
