Contract #: 04-0120F4Cty: SF/ALA Rte: 80 PM: 13.2/13.9File #: 1.28**WELDING INSPECTION REPORT****Resident Engineer:** Casey, William**Address:** 333 Burma Road**City:** Oakland, CA 94607**Report No:** WIR-028922**Date Inspected:** 28-Dec-2012**Project Name:** SAS Superstructure**OSM Arrival Time:** 700**Prime Contractor:** American Bridge/Fluor Enterprises, a JV**OSM Departure Time:** 1530**Contractor:** American Bridge/Fluor Enterprises, a JV**Location:** Job Site**CWI Name:** William Sherwood**CWI Present:** Yes No**Inspected CWI report:** Yes No N/A**Rod Oven in Use:** Yes No N/A**Electrode to specification:** Yes No N/A**Weld Procedures Followed:** Yes No N/A**Qualified Welders:** Yes No N/A**Verified Joint Fit-up:** Yes No N/A**Approved Drawings:** Yes No N/A**Approved WPS:** Yes No N/A**Delayed / Cancelled:** Yes No N/A**Bridge No:** 34-0006**Component:** SAS Tower and OBG**Summary of Items Observed:**

WELDING INSPECTION REPORT

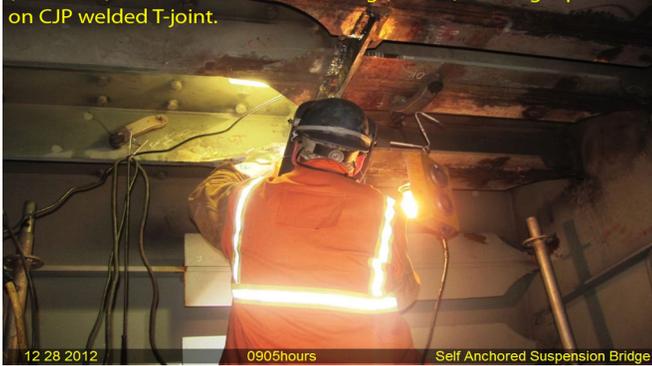
12 28 2012 0906hours Self Anchored Suspension Bridge

At OBG 13W-PP122.2-W5 LS6-TSA deck stiffener flange to transverse stiffener 'A', ABF welder Ric Clayborn was observed perform 4G (overhead) Shielded Metal Arc Welding (SMAW) welding repair on CJP welded T-joint.

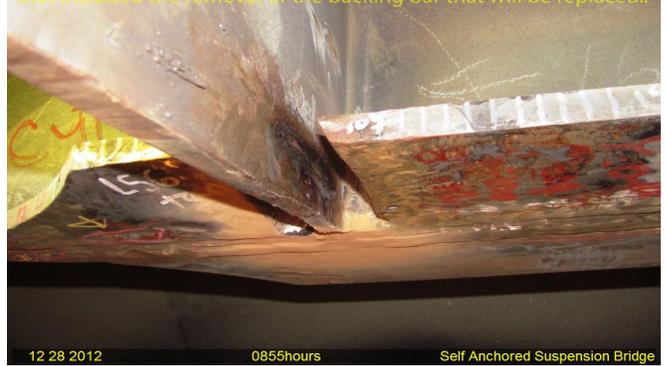
12 28 2012 0855hours Self Anchored Suspension Bridge

At OBG 13W-PP122.2-W5 LS6-TSA deck stiffener flange to transverse stiffener 'A', ABF personnel have excavated the UT detected defect that included the removal of the backing bar that will be replaced..
