DEPARTMENT OF TRANSPORTATION

Contract #: 04-0120F4Cty: SF/ALA Rte: 80 PM: 13.2/13.9File #: 1.28**WELDING INSPECTION REPORT****Resident Engineer:** Casey, William**Address:** 333 Burma Road**City:** Oakland, CA 94607**Report No:** WIR-028923**Date Inspected:** 31-Dec-2012**Project Name:** SAS Superstructure**OSM Arrival Time:** 700**Prime Contractor:** American Bridge/Fluor Enterprises, a JV**OSM Departure Time:** 1530**Contractor:** American Bridge/Fluor Enterprises, a JV**Location:** Job Site**CWI Name:** William Sherwood**CWI Present:** Yes No**Inspected CWI report:** Yes No N/A**Rod Oven in Use:** Yes No N/A**Electrode to specification:** Yes No N/A**Weld Procedures Followed:** Yes No N/A**Qualified Welders:** Yes No N/A**Verified Joint Fit-up:** Yes No N/A**Approved Drawings:** Yes No N/A**Approved WPS:** Yes No N/A**Delayed / Cancelled:** Yes No N/A**Bridge No:** 34-0006**Component:** SAS Tower and OBG**Summary of Items Observed:**

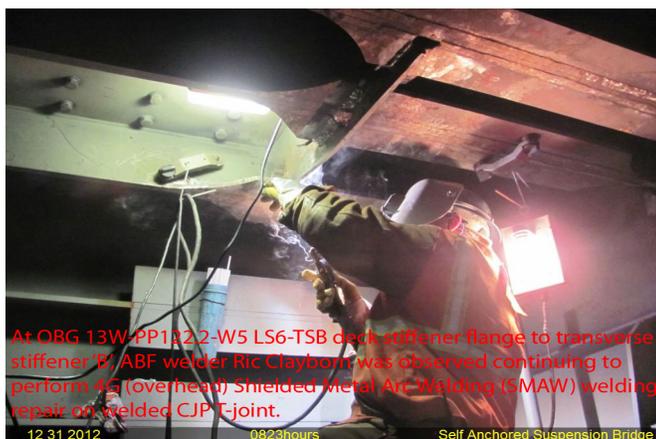
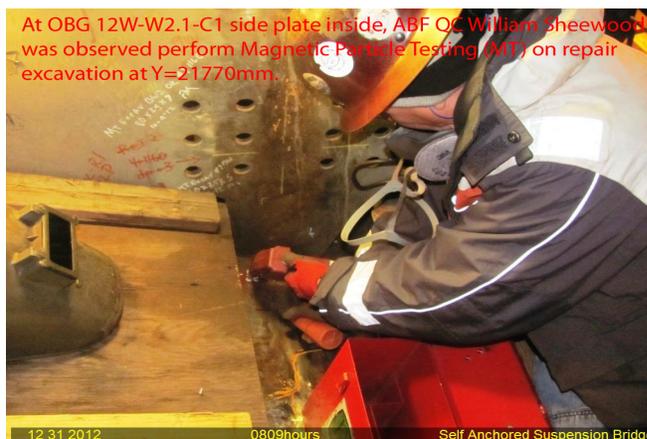
At OBG 12W-W2.1-C1 side plate inside, QA randomly observed ABF/JV welder Ric Chouinard continuing to perform CJP groove welding second time repair on a Non-Seismic Performance Critical Member (SPCM) due to Ultrasonic Testing (UT) detected defect on welded splice butt joint. The welder excavated the defect using a die grinder and after its completion, ABF QC William Sherwood performed Magnetic Particle Testing (MT) on the removal of the defects with no relevant defect noted during the test. The welder was noted using propylene gas torch to preheat the repair area and its vicinity to 150°F and as soon as the required temperature was attained the welder started performing the welding repair. Welder Ric Chouinard was observed manually welding in 1G (flat) position utilizing Shielded Metal Arc Welding (SMAW) with 3.2mm diameter E7018H4R electrode implementing the welding procedure ABF-WPS-D15-1000 Repair. Welder Ric Chouinard was noted welding at location Y=21770mm with excavation profile of 60mm long x 30mm wide x 10mm deep. During welding, ABF QC William Sherwood was noted monitoring the welder's welding parameter with measured working current of 126 amperes on the 3.2mm diameter E7018H4R electrodes. During the shift, the second time repair welding mentioned above was completed. After the welding at this location, the welder has moved and set-up at Y=30300mm of the same side plate where welder Cris Bruce has left off last Friday.

At OBG 13W-PP122.2-W5 deck stiffener flange inside, QA randomly observed ABF/JV welder Ric Clayborn continuing to perform CJP groove welding second time repair on a Non-Seismic Performance Critical Member

(SPCM) due to Ultrasonic Testing (UT) detected defect on welded stiffener T-joint. The welder excavated the defect, removed the backing bar with open root using a die grinder and after its completion, ABF QC William Sherwood performed Magnetic Particle Testing (MT) on the removal of the defects with no relevant defect noted during the test. The welder replaced the backing bar with new one prior welding. The welder was noted using propylene gas torch to preheat the repair area and its vicinity to 150°F and as soon as the required temperature was attained the welder started performing the welding repair. Welder Rick Clayborn was observed manually welding in 4G (overhead) position utilizing Shielded Metal Arc Welding (SMAW) with 3.2mm diameter E7018H4R electrode implementing the welding procedure ABF-WPS-D15-1000 Repair. During welding, ABF QC William Sherwood was noted monitoring the welder's welding parameter with measured working current of 130 amperes on the 3.2mm diameter E7018H4R electrodes. During the shift, the second time repair welding was still continuing and should remain Wednesday.
