**DEPARTMENT OF TRANSPORTATION**

Contract #: 04-0120F4Cty: SF/ALA Rte: 80 PM: 13.2/13.9File #: 1.28**WELDING INSPECTION REPORT****Resident Engineer:** Casey, William**Address:** 333 Burma Road**City:** Oakland, CA 94607**Report No:** WIR-028943**Date Inspected:** 02-Jan-2013**Project Name:** SAS Superstructure**OSM Arrival Time:** 700**Prime Contractor:** American Bridge/Fluor Enterprises, a JV**OSM Departure Time:** 1730**Contractor:** American Bridge/Fluor Enterprises, a JV**Location:** Job Site**CWI Name:** William Sherwood**CWI Present:** Yes No**Inspected CWI report:** Yes No N/A**Rod Oven in Use:** Yes No N/A**Electrode to specification:** Yes No N/A**Weld Procedures Followed:** Yes No N/A**Qualified Welders:** Yes No N/A**Verified Joint Fit-up:** Yes No N/A**Approved Drawings:** Yes No N/A**Approved WPS:** Yes No N/A**Delayed / Cancelled:** Yes No N/A**Bridge No:** 34-0006**Component:** SAS Tower and OBG**Summary of Items Observed:**

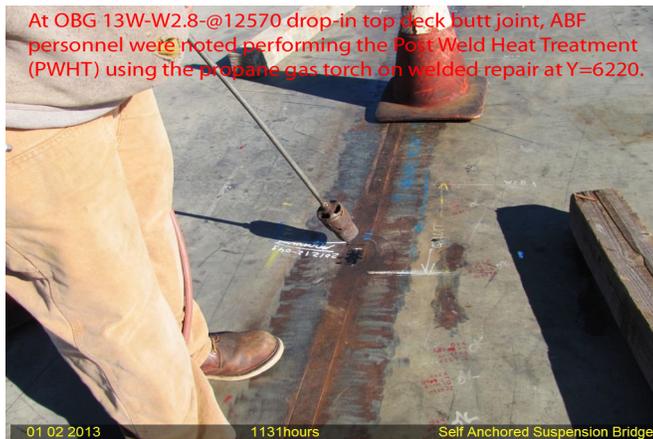
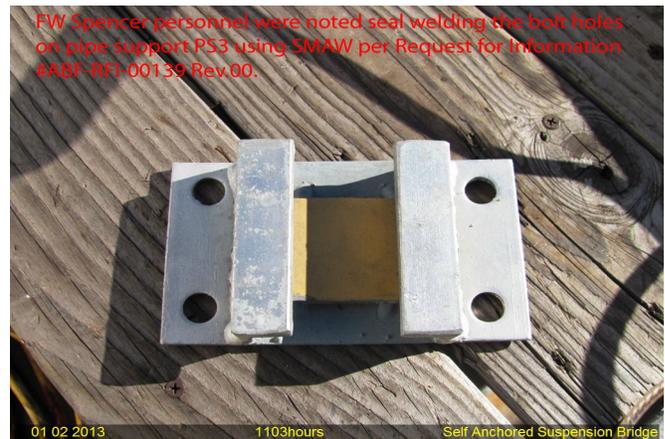
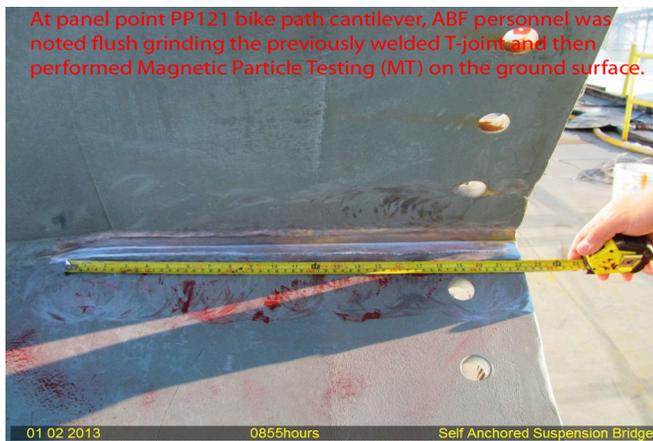
1. Bike Path cantilever panel point PP121 – flush ground welded T- joint cover QA verified.

This QA randomly observed FW Spencer Damian Llanos perform seal welding on the four (4) bolt holes on every pipe support PS3s that are intended for bike path cantilever beams. The welder was noted seal welding the bolt holes using Shielded Metal Arc Welding (SMAW) with 3.2mm diameter E7018H4R electrode per Request for Information (RFI) ABF-RFI-003139 Rev. 00. During the shift, ABF QC Salvador Merino was noted monitoring the welder. At the end of the shift, seal welding on the PS3 supports was still continuing and should remain tomorrow.
