**DEPARTMENT OF TRANSPORTATION**

Contract #: 04-0120F4Cty: SF/ALA Rte: 80 PM: 13.2/13.9File #: 1.28**WELDING INSPECTION REPORT****Resident Engineer:** Casey, William**Address:** 333 Burma Road**City:** Oakland, CA 94607**Report No:** WIR-028944**Date Inspected:** 03-Jan-2013**Project Name:** SAS Superstructure**OSM Arrival Time:** 700**Prime Contractor:** American Bridge/Fluor Enterprises, a JV**OSM Departure Time:** 1730**Contractor:** American Bridge/Fluor Enterprises, a JV**Location:** Job Site**CWI Name:** William Sherwood**CWI Present:** Yes No**Inspected CWI report:** Yes No N/A**Rod Oven in Use:** Yes No N/A**Electrode to specification:** Yes No N/A**Weld Procedures Followed:** Yes No N/A**Qualified Welders:** Yes No N/A**Verified Joint Fit-up:** Yes No N/A**Approved Drawings:** Yes No N/A**Approved WPS:** Yes No N/A**Delayed / Cancelled:** Yes No N/A**Bridge No:** 34-0006**Component:** SAS Tower and OBG**Summary of Items Observed:**

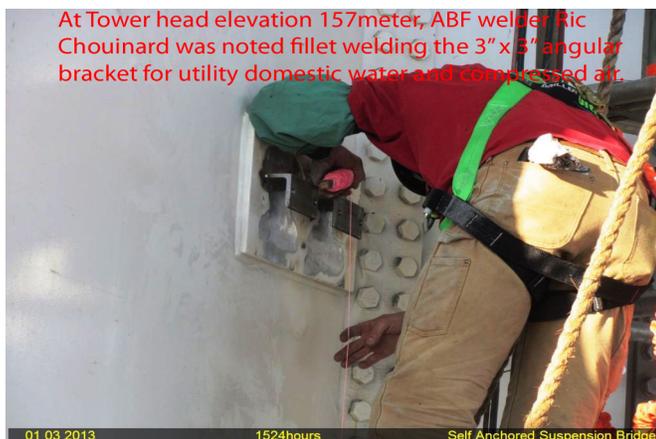
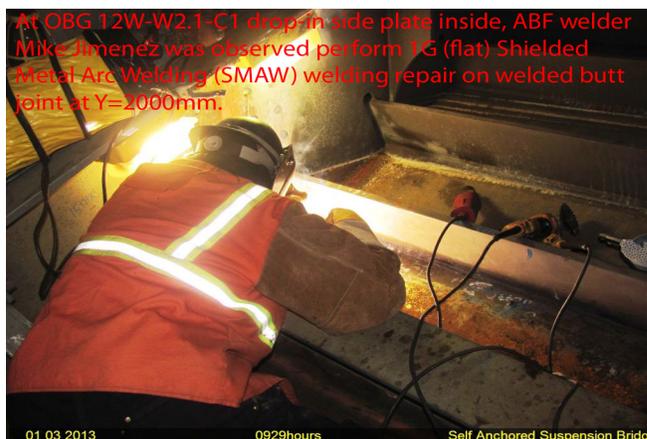
At Tower elevation 157.789meter, ABF welder Ric Chouinard was observed performing all around 8mm fillet welding on two (2) 3" x 3" x 6 1/4" long angular shape brackets to previously welded sole plate at South shaft skin plate 'D'. The welder was noted using Shielded Metal Arc Welding (SMAW) with 3.2mm E7018H4R electrode implementing ABF-WPS-D1.5-F1200A. The brackets being welded are pipe supports for the domestic water and compressed air lines and per CCO 203. ABF QC Fred Michels was noted monitoring the welder during the shift.
