Contract #: 04-0120F4Cty: SF/ALA Rte: 80 PM: 13.2/13.9File #: 1.28**WELDING INSPECTION REPORT**

Report No: WIR-028952
Date Inspected: 07-Jan-2013

Project Name: SAS Superstructure **OSM Arrival Time:** 700
Prime Contractor: American Bridge/Fluor Enterprises, a JV **OSM Departure Time:** 1730
Contractor: American Bridge/Fluor Enterprises, a JV **Location:** Job Site

CWI Name:	Fred Michels and Barry Drake			CWI Present:	Yes	No	
Inspected CWI report:	Yes	No	N/A	Rod Oven in Use:	Yes	No	N/A
Electrode to specification:	Yes	No	N/A	Weld Procedures Followed:	Yes	No	N/A
Qualified Welders:	Yes	No	N/A	Verified Joint Fit-up:	Yes	No	N/A
Approved Drawings:	Yes	No	N/A	Approved WPS:	Yes	No	N/A
				Delayed / Cancelled:	Yes	No	N/A
Bridge No:	34-0006			Component:	SAS Tower and OBG

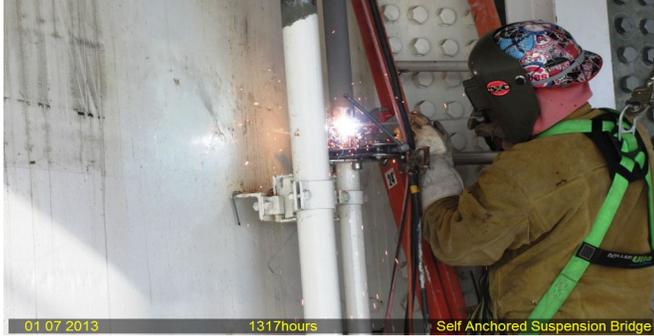
At tower elevation 143meter, this QA randomly observed FW Spencer qualified welder Damian Llanos perform Complete Joint Penetration (CJP) 2G (horizontal position) Shielded Metal Arc Welding (SMAW) welding root pass to cover pass on 3” diameter compressed air and 2” diameter domestic water lines. The system lines being welded are field splices along the tower elevation. The welder was noted welding the root pass with 3/32” diameter E6010 electrode and followed by fill pass to cover pass using 3/32” diameter E7018H4R electrode implementing Caltrans approved procedure FW Spencer WPS 1-12-1. The welder was noted preheating and removing the moisture of the joint using a portable propane gas torch prior welding. During welding, ABF QC Steve Jensen was noted monitoring the parameters of the welder. At the end of the shift, one (1) 3” diameter field splice was completed and visually accepted by QC but the 2” diameter domestic water line was still in-progress. This QA performed VT verification on the completed weld splice and it appears in compliance to the Contract requirements.

At Tower elevation 145meter, FW Spencer welder Damian Llanos was observed performing 2G (horizontal) position Shielded Metal Arc Welding (SMAW) welding root pass to cover pass on 3" and 2" diameter utility lines.

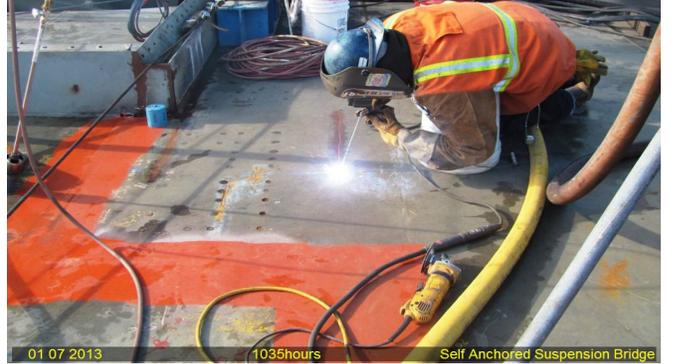
At OBG 13E top deck plate outside, ABF welder Mike Jimenez was observed performing base metal repair on the deck plate due to removal of welded temporary attachments. The welder was using Shielded Metal Arc Welding (SMAW) with 3.2mm diameter E7018H4R electrode. The welder was also noted cleaning/grinding the surface of the gouges and preheating the plate to more than 150°F prior welding. According to the welder, he was instructed by his foreman to perform the repair just as the QA observations has mentioned. This QA has asked the ABF QC Barry Drake if there was an approval for the base metal repair but he responded that it was only verbal approval from ABF QC Manager Jim Bowers. Due to the absence of proper approval prior to the base metal repair, this QA has issued an Incident Report.

During the shift, ABF QC John Hayes was noted performing Magnetic Particle Testing (MT) on the completely welded base metal repair at 13E-PP120.5-E2.1 when four linear indications were noted. These indications were mentioned to ABF foreman Ric Clayborn and that a Request for Weld Repair (RWR) should be initiated. The foreman ignored the conversation and proceeded to repair the linear indications around the three bolt holes without the proper approval from the Engineer. Due to this infraction, an Incident Report was also issued to ABF.

At OBG 13E drop-in top deck plate outside, ABF welder Mike Jimenez was observed perform base metal welding repair on temporary welded attachments.

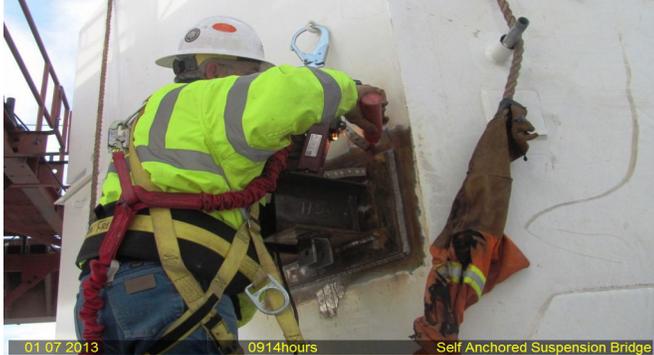
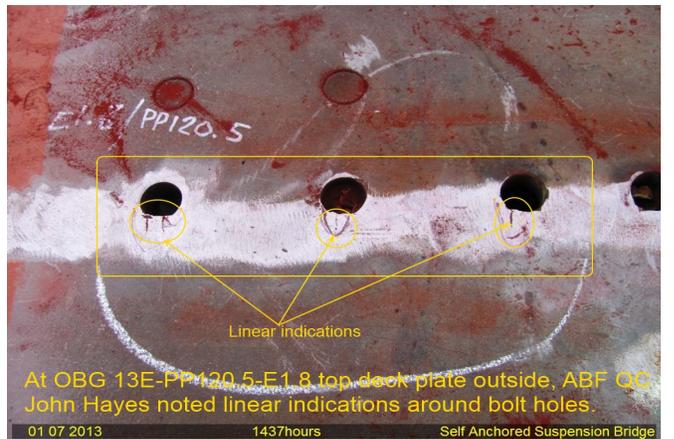
At Tower elevation 147meter, ABF QV Fred Michels was observed performing Magnetic Particle Testing (MT) on completely fillet welded bracket assembly for utility pipe lines.
