Contract #: 04-0120F4Cty: SF/ALA Rte: 80 PM: 13.2/13.9File #: 1.28**WELDING INSPECTION REPORT**

Report No: WIR-028959
Date Inspected: 10-Jan-2013

Project Name: SAS Superstructure
Prime Contractor: American Bridge/Fluor Enterprises, a JV
Contractor: American Bridge/Fluor Enterprises, a JV

CWI Name:	Steve Jensen	CWI Present:	Yes	No
Inspected CWI report:	Yes No N/A	Rod Oven in Use:	Yes No N/A	
Electrode to specification:	Yes No N/A	Weld Procedures Followed:	Yes No N/A	
Qualified Welders:	Yes No N/A	Verified Joint Fit-up:	Yes No N/A	
Approved Drawings:	Yes No N/A	Approved WPS:	Yes No N/A	
		Delayed / Cancelled:	Yes No N/A	
Bridge No:	34-0006	Component:	SAS Tower

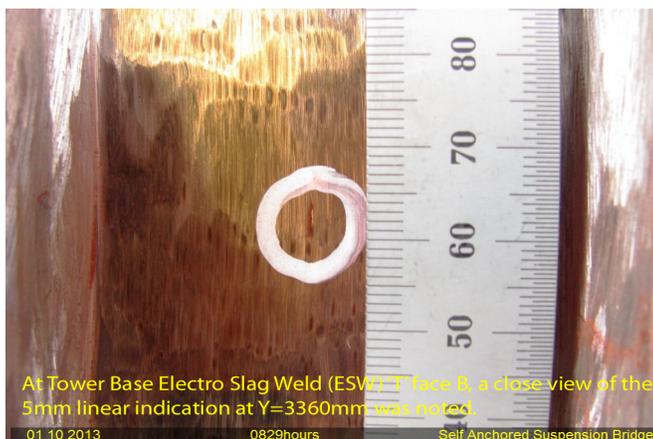
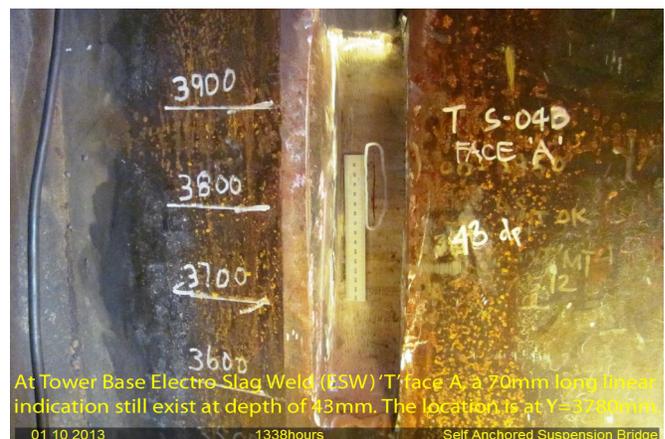
At Tower Base Electro Slag Weld (ESW) 'T' weld joint #S-043 face A, ABF personnel was observed continuing to perform exploratory excavation on welded ESW at location Y=3600 to Y=3950 due to UT detected defects. The ABF personnel have resumed the exploratory excavation from 40mm deep where they left off yesterday. The personnel were noted using only the disc grinder in every 1mm increments of excavation. ABF QC Steve Jensen was observed performing Magnetic Particle Testing (MT) on the following various depths with indications stated below. This QA also performed the same test and noted same result. During the shift, the ABF personnel continued the excavation in 1mm increments using the same method of test and verification up to 47mm with indications as noted. The shift was completed up to this depth of excavation.

1. 40mm in depth – one 5mm long transverse indication at Y=3890mm and one 75mm long linear indication at Y=3870mm, X=15mm was noted.
2. 41mm in depth – one 5mm long transverse indication at Y=3890mm, one 5mm long transverse indication at Y=3700mm and one 75mm long linear indication at Y=3870mm, X=15mm was noted.

At Tower Base Electro Slag Weld (ESW) 'T' weld joint #S-043 face B, ABF personnel was observed continuing to perform exploratory excavation on welded ESW at location Y=3250mm to Y=3500mm due to UT detected defects. The ABF personnel have resumed the exploratory excavation from 33mm deep ABF personnel have left off previously. The personnel were noted using only the disc grinder in every 1mm increments of excavation. ABF QC Steve Jensen was observed performing Magnetic Particle Testing (MT) on the following various depths with noted indications. This QA also performed the same test and noted same result. During the shift, the ABF personnel continued the excavation in 1mm increments using the same method of test and verification up to 35mm with same result. The excavation was completed up to this depth with no more indication detected.

1. 33mm in depth – 5mm linear indication noted at Y=3360, X=0

2. 34mm in depth – 5mm linear indication at Y=3450mm, 7mm linear indication at Y=3300mm and 2mm linear indication at Y=3320 all at X=30mm were noted.

3. 35mm in depth – all three indications have been removed and no more indications noted.

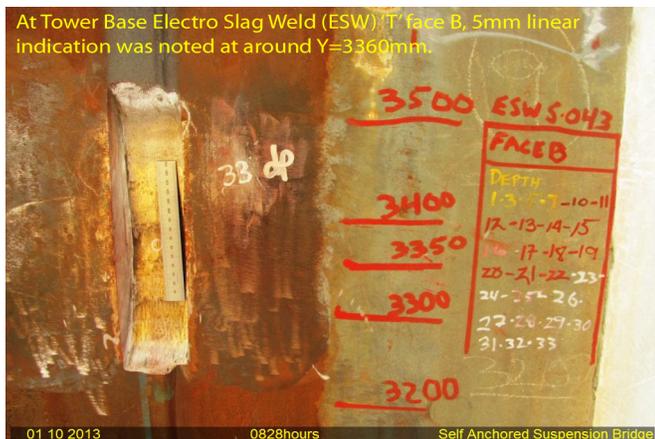
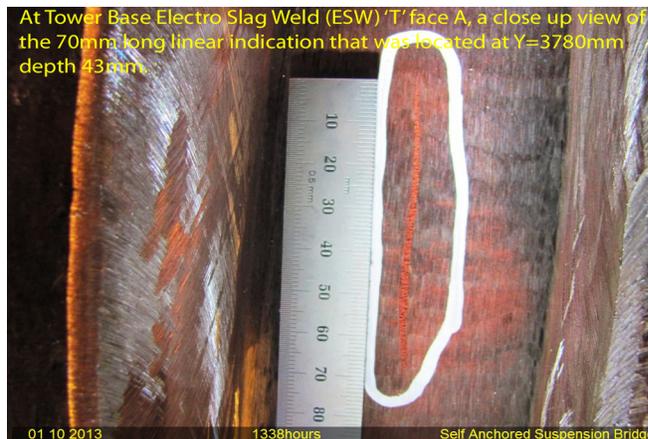
3. 42mm in depth – one 72mm long linear indication at Y=3870mm, X=15mm was noted. The two transverse indications were removed.

4. 43mm in depth – one 70mm long linear indication at Y=3870mm, X=15mm was noted.

5. 44mm in depth – one 68mm long linear indication at Y=3870mm, X=15mm was noted.

6. 45mm in depth – one 70mm long linear indication at Y=3870mm, X=15mm was noted.

7. 46mm in depth – one 65mm long linear indication at Y=3870mm, X=15mm was noted.

8. 47mm in depth – one 62mm long linear indication at Y=3870mm, X=15mm was noted.
