Contract #: 04-0120F4Cty: SF/ALA Rte: 80 PM: 13.2/13.9File #: 1.28**WELDING INSPECTION REPORT**

Report No: WIR-028969
Date Inspected: 11-Jan-2013

Project Name: SAS Superstructure
Prime Contractor: American Bridge/Fluor Enterprises, a JV
Contractor: American Bridge/Fluor Enterprises, a JV

CWI Name:	Steve Jensen	CWI Present:	Yes	No
Inspected CWI report:	Yes No N/A	Rod Oven in Use:	Yes No N/A	
Electrode to specification:	Yes No N/A	Weld Procedures Followed:	Yes No N/A	
Qualified Welders:	Yes No N/A	Verified Joint Fit-up:	Yes No N/A	
Approved Drawings:	Yes No N/A	Approved WPS:	Yes No N/A	
		Delayed / Cancelled:	Yes No N/A	
Bridge No:	34-0006	Component:	SAS Tower

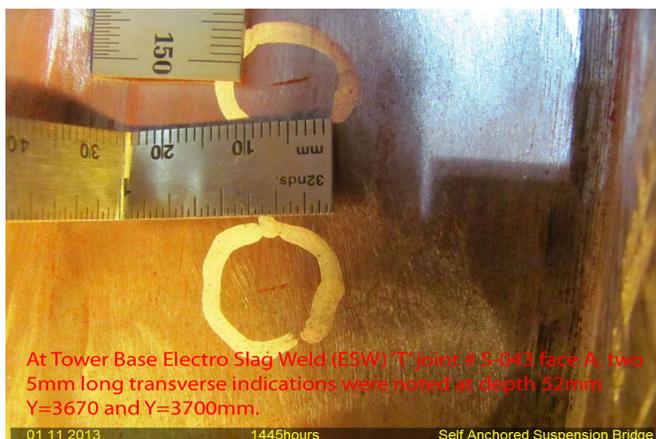
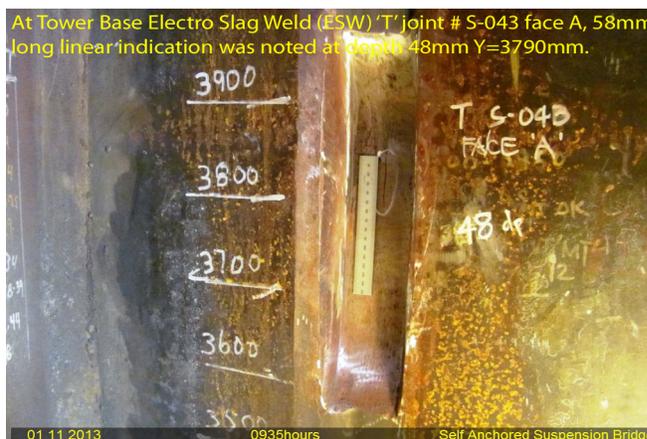
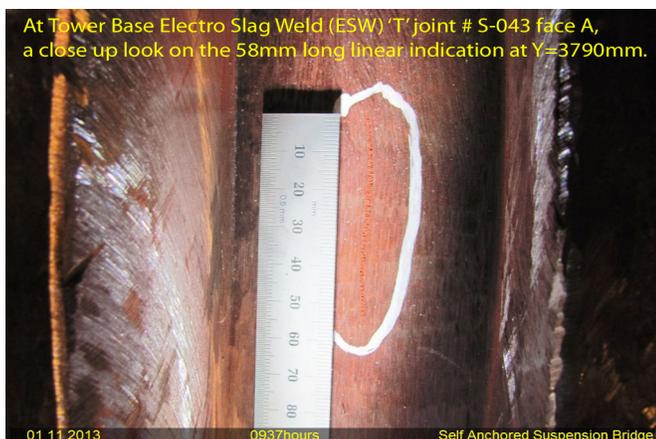
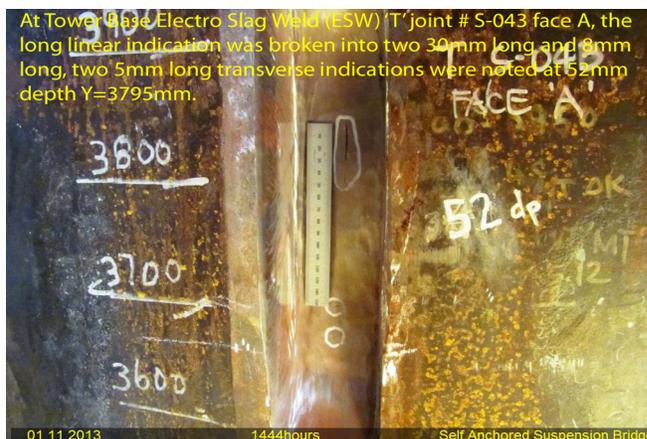
At Tower Base Electro Slag Weld (ESW) 'T' weld joint #S-043 face A, ABF personnel was observed continuing to perform exploratory excavation on welded ESW at location Y=3600 to Y=3950 due to UT detected defects. The ABF personnel have resumed the exploratory excavation from 48mm deep where they left off yesterday. The personnel were noted using only the disc grinder in every 1mm increments of excavation. ABF QC Steve Jensen was observed performing Magnetic Particle Testing (MT) on the following various depths with indications stated below. This QA also performed the same test and noted same result. During the shift, the ABF personnel continued the excavation in 1mm increments using the same method of test and verification up to 53mm with indications as noted below. The shift was completed up to this depth of excavation.

1. 48mm in depth – one 58mm long linear indication at Y=3790mm, X=15mm was noted.
2. 49mm in depth –one 55mm long linear indication at Y=3790mm, X=15mm was noted.
3. 50mm in depth – one 53mm long linear indication at Y=3795mm, X=15mm was noted, one 5mm long transverse indication at Y=3670mm and one 5mm transverse indication at 3700mm.

4. 51mm in depth – one 50mm long linear indication at Y=3795mm, X=15mm was noted, one 5mm long transverse indication at Y=3650mm and one 5mm transverse indication at 3700mm.

5. 52mm in depth – the long 50mm linear indication at Y=3795mm is now broken into two indications which is separated by approximately 10mm. One was 30mm long while the other was 8mm long., one 5mm long transverse indication at Y=3650mm and one 5mm transverse indication at 3700mm still exist.

4. 53mm in depth – the two broken linear indications are now approximately 15mm apart and one was 28mm long at Y=3800mm while the other was 4mm long at Y=3670. One 5mm long transverse indication at Y=3650mm and one 5mm transverse indication at 3700mm still exist.

The exploratory excavations at this location will be continued on the following shift.
