Contract #: 04-0120F4Cty: SF/ALA Rte: 80 PM: 13.2/13.9File #: 1.28**WELDING INSPECTION REPORT**

Report No: WIR-028979
Date Inspected: 05-Jan-2013

Project Name: SAS Superstructure
Prime Contractor: American Bridge/Fluor Enterprises, a JV
Contractor: American Bridge/Fluor Enterprises, a JV

CWI Name:	As noted below.	CWI Present:	Yes	No
Inspected CWI report:	Yes No N/A	Rod Oven in Use:	Yes No N/A	
Electrode to specification:	Yes No N/A	Weld Procedures Followed:	Yes No N/A	
Qualified Welders:	Yes No N/A	Verified Joint Fit-up:	Yes No N/A	
Approved Drawings:	Yes No N/A	Approved WPS:	Yes No N/A	
		Delayed / Cancelled:	Yes No N/A	
Bridge No:	34-0006	Component:	Tower

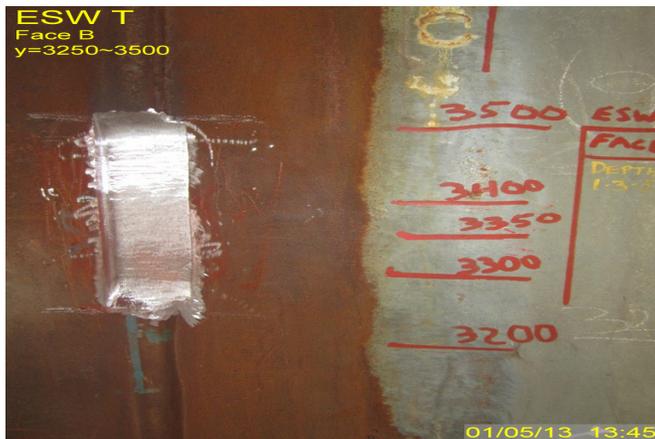
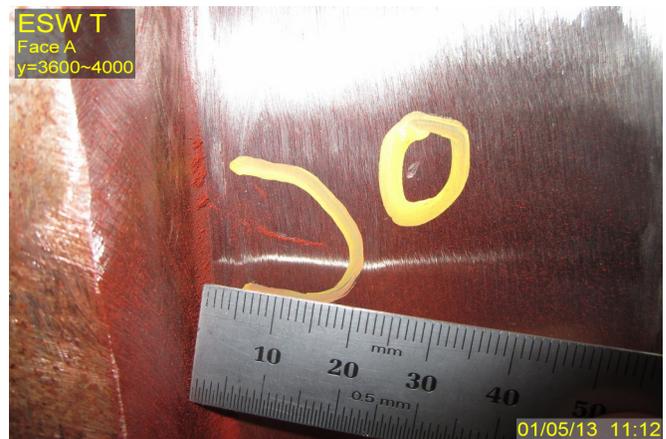
This QA performed observation of excavation of Electroslag Weld (ESW) designated as ESW T, Face A. Excavation was performed at location (Y= 3600mm~4000mm).

One (1) indication observed. (Slag)

One (1) indication observed. (Transverse)

This QA performed observation of excavation of Electroslag Weld (ESW) designated as ESW T, Face B. Excavation was performed at location (Y= 3250mm~3500mm).

No indications observed.
