**DEPARTMENT OF TRANSPORTATION**

Contract #: 04-0120F4Cty: SF/ALA Rte: 80 PM: 13.2/13.9File #: 1.28**WELDING INSPECTION REPORT****Resident Engineer:** Casey, William**Address:** 333 Burma Road**City:** Oakland, CA 94607**Report No:** WIR-028986**Date Inspected:** 14-Jan-2013**Project Name:** SAS Superstructure**OSM Arrival Time:** 700**Prime Contractor:** American Bridge/Fluor Enterprises, a JV**OSM Departure Time:** 1730**Contractor:** American Bridge/Fluor Enterprises, a JV**Location:** Job Site**CWI Name:** William Sherwood**CWI Present:** Yes No**Inspected CWI report:** Yes No N/A**Rod Oven in Use:** Yes No N/A**Electrode to specification:** Yes No N/A**Weld Procedures Followed:** Yes No N/A**Qualified Welders:** Yes No N/A**Verified Joint Fit-up:** Yes No N/A**Approved Drawings:** Yes No N/A**Approved WPS:** Yes No N/A**Delayed / Cancelled:** Yes No N/A**Bridge No:** 34-0006**Component:** SAS Tower**Summary of Items Observed:**

# WELDING INSPECTION REPORT

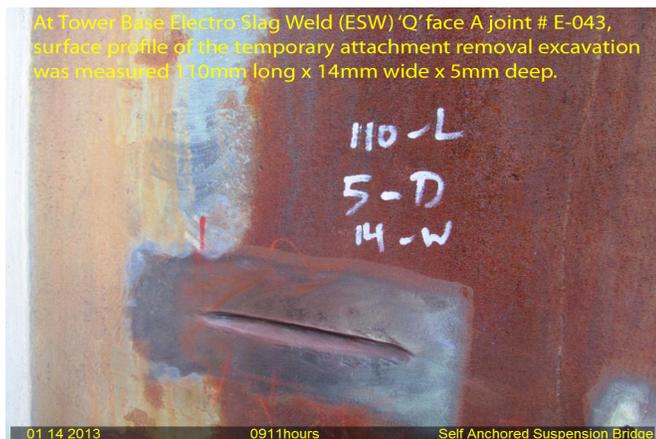
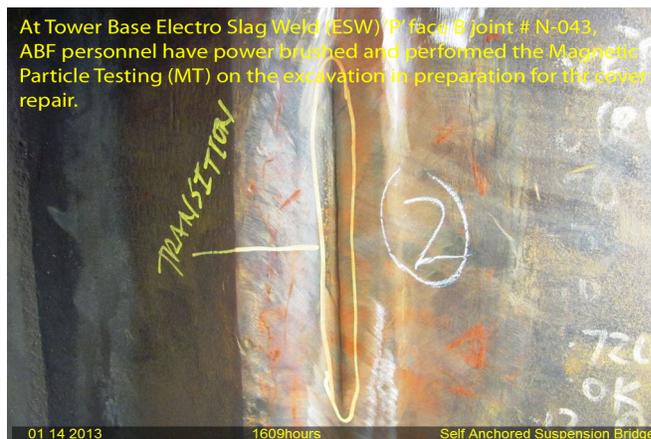
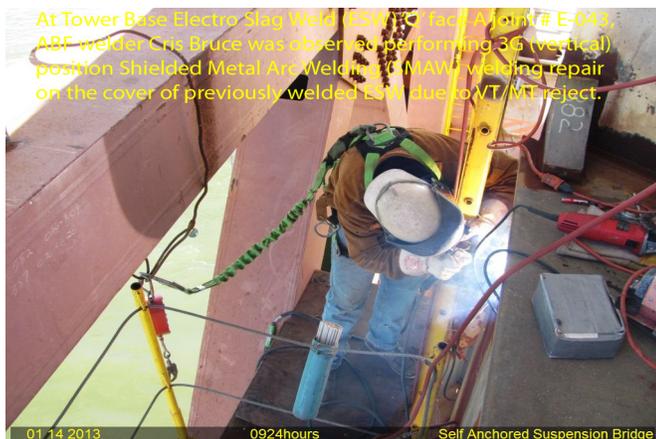
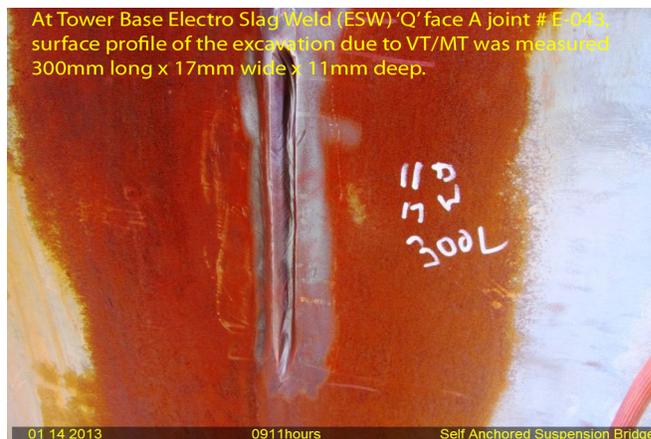
At Tower Base Electro Slag Weld (ESW) 'Q' weld joint #E-043 face A, ABF welder Cris Bruce was observed perform 2G/3G welding repair on the weld cover on previously welded ESW. The welder was noted utilizing Shielded Metal Arc Welding (SMAW) with 1/8" diameter E7018H4R electrode implementing ABF-WPS-D15-1000 Repair Rev.3. The surface of the areas that were welded was ground smooth and then tested by ABF QC William Sherwood using Magnetic Particle Testing (MT) with no relevant indications noted. This QA also performed the same test and noted same result. Prior welding, ABF personnel have preheated the repair area to more than 300°F using propylene gas torch. During the shift, the ABF QC William Sherwood was noted monitoring the welding parameters and workmanship of the repairs being welded.

1. Y=9270mm 110mm long x 14mm wide x 5mm deep (horizontal excavation/temporary attachment removal).
2. Y=9120mm 140mm long x 17mm wide x 10mm deep (vertical on weld zone)
3. Y=8790mm 300mm long x 17mm wide x 11mm deep (vertical on weld zone)
4. Y=5620mm 200mm long x 11mm wide x 7mm deep (vertical on weld zone)
5. Y=5330mm 140mm long x 10mm wide x 2mm deep (horizontal excavation/temporary attachment removal)
6. Y=7880mm 140mm long x 8mm wide x 5mm deep (horizontal excavation/temporary attachment removal)

After the repair completion on the cover of the ESW at 'Q' face A mentioned above, the welder has moved to ESW 'P' and 'Q' face A and set-up their equipment and tools for their next welding repair. ABF personnel have started grinding the areas that need to be repaired. ABF QC William Sherwood performed the Magnetic Particle Testing (MT) on these areas with no relevant indications noted.
