Contract #: 04-0120F4Cty: SF/ALA Rte: 80 PM: 13.2/13.9File #: 1.28**WELDING INSPECTION REPORT****Resident Engineer:** Casey, William**Address:** 333 Burma Road**City:** Oakland, CA 94607**Report No:** WIR-029022**Date Inspected:** 17-Jan-2013**Project Name:** SAS Superstructure**OSM Arrival Time:** 700**Prime Contractor:** American Bridge/Fluor Enterprises, a JV**OSM Departure Time:** 1730**Contractor:** American Bridge/Fluor Enterprises, a JV**Location:** Job Site**CWI Name:** See below.**CWI Present:** Yes No**Inspected CWI report:** Yes No N/A**Rod Oven in Use:** Yes No N/A**Electrode to specification:** Yes No N/A**Weld Procedures Followed:** Yes No N/A**Qualified Welders:** Yes No N/A**Verified Joint Fit-up:** Yes No N/A**Approved Drawings:** Yes No N/A**Approved WPS:** Yes No N/A**Delayed / Cancelled:** Yes No N/A**Bridge No:** 34-0006**Component:** OBG**Summary of Items Observed:**

WELDING INSPECTION REPORT

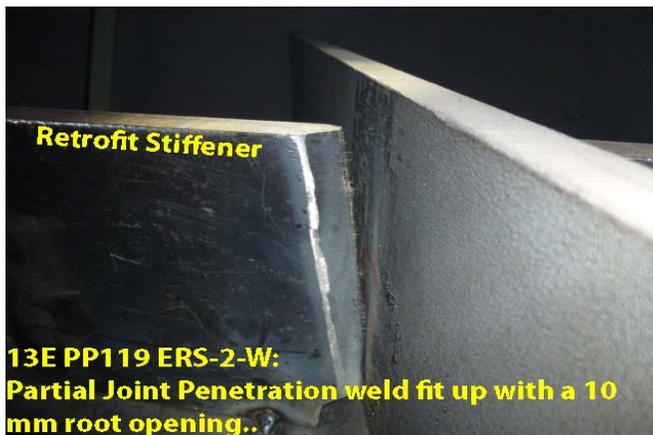
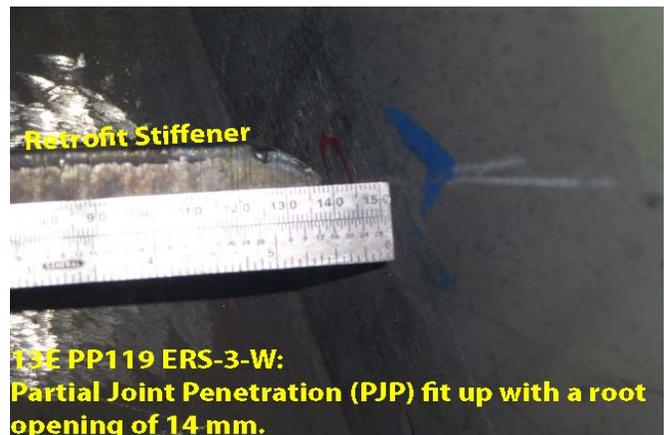
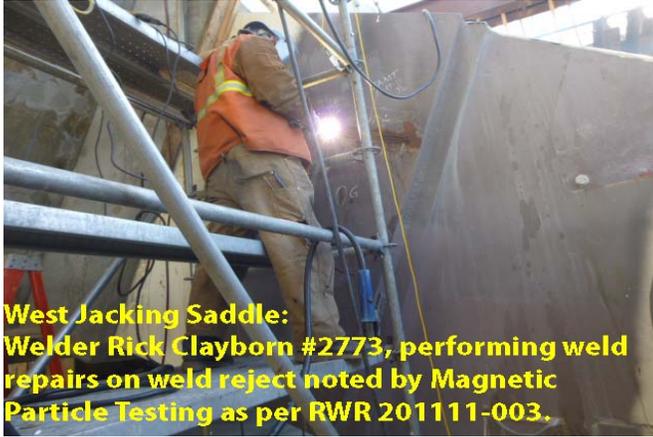
Welder was observed welding fillet welds and PJP welds for the Retrofit Stiffeners at 13E PP119-ERS. The stiffeners mentioned above are the CCO 238 Retrofit Stiffeners to the "C" side plating. Welder was observed preheating and using Welding Procedure Specification (WPS) ABF-WPS-D15-F2200-2 for the fillet welds and 2170-3 for the partial joint penetration or PJP welds. Welding parameters were verified by QC Inspector John Hays throughout the day and appear to be in compliance with the both WPSs noted above.

Welder was observed welding fillet welds and PJP welds for the Retrofit Stiffeners at 13E PP118.5-ERS. The stiffeners mentioned above are the CCO 238 Retrofit Stiffeners to the "C" side plating. Welder was observed preheating and using Welding Procedure Specification (WPS) ABF-WPS-D15-F2200-2 for the fillet welds and 2170-3 for the partial joint penetration or PJP welds. Welding parameters were verified by QC Inspector John Hays throughout the day and appear to be in compliance with the both WPSs noted above.

An Incident Report report was submitted for the CCO238 OBG Retrofit Stiffeners for the excessive root opening noted at a few of the stiffeners. QC Inspector John Hays was informed of the root opening issue. See “Incident Report” for detailed information.
