DEPARTMENT OF TRANSPORTATION

Contract #: 04-0120F4Cty: SF/ALA Rte: 80 PM: 13.2/13.9File #: 1.28**WELDING INSPECTION REPORT****Resident Engineer:** Casey, William**Address:** 333 Burma Road**City:** Oakland, CA 94607**Report No:** WIR-029030**Date Inspected:** 19-Jan-2013**Project Name:** SAS Superstructure**OSM Arrival Time:** 700**Prime Contractor:** American Bridge/Fluor Enterprises, a JV**OSM Departure Time:** 1530**Contractor:** American Bridge/Fluor Enterprises, a JV**Location:** Job Site**CWI Name:** William Sherwood**CWI Present:** Yes No**Inspected CWI report:** Yes No N/A**Rod Oven in Use:** Yes No N/A**Electrode to specification:** Yes No N/A**Weld Procedures Followed:** Yes No N/A**Qualified Welders:** Yes No N/A**Verified Joint Fit-up:** Yes No N/A**Approved Drawings:** Yes No N/A**Approved WPS:** Yes No N/A**Delayed / Cancelled:** Yes No N/A**Bridge No:** 34-0006**Component:** SAS Tower**Summary of Items Observed:**

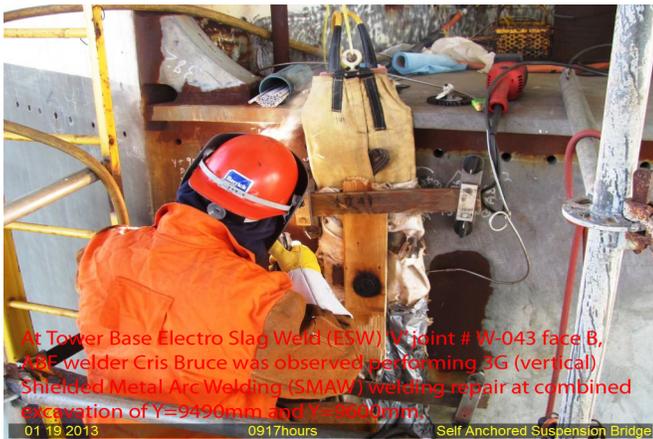
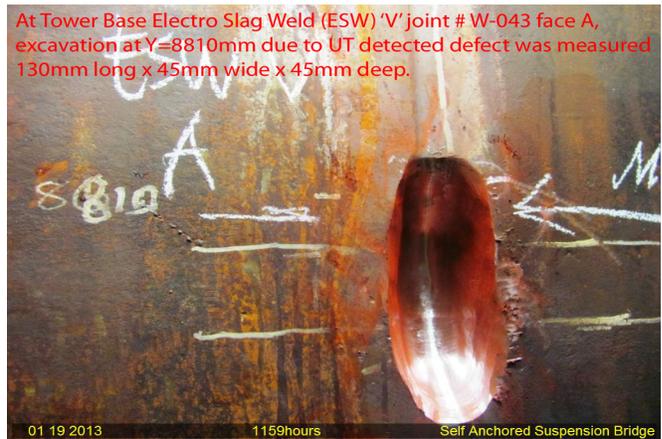
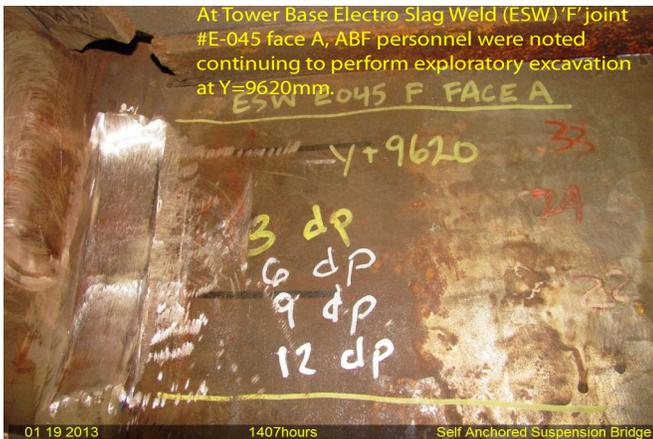
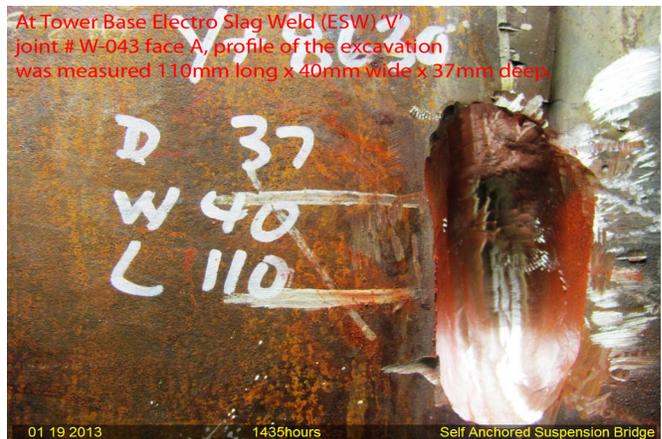
At Tower Base Electro Slag Weld (ESW) "V" weld joint #W-043 face B, ABF welder Chris Bruce was observed performing the repair welding at the Y coordinates 9490mm and 9600mm. The welder was noted utilizing Shielded Metal Arc Welding (SMAW) as per the Welding Procedure Specification (WPS) ABF-WPS-D15-1000 Repair Rev. 3. Welding parameter measured during welding was noted as 185 amperes utilizing the 4mm E7018H4R electrode as referenced per the WPS. This weld repair is being performed per the Request for Weld Repairs (RWRs) #201301-032 and #201301-033. During the shift, ABF QC William Sherwood was noted monitoring the welding parameters and workmanship of the repair being welded. The welding was not completed during this shift and will be continued on the next scheduled shift. The welder also performed the Post Weld Heat Treatment (PWHT) as required per the contract documents.

At Tower Base Electro Slag Weld (ESW) "V" weld joint #W-043 face A, ABF welder Eric Sparks was observed performing the excavations of two UT rejects identified and located at Y coordinates 8810mm and 8630mm. The excavations are being performed as per the approved RWR#'s 201301-031 and 201301-031. Prior to the excavation, the welder was noted preheating the repair area to a minimum of 350°F using Miller Proheat 35 Induction Heating System with the heater blanket placed on the outside. After completing the excavation, ABF QC William Sherwood performed Magnetic Particle Testing (MPT) and no rejectable indications were noted. At this time, this QAI performed an MPT to verify the weld and the QC inspection for compliance and at the

conclusion of the verification this QAI concurs with Mr. Sherwood's assessment. The dimensions of the excavations are as follows: 130mm long x 45mm wide x 45mm deep for the location at Y=8810mm and 110mm long x 40mm wide x 37mm deep for the location at Y=8630mm. No welding of this excavation was performed during this shift.

At Tower Base Electro Slag Weld (ESW) "F" weld joint #E-045 face A, ABF personnel was observed performing exploratory excavation of the indication found by UT located at Y coordinate 9620mm. The ABF personnel have resumed the exploratory excavation from 3mm deep which was started on the previous scheduled shift. The ABF personnel was observed grinding which was performed at 3mm intervals. ABF QC William Sherwood was observed performing Magnetic Particle Testing (MT) on the following various depths with indications noted below. This QAI performed an MPT to verify the QC testing for compliance and at the conclusion of the testing this QAI concurs with Mr. Sherwood's assessment. During the shift, the ABF personnel have excavated up to 12mm deep.

1. At 6mm deep – no significant indications noted.
2. At 9mm deep - no significant indications noted.
3. At 12mm deep – no significant indications noted.
