DEPARTMENT OF TRANSPORTATION

Contract #: 04-0120F4Cty: SF/ALA Rte: 80 PM: 13.2/13.9File #: 1.28**WELDING INSPECTION REPORT****Resident Engineer:** Casey, William**Address:** 333 Burma Road**City:** Oakland, CA 94607**Report No:** WIR-029031**Date Inspected:** 21-Jan-2013**Project Name:** SAS Superstructure**OSM Arrival Time:** 700**Prime Contractor:** American Bridge/Fluor Enterprises, a JV**OSM Departure Time:** 1730**Contractor:** American Bridge/Fluor Enterprises, a JV**Location:** Job Site

CWI Name:	William Sherwood and Steve Jensen			CWI Present:	Yes	No	
Inspected CWI report:	Yes	No	N/A	Rod Oven in Use:	Yes	No	N/A
Electrode to specification:	Yes	No	N/A	Weld Procedures Followed:	Yes	No	N/A
Qualified Welders:	Yes	No	N/A	Verified Joint Fit-up:	Yes	No	N/A
Approved Drawings:	Yes	No	N/A	Approved WPS:	Yes	No	N/A
				Delayed / Cancelled:	Yes	No	N/A
Bridge No:	34-0006			Component:	SAS Tower

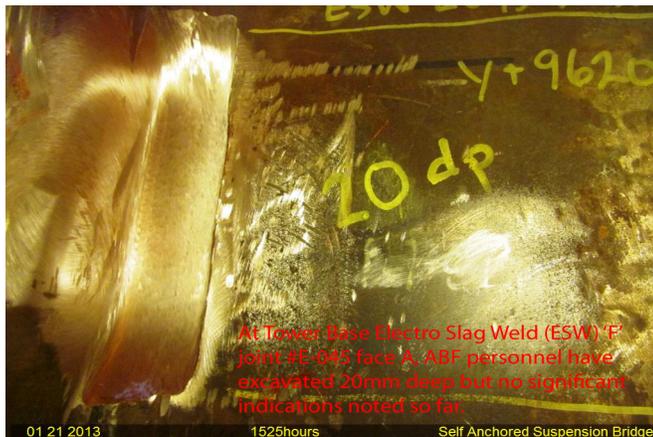
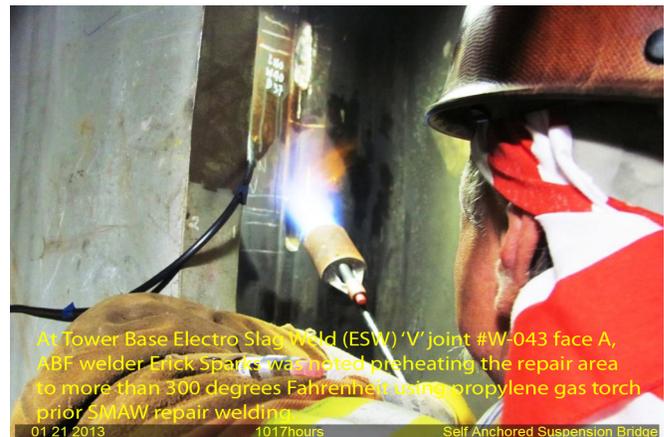
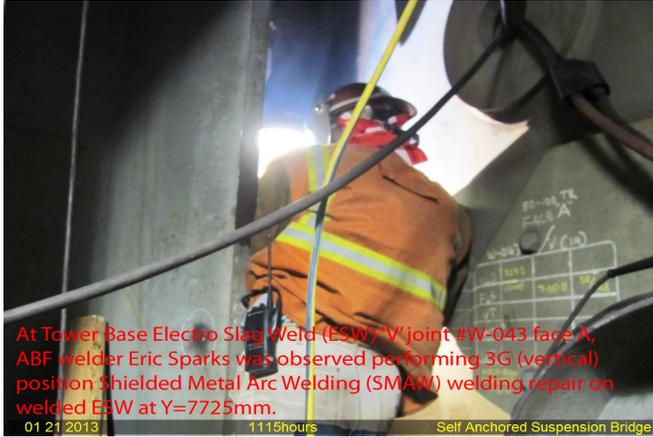
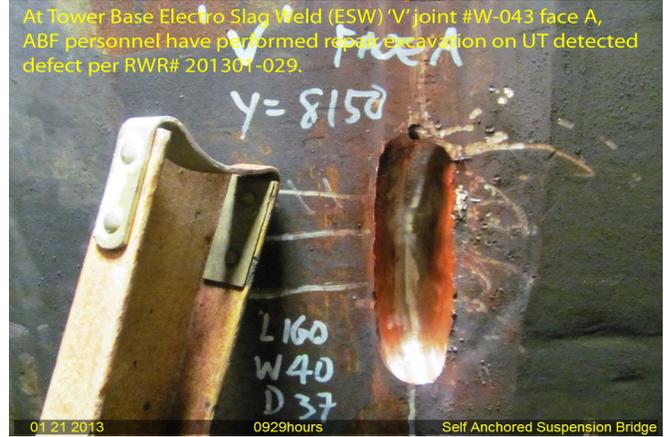
At Tower Base Electro Slag Weld (ESW) joint "V" (Weld No. W-043) face B, ABF welder Eric Sparks was observed performing the repair welding (UT reject) located at Y coordinate 7725mm. The boat shape repair excavation profile was measured 110mm long x 40mm wide x 40mm deep. The welder was observed utilizing the 4 mm diameter E7018H4R electrode as per the Shielded Metal Arc Welding (SMAW) with 4mm diameter E7018H4R electrode as per the Welding Procedure Specification (WPS) ABF-WPS-D15-1000 Repair Rev. 3. Prior to the welding, the welder was noted preheating the repair area to a minimum of 350°F using propylene gas torch. The welding parameters were measured during the welding and the average amperage appeared to be 180 Amps. The weld repair was performed as per the Request for Weld Repair (RWR) #201301-028. The Quality Control (QC) inspector, William Sherwood, was observed monitoring the welding parameters and workmanship of the weld repair. The repair welding was not completed during this shift and will resume on the next scheduled shift. This task was turned over to QAI Fritz Belford.

At Tower Base Electro Slag Weld (ESW) joint "V" (Weld No. W-043) face A, ABF personnel was observed performing the excavation (UT reject) located at Y coordinate 8150mm. The repair excavation was performed as per the approved RWR# 201301-029. Prior to the excavation, the welder was noted preheating the repair area to a minimum of 350°F utilizing propylene gas torch. After completing the excavation, ABF QC William Sherwood performed Magnetic Particle Testing (MPT) and no indications were noted. The dimensions of the excavation was

as follows: 160mm long x 40mm wide x 37mm deep. At the conclusion of the QC testing this QAI performed MPT to verify the excavation and QC testing and at the conclusion of the testing this QAI concurs with QC assessment. The visual inspection and testing were completed during this shift. No welding was performed on this date.

At Tower Base Electro Slag Weld (ESW) joint "F" (Weld joint E-045) face A, ABF personnel was observed performing exploratory excavation (UT reject) located at Y coordinate 9620mm. This task is a carry over from the previous shift starting from the depth of 12mm deep. The grinding was performed utilizing a disc grinder with a maximum depth in 3mm increments of excavation up to 16mm deep and the remaining excavations at 1mm increments. This task was performed as a directive by the contractor to provide QC/QA inspection and testing. The Quality Control (QC) inspector Steve Jensen was observed performing Magnetic Particle Testing (MPT) at the following various depths with results recorded below. At the conclusion of the QC testing this QAI performed MPT to verify the excavation and QC inspection and testing complies with the contract documents. At the conclusion of the testing this QAI concurs with QC assessment. The excavation is completed to approximately 20mm in depth with no significant indications noted so far.

1. At 16mm deep – no significant indications noted.
2. At 17mm deep - no significant indications noted.
3. At 18mm deep – no significant indications noted.
4. At 19mm deep - no significant indications noted.
5. At 20mm deep – no significant indications noted.
