DEPARTMENT OF TRANSPORTATION

Contract #: 04-0120F4Cty: SF/ALA Rte: 80 PM: 13.2/13.9File #: 1.28**WELDING INSPECTION REPORT****Resident Engineer:** Casey, William**Address:** 333 Burma Road**City:** Oakland, CA 94607**Report No:** WIR-029048**Date Inspected:** 24-Jan-2013**Project Name:** SAS Superstructure**OSM Arrival Time:** 700**Prime Contractor:** American Bridge/Fluor Enterprises, a JV**OSM Departure Time:** 1530**Contractor:** American Bridge/Fluor Enterprises, a JV**Location:** USA Hoist, Crest Hill, IL

Bridge No: 34-0006**Component:** SAS Tower Elevator**Summary of Items Observed:**

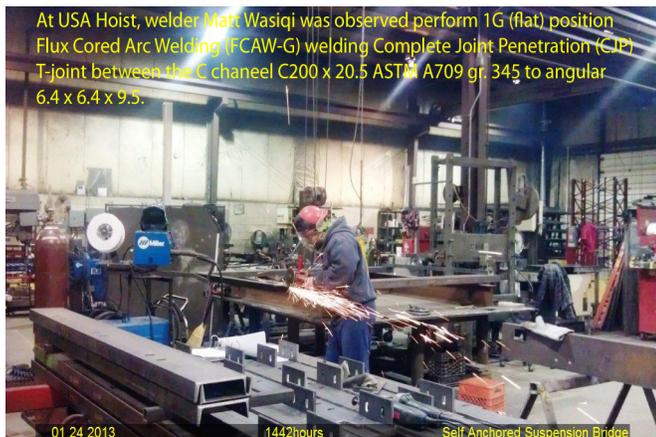
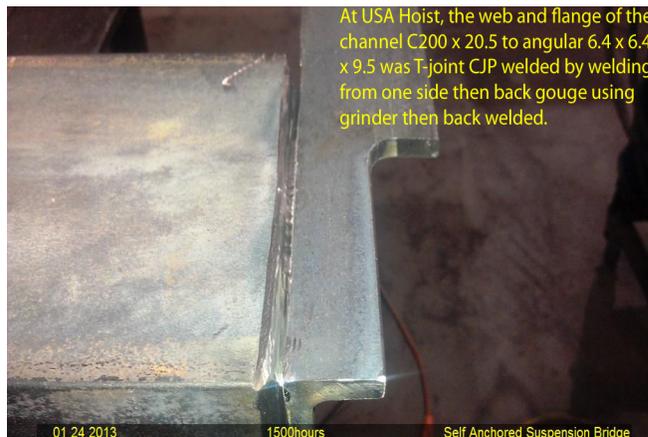
At USA Hoist assembly shop, this QA randomly observed USA certified welder Matt Wasiqi perform 1G (flat) position gas shielded Flux Cored Arc Welding (FCAW-G) welding Complete Joint Penetration (CJP) between C-channels C200 x 20.5/C180 x 18.2 x 2500mm long part numbers 914931/914925 and angular 6.4 x 6.4 x 9.5 x 1800mm long part number 914900-02. The C200 x 20.5 channel is being welded on the left side of the 6.4 x 6.4 angular while the C180 x 18.2 channel is being welded on the right side. The original design was 45 degree single bevel with back gouge but due to the tapering thickness of the flange of the channel, there will be limited access to perform the CJP. This QA and fellow QA Dustyn Broening discussed this situation to Mr. Bob Beck USA Hoist Engineer and Mr. Tim Moran USA Hoist Project Manager and acting Quality Control. USA Hoist decided to change the design to double bevel to get a better CJP welding access to the tapering channel flange. According to Mr. Tim Moran, this joint design change will be submitted to Caltrans for approval. Since the change of the joint design was implemented prior to Engineer's approval, an Incident Report was initiated. These channels to angle connections are intended for door enclosure frame for elevator stops at 2 (elevation 53.85 meter), stop 3 (elevation 89.85 meter) and stop 6 (elevation 156.80 meter).

The welder was noted using gas shielded FCAW-G with 1.1mm E71T-1C Familiarc DW-50 wire electrode implementing USA Hoist Welding Procedure Specification FCAW 2916. The shielding gas being used was noted a combination of 75% Argon and 25% CO2. During the shift, the working welding parameters was measured 28

volts and 225 amperes which deemed in compliance to the company procedure. At the end of the shift, two (2) of the three (3) identical frame for the three stops have been started but not completed.

This QA and fellow QA Dustyn Broening discussed the change in joint design situation to Mr. Bob Beck USA Hoist Engineer and Mr. Tim Moran USA Hoist Project Engineer and acting Quality Control. USA Hoist decided to change the design to double bevel to get a better CJP welding access to the tapering channel flange. According to Mr. Tim Moran, this joint design change will be submitted to Caltrans for approval.
