**DEPARTMENT OF TRANSPORTATION**

Contract #: 04-0120F4Cty: SF/ALA Rte: 80 PM: 13.2/13.9File #: 1.28**WELDING INSPECTION REPORT****Resident Engineer:** Casey, William**Address:** 333 Burma Road**City:** Oakland, CA 94607**Report No:** WIR-029056**Date Inspected:** 01-Feb-2013**Project Name:** SAS Superstructure**OSM Arrival Time:** 700**Prime Contractor:** American Bridge/Fluor Enterprises, a JV**OSM Departure Time:** 1530**Contractor:** American Bridge/Fluor Enterprises, a JV**Location:** USA Hoist, Crest Hill, IL

**Bridge No:** 34-0006**Component:** SAS Tower Elevator**Summary of Items Observed:**

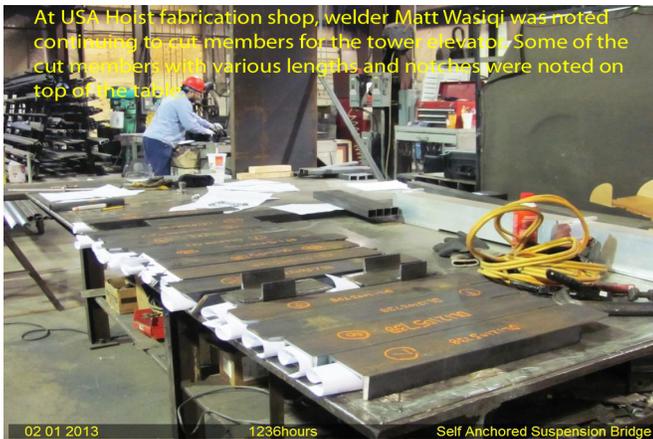
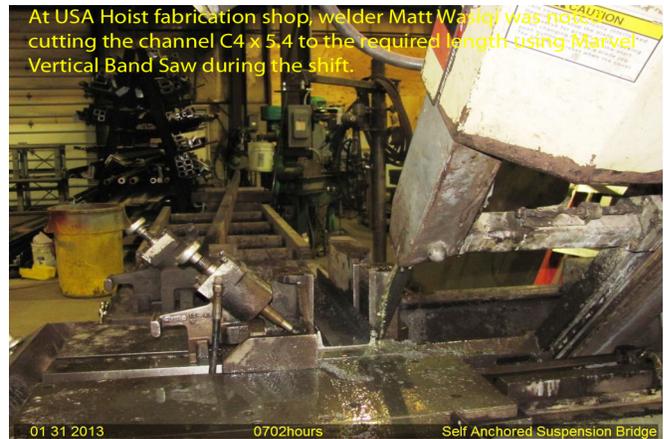
Above mentioned elevator cab frame part members were cut and notched as required during the shift. According to Mr. Genaro Ulloa, there are still many part members to be cut and that he is waiting for the shop drawing from Mr. Bob Overbeek USA Hoist Engineer.
