DEPARTMENT OF TRANSPORTATION

Quality Assurance and Source Inspection

WELDING INSPECTION REPORT

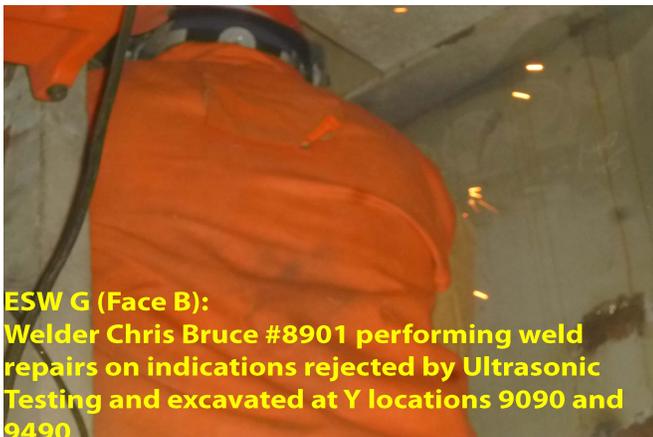
The welder was observed Carbon Arc Gouging (CAG) and performing the weld repairs on excavations on the Electroslag Weld "G" S-045 at face B. The indications were rejected with Ultrasonic Testing Shear Wave and were excavated at Y locations 9090 and 9490 as per Request for Weld Repairs or the RWR 201301-054 & 055. The welder was observed preheating the weld to 300 degrees Fahrenheit prior to welding using the Miller ProHeat 35 with heat induction blankets. The welder utilized the Welding Procedure Specification (WPS) ABF-WPS-D15-1000-Repair Rev.3 for Shield Metal Arc Welding (SMAW). The welding parameters were verified by QC Inspector William Sherwood throughout the day and they appeared to be in compliance with the WPS noted above. After welding as noted above the welder was observed grinding welds "M" W-042 and "L" S-042 in preparation for Visual and Ultrasonic Testing.

ESW G (Face B):
Welder Chris Bruce #8901 performing weld repairs on indications rejected by Ultrasonic Testing and excavated at Y locations 9090 and 9490

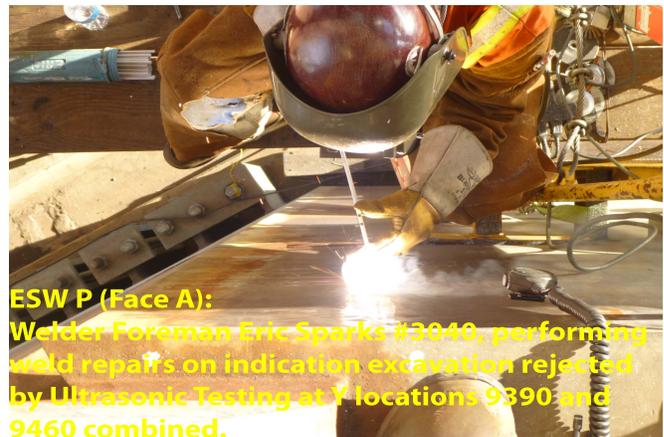
The welder was observed performing the weld repair on the excavation on the Electroslag Weld "P" N-043 at face A. The indications were rejected with Ultrasonic Testing Shear Wave and were excavated at Y locations 8980 and 9030 as per Request for Weld Repairs or the RWR 201301-051 and -052. The welder was observed preheating the weld to 300 degrees Fahrenheit prior to welding using the Miller ProHeat 35 with heat induction blankets. The welder utilized the Welding Procedure Specification (WPS) ABF-WPS-D15-1000-Repair Rev.3 for Shield Metal

ESW P (Face A):
Welder Foreman Eric Sparks #3040, performing weld repairs on indication excavation rejected by Ultrasonic Testing at Y locations 9390 and 9460 combined.
