DEPARTMENT OF TRANSPORTATION

Contract #: 04-0120F4Cty: SF/ALA Rte: 80 PM: 13.2/13.9File #: 1.28**WELDING INSPECTION REPORT****Resident Engineer:** Casey, William**Address:** 333 Burma Road**City:** Oakland, CA 94607**Report No:** WIR-029095**Date Inspected:** 06-Feb-2013**Project Name:** SAS Superstructure**OSM Arrival Time:** 700**Prime Contractor:** American Bridge/Fluor Enterprises, a JV**OSM Departure Time:** 1730**Contractor:** American Bridge/Fluor Enterprises, a JV**Location:** Job Site**CWI Name:** As noted below**CWI Present:** Yes No**Inspected CWI report:** Yes No N/A**Rod Oven in Use:** Yes No N/A**Electrode to specification:** Yes No N/A**Weld Procedures Followed:** Yes No N/A**Qualified Welders:** Yes No N/A**Verified Joint Fit-up:** Yes No N/A**Approved Drawings:** Yes No N/A**Approved WPS:** Yes No N/A**Delayed / Cancelled:** Yes No N/A**Bridge No:** 34-0006**Component:** SAS OBG**Summary of Items Observed:**

WELDING INSPECTION REPORT

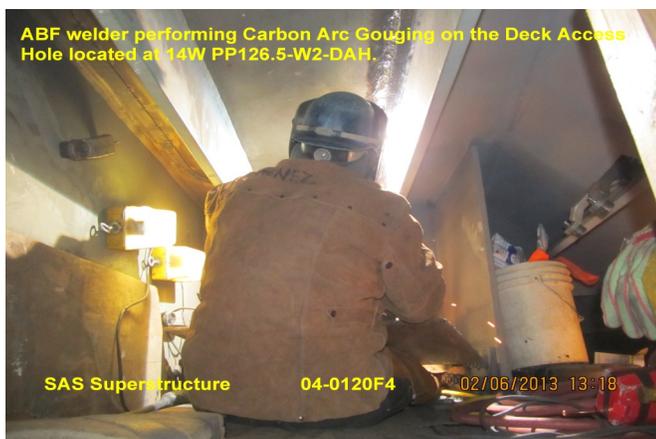
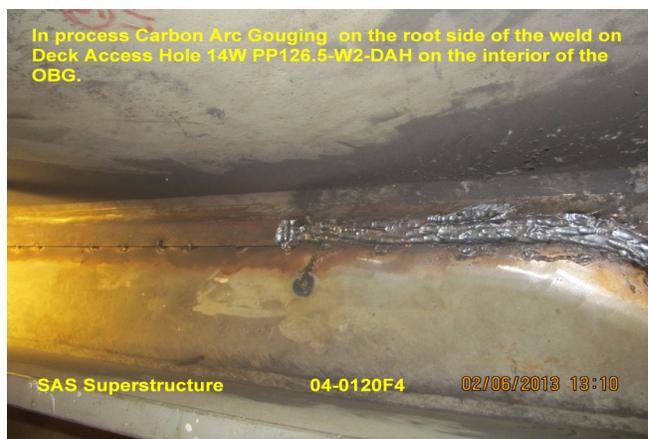
This QA Inspector randomly observed ABF/JV welder Mike Jimenez #4671 performing the Carbon Arc Gouging (CAG) process in the 4G overhead position on the root side of the weld of the Deck Access Hole of 14W PP126.5-W2-DAH. This QA inspector made subsequent observations throughout the shift to monitor quality and noted that the work is in progress and appears to be in general conformance to the contract requirements.

ABF welder Wai Kit Lai #2953 was observed performing Shielded Metal Arc welding (SMAW) on the Deck Access Hole at 14E PP126.5-E2-DAH. The welder was observed utilizing WPS ABF-D1.5-1040C-CU for SMAW. The welder was observed preheating the welds prior to welding. Other welding parameters as inspected by the QC Inspector were recoded as 32 Amperes and appeared to be in compliance with the WPS noted above. Work is in progress on the interior side of the plate.

This QA Inspector made random observations of the SMAW of equipment pads to the deck of the 90 meter elevation of the Tower. ABF/JV welder Xiao Hua Luo #1291 performed the welding in compliance and conforming to ABF-WPS-D1.5-F1200A for fillet welding with the SMAW process. Upon completion, QC Inspector Fred Mikels tested the welds by means of Magnetic Particle Inspection to verify soundness of the metal.

The work and testing was found to be acceptable and appeared to be in general conformance to the contract documents.
