Contract #: 04-0120F4Cty: SF/ALA Rte: 80 PM: 13.2/13.9File #: 99.28**WELDING INSPECTION REPORT****Resident Engineer:** Casey, William**Address:** 333 Burma Road**City:** Oakland, CA 94607**Report No:** WIR-029099**Date Inspected:** 08-Feb-2013**Project Name:** SAS Superstructure**OSM Arrival Time:** 700**Prime Contractor:** American Bridge/Fluor Enterprises, a JV**OSM Departure Time:** 1530**Contractor:** USA Hoist**Location:** USA Hoist, Crest Hill, IL

Bridge No: 34-0006**Component:** SAS Tower Elevator**Summary of Items Observed:**

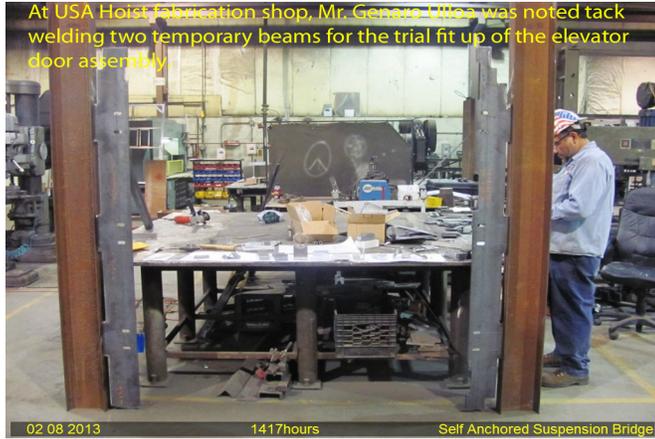
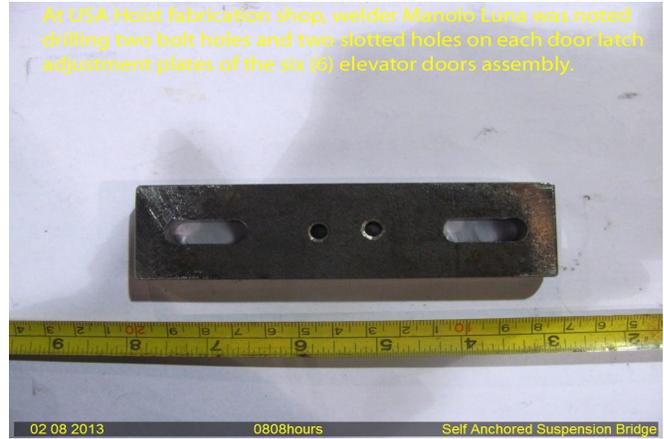
After the welding completion of the stiffener plates and holding brackets for the door lock on all six (6) elevator door stops 1 thru 6, USA Hoist welder Manolo Luna started perform drilling on six (6) 5" long x 1 1/4" wide x 1/2" plates intended for door latch adjustment plate for all 6 elevator door locks. The welder was noted drilling two (2) 3/16" diameter bolt holes on the plates then tapped them with 1/4"-20 UNC. After the completion of 1/4" tapping on all six (6) adjustment plates, the welder has drilled two slotted holes on the same six plates. The welder was seen drilling two 5/16" x 1" slotted holes and two tapped bolt holes on each adjustment plates following USA Hoist shop drawing 914910-05. During the shift, two tapped bolt holes and two slotted holes were drilled on all six door latch adjustment plates intended for the six elevator door locks have been completed.

At USA Hoist fabrication shop, welding foreman Genaro Ulloa was noted erecting the temporary frame for the trial fit up of six (6) elevator door stops enclosure frame assembly before sending them for hot dipped galvanizing. During the conversation with the foreman, he mentioned that USA Hoist wants to make sure that the assembly will fit correct accordingly and the installed camber will be noted. The welder has tack welded one beam on left and right sides of the work table then bolted the hinged frame and fixed frame to the beams. This procedure was done during the shift but was not able to trial fit the whole assembly due to limited time. Mr. Genaro informed this QA that they will continue on Monday.
