DEPARTMENT OF TRANSPORTATION

Contract #: 04-0120F4Cty: SF/ALA Rte: 80 PM: 13.2/13.9File #: 1.28**WELDING INSPECTION REPORT****Resident Engineer:** Casey, William**Address:** 333 Burma Road**City:** Oakland, CA 94607**Report No:** WIR-029136**Date Inspected:** 15-Feb-2013**Project Name:** SAS Superstructure**OSM Arrival Time:** 700**Prime Contractor:** American Bridge/Fluor Enterprises, a JV**OSM Departure Time:** 1730**Contractor:** American Bridge/Fluor Enterprises, a JV**Location:** Job Site**CWI Name:** See below.**CWI Present:** Yes No**Inspected CWI report:** Yes No N/A**Rod Oven in Use:** Yes No N/A**Electrode to specification:** Yes No N/A**Weld Procedures Followed:** Yes No N/A**Qualified Welders:** Yes No N/A**Verified Joint Fit-up:** Yes No N/A**Approved Drawings:** Yes No N/A**Approved WPS:** Yes No N/A**Delayed / Cancelled:** Yes No N/A**Bridge No:** 34-0006**Component:** Tower**Summary of Items Observed:**

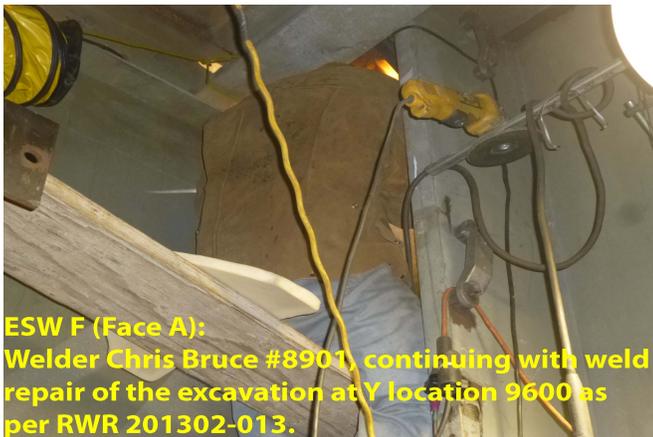
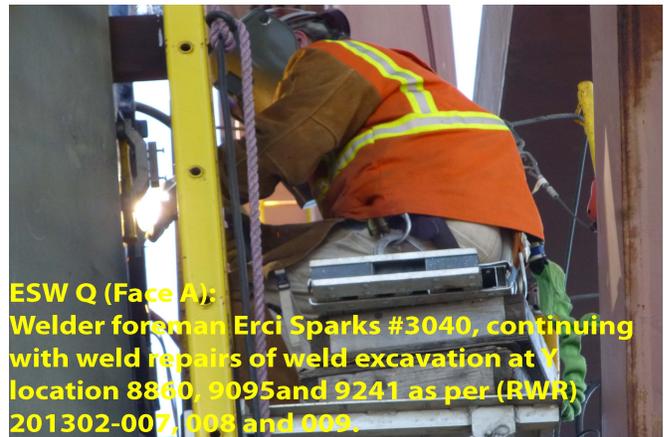
The welder was observed continuing the weld repair on the Electroslag Weld "F" at face A, at Y location 9600 as per Request for Weld Repair (RWR) 201302-013 in way of an Ultrasonic Testing rejected indication. The indication was excavated 1mm at time to a depth of 40mm as part of exploratory excavation for flaw characterization. The welder was observed preheating the weld to 300 degrees Fahrenheit prior to welding using the Miller ProHeat 35 with heat induction blankets. The welder utilized the Welding Procedure Specification (WPS) ABF-WPS-D15-1000-Repair Rev.3 for Shield Metal Arc Welding (SMAW). The welding parameters were verified by QC Inspector William Sherwood throughout the day and appeared to be in compliance with the WPS noted above.

The welder was observed continuing with the weld repair on the Electroslag weld "Q" at face A, at Y locations 8860, 9095 and 9241 as per Request for Weld Repair (RWR) 201302-007, 008 and 009 in way of UT rejected indications. The welder was observed preheating the weld to 300 degrees Fahrenheit prior to excavating using the Miller ProHeat 35 with heat induction blankets. The welder utilized the Welding Procedure Specification (WPS) ABF-WPS-D15-1000-Repair Rev.3 for Shield Metal Arc Welding (SMAW). The welding parameters were verified by QC Inspector William Sherwood throughout the day and appeared to be in compliance with the WPS
