DEPARTMENT OF TRANSPORTATION

Quality Assurance and Source Inspection

Contract #: 04-0120F4Cty: SF/ALA Rte: 80 PM: 13.2/13.9File #: 1.28**WELDING INSPECTION REPORT****Resident Engineer:** Casey, William**Address:** 333 Burma Road**City:** Oakland, CA 94607**Report No:** WIR-029165**Date Inspected:** 25-Feb-2013**Project Name:** SAS Superstructure**OSM Arrival Time:** 700**Prime Contractor:** American Bridge/Fluor Enterprises, a JV**OSM Departure Time:** 1730**Contractor:** American Bridge/Fluor Enterprises, a JV**Location:** Job Site**CWI Name:** As noted below**CWI Present:** Yes No**Inspected CWI report:** Yes No N/A**Rod Oven in Use:** Yes No N/A**Electrode to specification:** Yes No N/A**Weld Procedures Followed:** Yes No N/A**Qualified Welders:** Yes No N/A**Verified Joint Fit-up:** Yes No N/A**Approved Drawings:** Yes No N/A**Approved WPS:** Yes No N/A**Delayed / Cancelled:** Yes No N/A**Bridge No:** 34-0006**Component:** SAS OBG**Summary of Items Observed:**

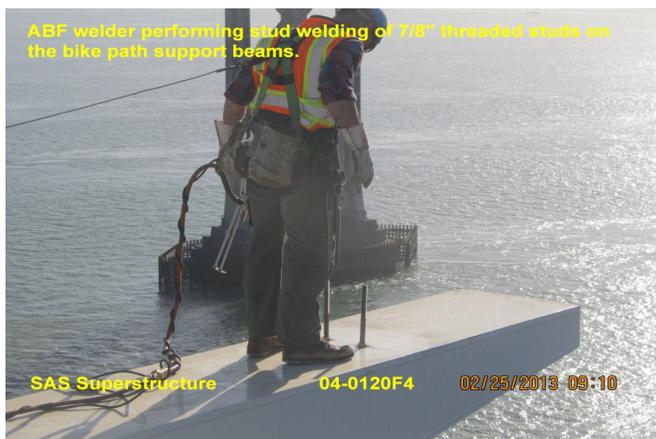
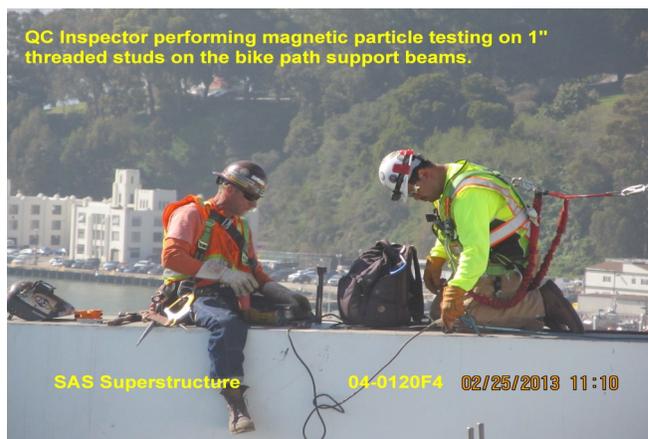
This QA Inspector randomly observed ABF welder Ethan Kent #7726 perform the Stud Welding process on the Bike Path support beams on the East OBG on panel points 109, 111, 115, 123, 125, 127 and 128. A total of two 7/8" threaded studs were placed and bend tested prior to the intended application and within the parameters of ABF-WPS-5001-STUD. This QA Inspector and QC verified the complete fusion and the allowable offset in degrees. This QA Inspector made subsequent observations to monitor quality and noted that the work at this location appeared to be in general conformance with the contract documents.

This QA Inspector randomly observed ABF welder Mike Jimenez #4671 perform the SMAW welding process in the 1G flat position on 1" threaded studs on the bike path support beams located at panel point 121. The studs were

prepared with a 45° bevel on two sides and upon completion of one side, the root was back gouged and tested by means of Magnetic Particle (MT) testing to ensure soundness of the metal and complete fusion. The parameters and the welding were monitored by QC for compliance with ABF-WPS-D1.5-1100-Revision 1. This QA Inspector made subsequent observations throughout the shift to monitor quality and noted that the work at this location appeared to be in general conformance with the contract specifications.
