Contract #: 04-0120F4Cty: SF/ALA Rte: 80 PM: 13.2/13.9File #: 99.28**WELDING INSPECTION REPORT****Resident Engineer:** Casey, William**Address:** 333 Burma Road**City:** Oakland, CA 94607**Report No:** WIR-029208**Date Inspected:** 28-Feb-2013**Project Name:** SAS Superstructure**OSM Arrival Time:** 700**Prime Contractor:** American Bridge/Fluor Enterprises, a JV**OSM Departure Time:** 1530**Contractor:** USA Hoist**Location:** USA Hoist, Crest Hill, IL

Bridge No: 34-0006**Component:** SAS Tower Elevator**Summary of Items Observed:**

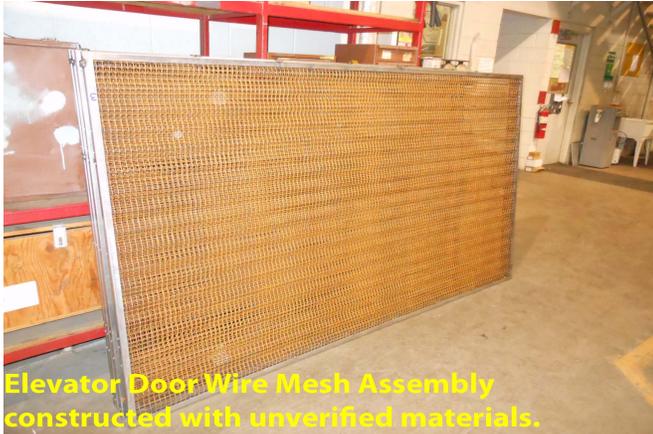
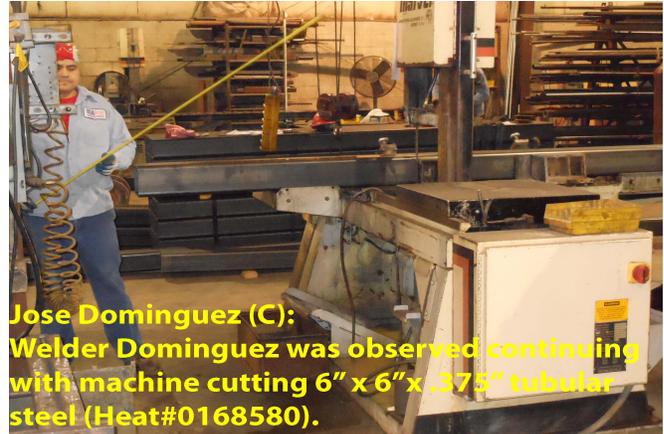
Welder Wasigi was observed continue with removing the temporary mounting bolts of the Door Mesh to the Door Frame and countersink drilling the door stop bolts holes for the door mesh M8 x 25MM LG, FHCS mounting bolts for door 6. Afterwards welder was observed fitting door to the Full Gate Assembly for fit check.

Welder Dominguez was observed continuing with machine cutting 6" x 6" x .375" tubular steel (Heat#0168580) for the elevator tower to the specified lengths.
