**DEPARTMENT OF TRANSPORTATION**

Contract #: 04-0120F4Cty: SF/ALA Rte: 80 PM: 13.2/13.9File #: 99.28**WELDING INSPECTION REPORT****Resident Engineer:** Casey, William**Address:** 333 Burma Road**City:** Oakland, CA 94607**Report No:** WIR-029210**Date Inspected:** 04-Mar-2013**Project Name:** SAS Superstructure**OSM Arrival Time:** 700**Prime Contractor:** American Bridge/Fluor Enterprises, a JV**OSM Departure Time:** 1530**Contractor:** USA Hoist**Location:** USA Hoist, Crest Hill, IL

**Bridge No:** 34-0006**Component:** SAS Tower Elevator**Summary of Items Observed:**

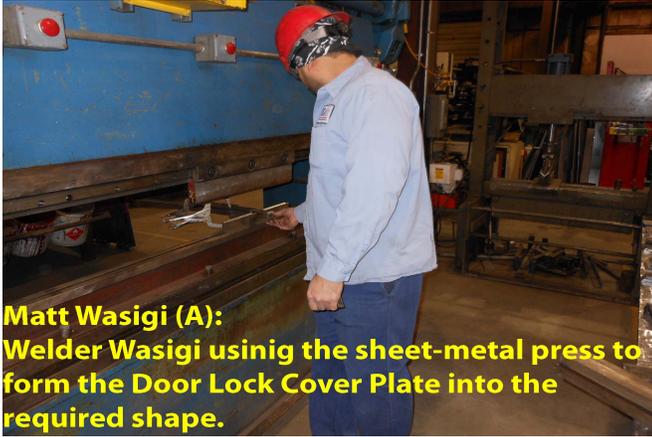
Welder Wasigi was observed to form the using the sheet-metal press by Verson Allsteel Press to form the Door Latch Plate and Door Lock Cover Plate (Part numbers 914900-05 & 914900-06 ) into the required shape for doors number 1 thru 6.

**Matt Wasigi (A):**  
Welder Wasigi using the sheet-metal press to form the Door Lock Cover Plate into the required shape.

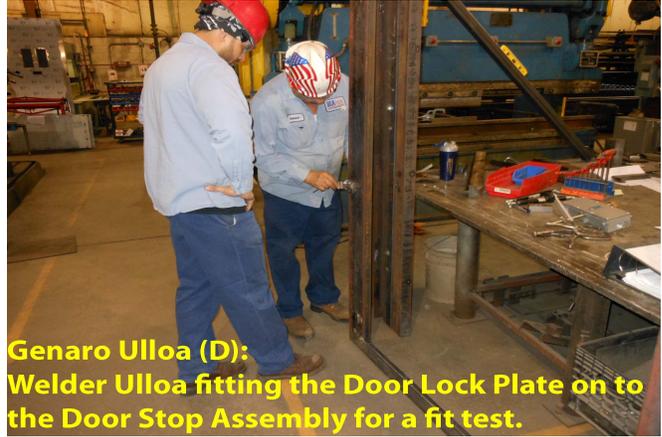
Welder Foreman Ulloa was observed fitting the Door Latch Plate (Part number 914900-06) to the Door Stop Assembly number 5 for a fit test verifying proper fit and clearances.

**Genaro Ulloa (D):**  
Welder Ulloa fitting the Door Lock Plate on to the Door Stop Assembly for a fit test.

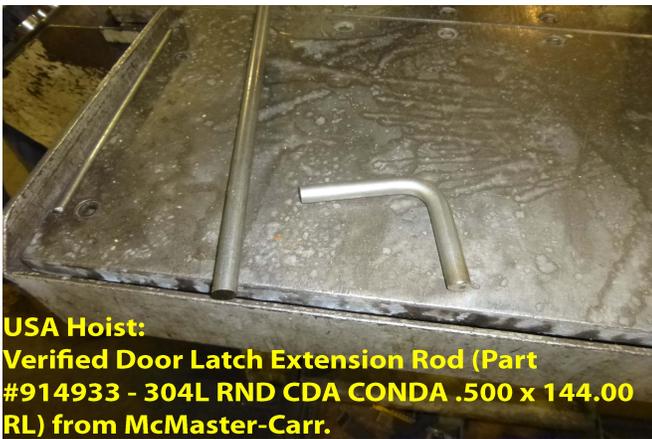
**USA Hoist:**  
Verified Door Latch Extension Rod (Part #914933 - 304L RND CDA CONDA .500 x 144.00 RL) from McMaster-Carr.
