Contract #: 04-0120F4Cty: SF/ALA Rte: 80 PM: 13.2/13.9File #: 1.28**WELDING INSPECTION REPORT**

Report No: WIR-029251
Date Inspected: 16-Mar-2013

Project Name: SAS Superstructure
Prime Contractor: American Bridge/Fluor Enterprises, a JV
Contractor: American Bridge/Fluor Enterprises, a JV

CWI Name:	Bernie Docena	CWI Present:	Yes	No
Inspected CWI report:	Yes No N/A	Rod Oven in Use:	Yes	No N/A
Electrode to specification:	Yes No N/A	Weld Procedures Followed:	Yes	No N/A
Qualified Welders:	Yes No N/A	Verified Joint Fit-up:	Yes	No N/A
Approved Drawings:	Yes No N/A	Approved WPS:	Yes	No N/A
		Delayed / Cancelled:	Yes	No N/A
Bridge No:	34-0006	Component:	Skyway Lifting Lug Holes

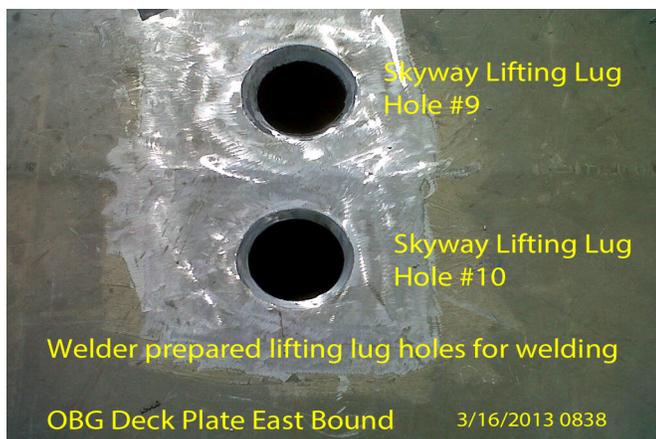
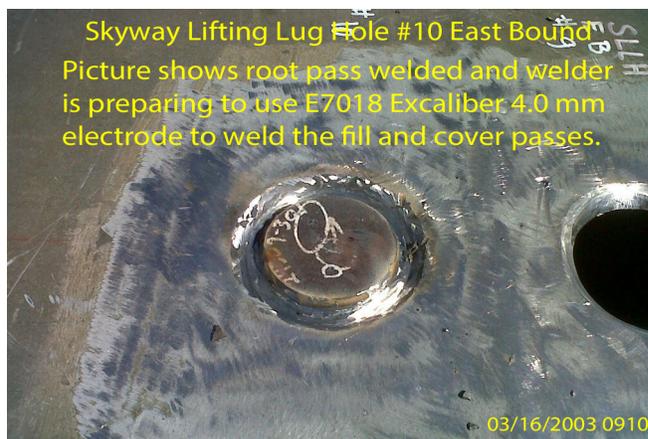
The QA Inspector observed ABF welder Kit Lai (Welder ID 2953) performing the fit-up, tack-weld, root, fill and cover pass weld operation per the Shielded Metal Arc Welding (SMAW) process in the (1G) flat position on the (top side) of deck plate on East bound SLLH #10.

The QA Inspector observed QC Inspector Bernie Docena verify that the fit-up of the lifting lug hole insert plate was fit-up into East bound SLLH #10 within the fit-up tolerances as specified in WPS D1.5-1030-SMAW-1G. The QA Inspector performed a fit-up verification inspection and the fit-up of the lifting lug hole insert plate into East bound SLLH #10 appeared to be in general compliance with WPS D1.5-1030-SMAW-1G

The QA Inspector observed that ABF welder Kit Lai was in-process on the cover pass weld operation on East bound SLLH #10 at the end of this QA Inspectors' shift.

The QA Inspector performed ultrasonic test (UT) verification inspection on the complete-joint penetration (CJP) butt-joint groove weld on East bound SLLH #1 after Quality Control (QC) performed their final NDT as per AWS D1.5-2002 and the contract specifications. The UT verification inspection was performed on 10% of the weld length around the inside and outside diameter of East bound SLLH #1.

The UT verification inspection performed on this date appeared to be in general compliance with AWS D1.5-2002 Table 6.3 for the 16 mm thick butt-joint groove weld of East bound SLLH #1. See TL-6027 Ultrasonic Test Report dated 16-Mar-2013 for further details of the UT inspection.
