**DEPARTMENT OF TRANSPORTATION**

Contract #: 04-0120F4Cty: SF/ALA Rte: 80 PM: 13.2/13.9File #: 1.28**WELDING INSPECTION REPORT****Resident Engineer:** Casey, William**Address:** 333 Burma Road**City:** Oakland, CA 94607**Report No:** WIR-029280**Date Inspected:** 04-Mar-2013**Project Name:** SAS Superstructure**OSM Arrival Time:** 700**Prime Contractor:** American Bridge/Fluor Enterprises, a JV**OSM Departure Time:** 1530**Contractor:** American Bridge/Fluor Enterprises, a JV**Location:** Job Site**CWI Name:** William Sherwood**CWI Present:** Yes No**Inspected CWI report:** Yes No N/A**Rod Oven in Use:** Yes No N/A**Electrode to specification:** Yes No N/A**Weld Procedures Followed:** Yes No N/A**Qualified Welders:** Yes No N/A**Verified Joint Fit-up:** Yes No N/A**Approved Drawings:** Yes No N/A**Approved WPS:** Yes No N/A**Delayed / Cancelled:** Yes No N/A**Bridge No:** 34-0006**Component:** SAS OBG**Summary of Items Observed:**

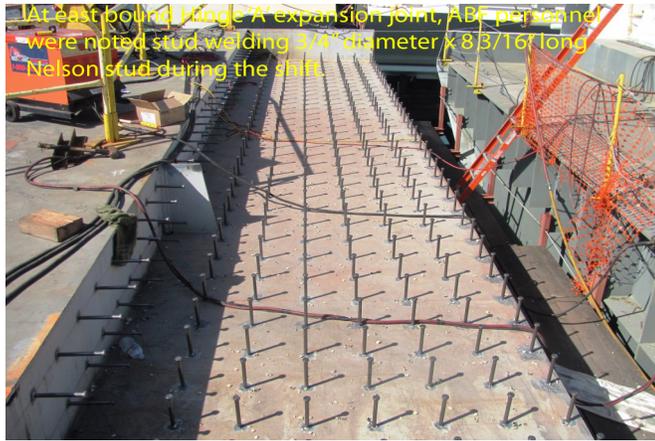
At the Hinge 'A' expansion joint of OBG to skyway, QA randomly observed ABF welder Mathew Cochran continuing to perform flat and horizontal stud welding on 3/4" diameter x 8 3/16" long stud to the top and side of the expansion joint deck as per the procedures ABF-WPS-D1.5-5062 (horizontal position) and ABF-WPS-D1.5-5063 (flat position). The welder performed a pre-production test of two (2) studs and were bent to an approximate angle of 30 degrees utilizing a ten pound sledge hammer. The welding and testing of the two studs were performed in the flat position. At the conclusion of the test, the welder started the production stud welding. Later in the shift the welder performed a pre-production test on two studs that were welded in the horizontal position utilizing the same size studs. The test results were noted as acceptable and at the conclusion of the test the welder started the stud welding on the side of the expansion deck implementing procedure ABF-WPS-D1.5-5062. The stud welding was not completed during this shift.

At east bound Hinge 'A' expansion joint, ABF personnel were noted stud welding 3/4" diameter x 8 3/16" long Nelson stud during the shift.

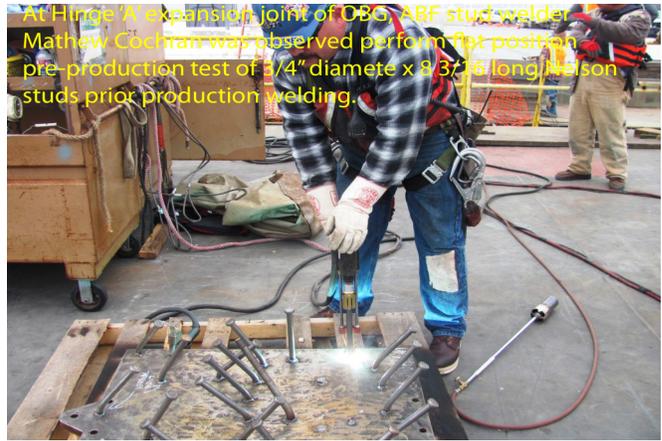
At Hinge 'A' expansion joint of OBG, ABF stud welder Mathew Cochran was observed perform flat position pre-production test of 3/4" diameter x 8 3/16" long Nelson studs prior production welding.

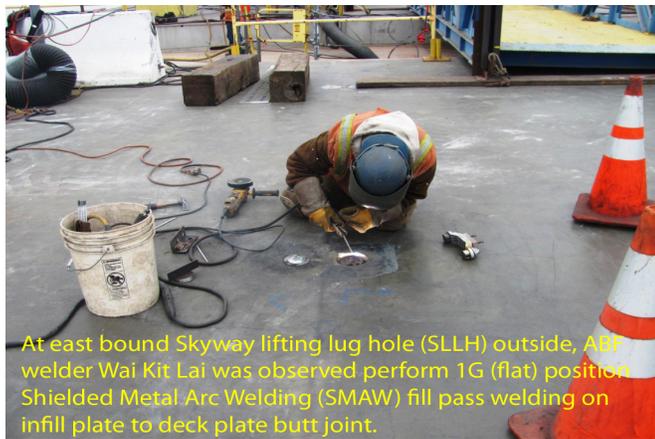
At East bound skyway lifting lug plate identified as ESSLH-6, located at the deck plate, this QA randomly observed ABF welder Wai Kit Lai perform the continued SMAW welding of the fill passes. The weld joint appears to have a 45 degrees single bevel groove using a copper backing plate that will be removed at conclusion of the welding. The welder was noted welding the lifting lug hole plate to top deck using 1/8" diameter E7018H4R electrode as per the Welding Procedure Specification (WPS) ABF-WPS-D15-1030-1. The ABF QC Inspector, William Sherwood, was noted monitoring the welding parameters and prior to the welding, Mr. Sherwood, together with this QA performed the fit-up inspection and at the conclusion of the inspection the fit-up appeared to comply with the contract documents. The welding of the lifting lug plate was completed and the preparation process was started on the lifting lug plate identified as weld number ESSLH-5.

At east bound Skyway lifting lug hole (SLLH) outside, ABF welder Wai Kit Lai was observed perform 1G (flat) position Shielded Metal Arc Welding (SMAW) fill pass welding on infill plate to deck plate butt joint.

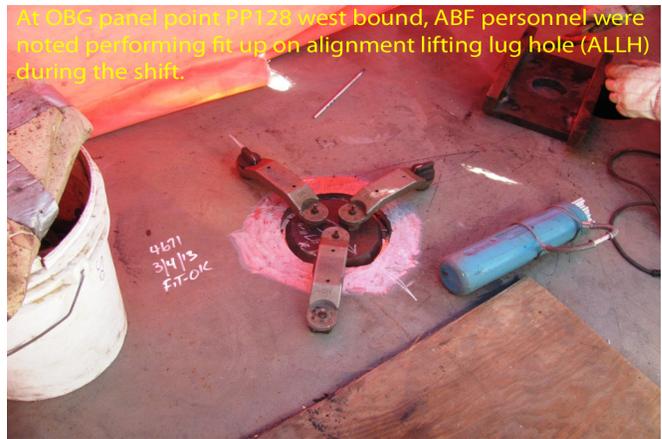
At OBG panel point PPT28 west bound, ABF personnel were noted performing fit up on alignment lifting lug hole (ALLH) during the shift.
