DEPARTMENT OF TRANSPORTATION

Quality Assurance and Source Inspection

Contract #: 04-0120F4Cty: SF/ALA Rte: 80 PM: 13.2/13.9File #: 1.28**WELDING INSPECTION REPORT****Resident Engineer:** Casey, William**Address:** 333 Burma Road**City:** Oakland, CA 94607**Report No:** WIR-029320**Date Inspected:** 16-Mar-2013**Project Name:** SAS Superstructure**OSM Arrival Time:** 700**Prime Contractor:** American Bridge/Fluor Enterprises, a JV**OSM Departure Time:** 1530**Contractor:** American Bridge/Fluor Enterprises, a JV**Location:** Job Site

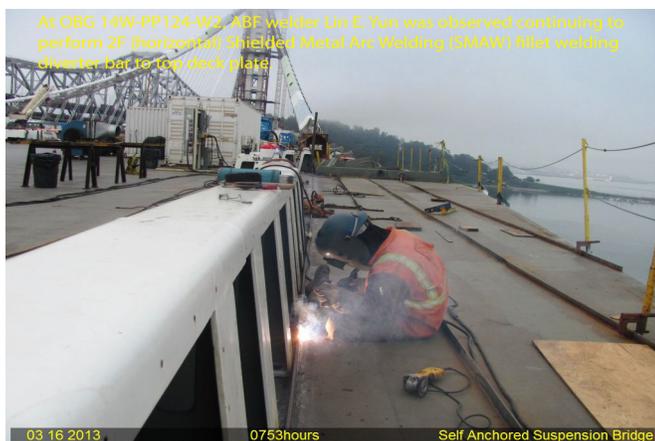
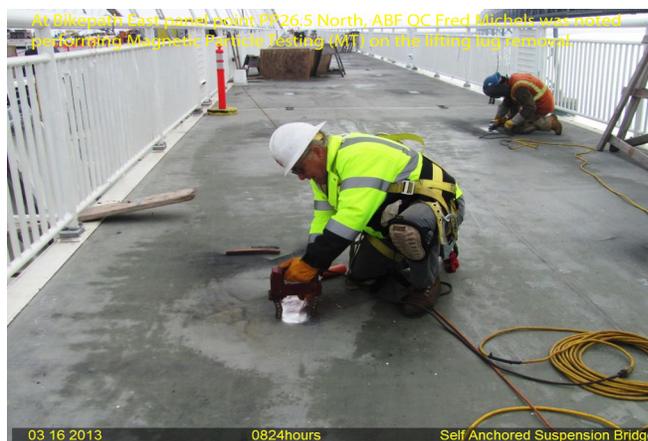
At OBG 13W-PP124-PP127-W2 top deck plate diverter bar, QA observed ABF welders Lin E. Yun and Guo Wu Chen perform the fillet welding on 2 1/4" wide x 3/8" thick diverter bar to the deck plate. The welders were welding in 2F (horizontal position) using 1/8" diameter E7018H4R electrode as per the Welding Procedure Specification (WPS) ABF-WPS-D15-F1200A. The diverter bar was originally fillet welded both on sides of the bar to the deck plate but was removed using carbon arc and ground smooth due to interference with the safety bridge railing. During welding, ABF Quality Control (QC) William Sherwood was noted monitoring the welding parameters of the welders. At the end of the shift, the fillet welding was not completed and will continue on the next scheduled shift.

At OBG 12W-PP116.5-W2 deck access hole inside, QA randomly observed the ABF/JV welder Chris Bruce perform the back gouging on the Complete Joint Penetration (CJP) butt joint. This task was not completed during this shift and will continue on the next scheduled shift.

1. L14E-PP127.75-E4 North-OBG lifting lug (pyramid) removal QA verified
2. L14E-PP127.75-E4 South-OBG lifting lug (pyramid) removal QA verified
3. Skyway east bound-lifting lug hole #1 removal QA verified.
4. Skyway east bound-lifting lug hole #5 removal QA verified.
5. Bikepath east panel point PP26.5-north lifting lug removal QA verified.
6. Bikepath east panel point PP27.5-north lifting lug removal QA verified.
7. Bikepath east panel point PP30.5-north and south lifting lug removal QA verified.
8. Bikepath east panel point PP31.5-north and south lifting lug removal QA verified.
9. Bikepath east panel point PP32.5-north and south lifting lug removal QA verified.
10. Bikepath east panel point PP33.5-north and south lifting lug removal QA verified.
11. Bikepath east panel point PP34.5-north and south lifting lug removal QA verified.
